EAST CAROLINA UNIVERSITY

Facility Condition Assessment

Old Cafeteria Complex

Inspected January 26, 2023

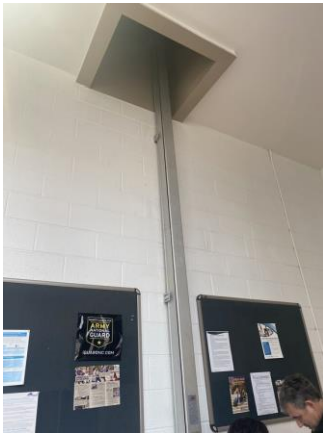
047001a 1/26/2023
Painted CMU wall and painted ceiling, roof ladder
Corridor

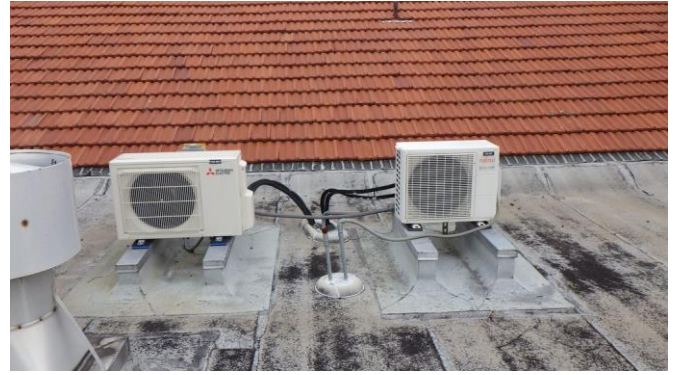
Supplementary cooling in IT closets is provided by two split ductless units. Both should be planned for replacement within the next ten years.

047001e 1/26/2023
Ductless split system condensing units CU#1, CU#2
Roof, south side

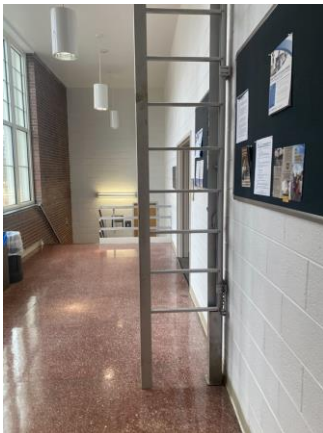
047002a 1/26/2023
CMU walls, terrazzo floor, roof ladder
Corridor

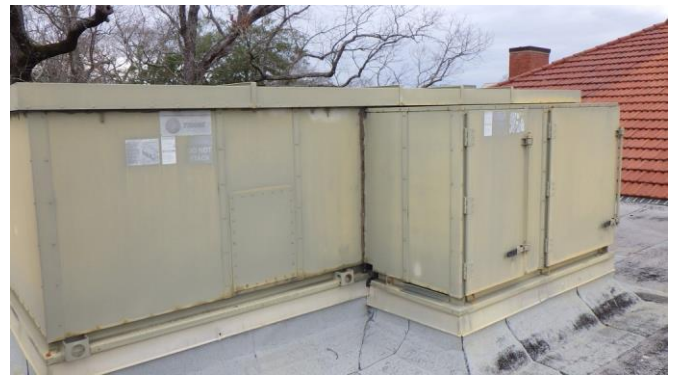
Heating, ventilation, and air conditioning are provided by unitary rooftop package units, split ductless units, and forced air units (air handlers) of various sizes. The 25 ton package unit serving the south wing offices will reach the end of its expected useful life within the report scope and should be planned for replacement. The first floor in this area is underserved by built-up air handlers located in small mechanical spaces, and humidity is a constant concern. These units should be replaced. It is likely that a small re-commissioning project will be necessary to properly design the HVAC system to condition these spaces.

047002e 1/26/2023
Rooftop package unit RT#1
Roof, south side

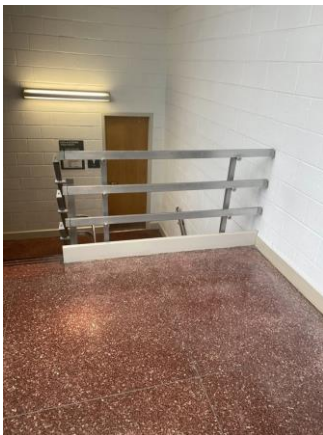
Accessibility legislation requires that stairs have graspable handrails on both sides, that the rails have a specific end geometry, and that the handrails continue horizontally at the landings. The stairs are deficient in handrail and guardrail design relative to current standards, and the stair finishes have deteriorated or are otherwise unsafe. Future renovation efforts should include comprehensive stair railing and finish upgrades.

047003a 1/26/2023
CMU walls, terrazzo floor, noncompliant guardrail
Stairwell

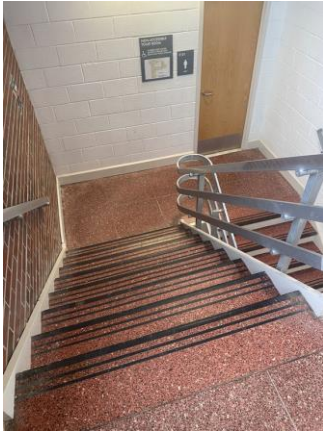
047004a 1/26/2023
CMU walls, terrazzo floor, noncompliant railing
Stairwell

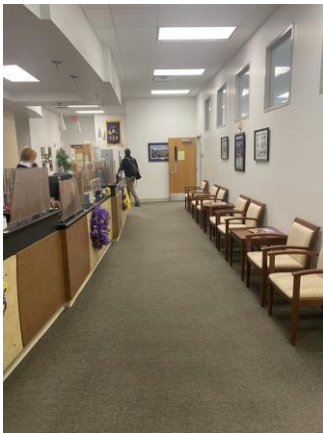
047005a 1/26/2023
Acoustical tile ceiling, painted walls, carpeting, counter
Work area

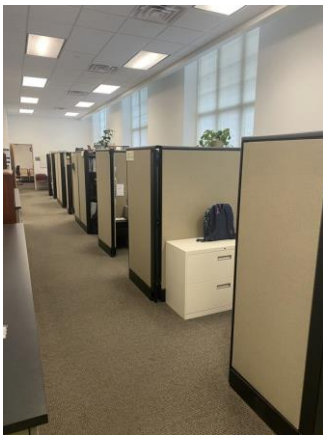
047006a 1/26/2023
Acoustical tile ceiling, painted walls, carpeting
Work area

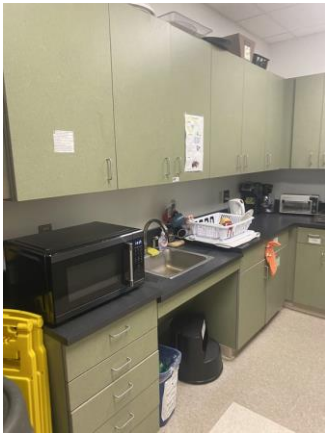
laminated counters and cabinetry. They are near the end of their lifecycle and should be replaced within the next ten years.

047007a 1/26/2023
Casework with a sink, vinyl tile floor, acoustical tile ceiling
Break area

The configuration of break room kitchenettes on the ground and second floors are a barrier to accessibility. The installation of wheelchair accessible kitchenette cabinetry is recommended.

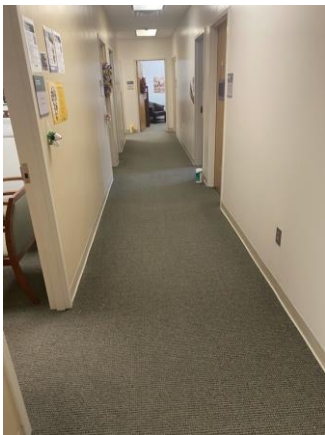
047009a 1/26/2023
Acoustical tile ceiling, painted walls, carpeting, wood doors
Corridor

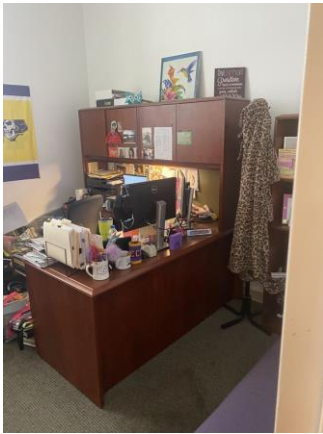
047010a 1/26/2023
Painted walls, carpeting
Office

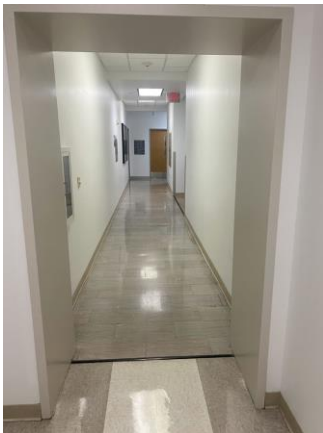
047011a 1/26/2023
Acoustical tile ceiling, vinyl floor tile (with and without
asbestos), painted walls, wood doors
Corridor

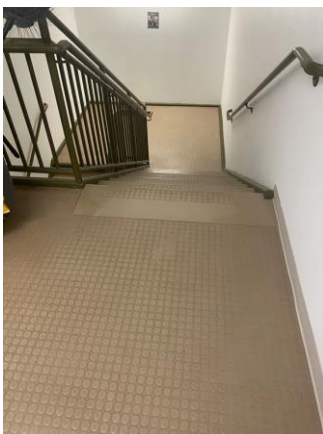
047012a 1/26/2023
Vinyl treads and landings, metal railings
Stairwell

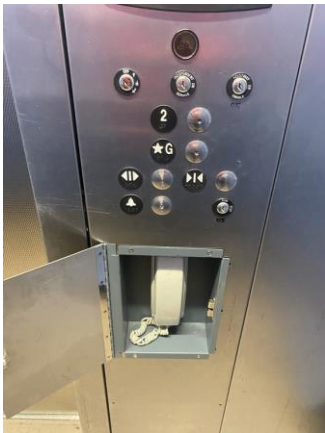
047014a 1/26/2023
Noncompliant elevator phone
Elevator

The elevator is partially ADA compliant. It is recommended that a compliant hands-free phone be installed to meet current standards.

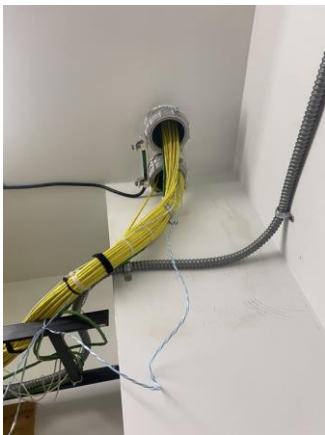
047015a 1/26/2023
Penetration through ceiling
Data closet

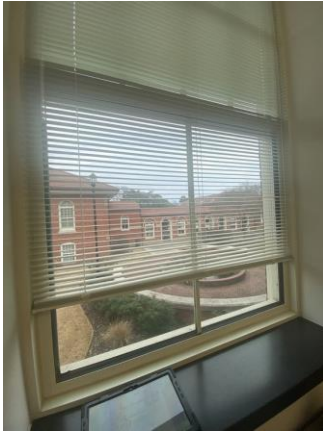
047016a 1/26/2023
Dual-pane, metal frame window
Tutor room

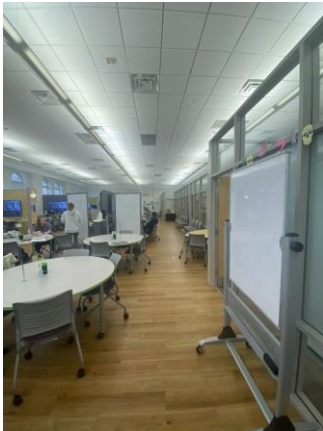
047017a 1/26/2023
Acoustical tile ceiling, wood flooring
Tutor room

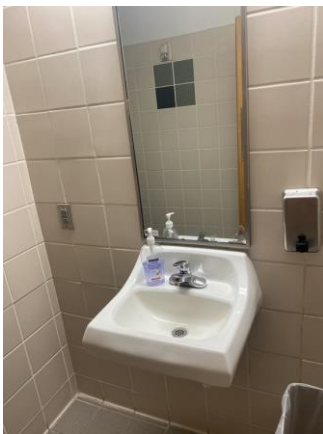
047018a 1/26/2023
Tile wall and floor, lavatory
Restroom

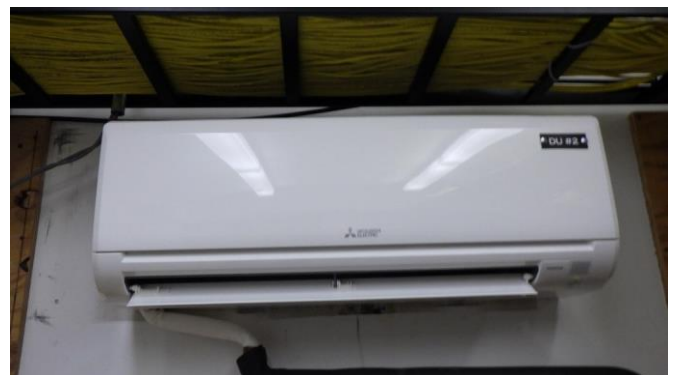
047018e 1/26/2023
Ductless split system evaporative unit DU#2
Communications 2210

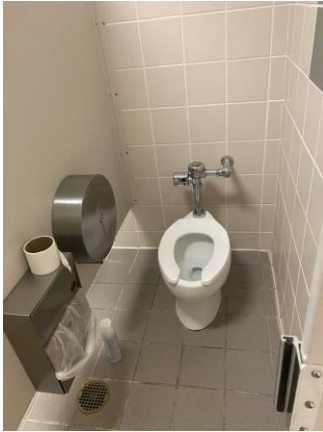
047019a 1/26/2023
Tile walls and floor, toilet with hands-free flush valve
Restroom

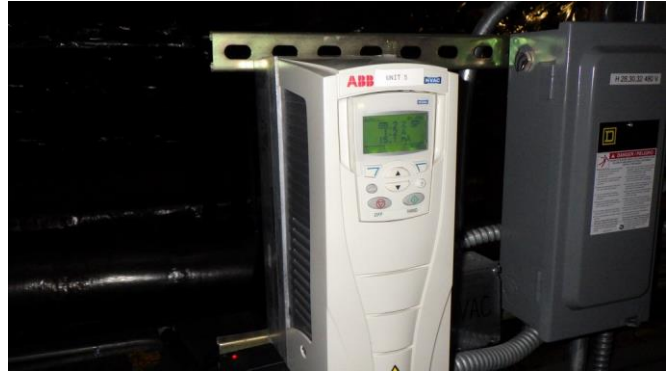
047019e 1/26/2023
FCU#5 supply fan VFD
Attic (above 2300)

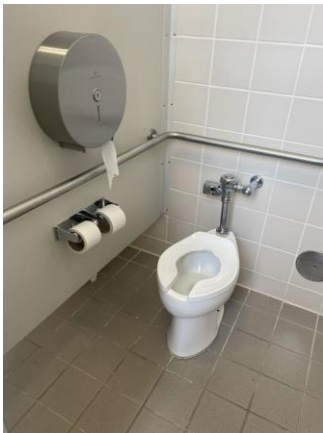
047020a 1/26/2023
Tile walls and floor, accessible water closet
Restroom

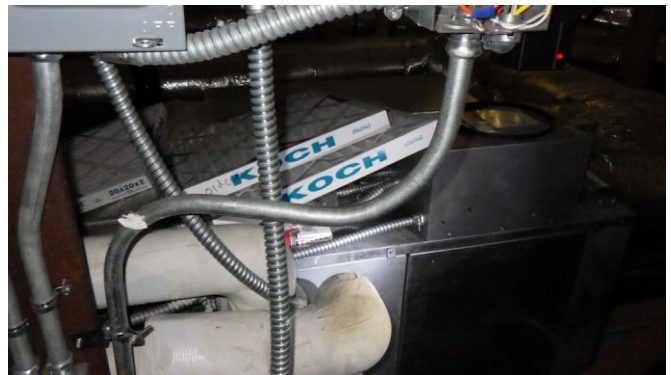
047020e 1/26/2023
FCU #6
Attic (above 2300)

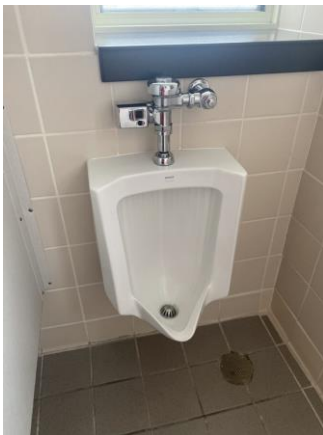
047021a 1/26/2023
Tile walls and floor, urinal
Restroom

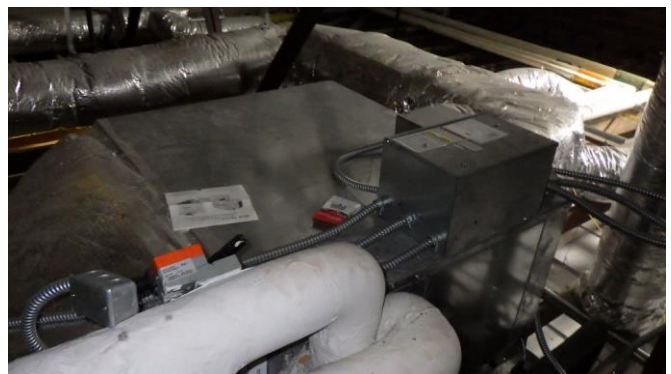
047021e 1/26/2023
FCU #3
Attic (above 2300)

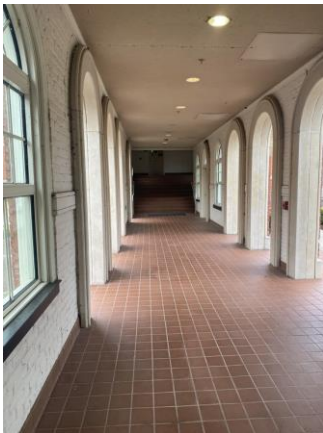
047023a 1/26/2023
Painted brick, quarry tile
Breezeway

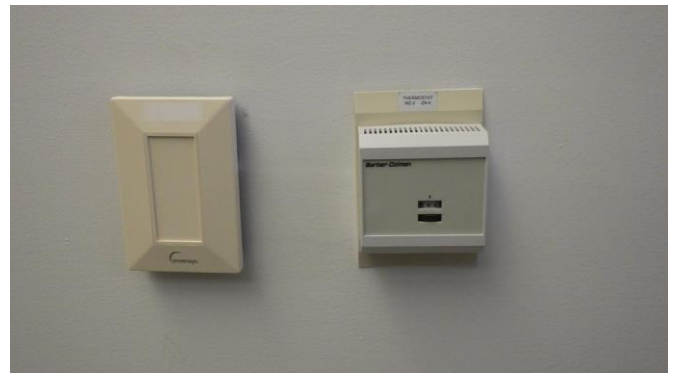
047023e 1/26/2023
HVAC sensor and thermostat
Corridor 2200D

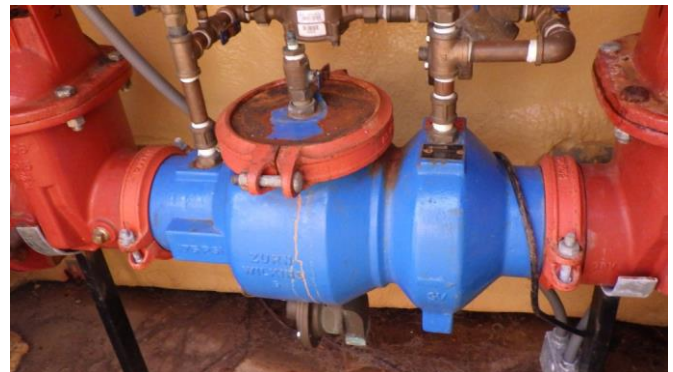
047024e 1/26/2023
Fire suppression system backflow preventer
North side

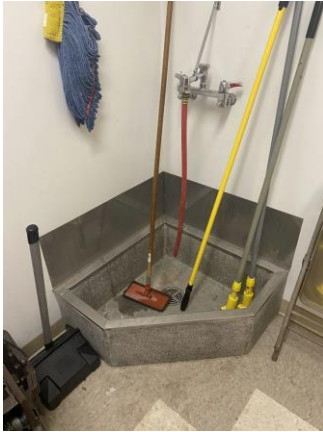
047025a 1/26/2023
Concrete utility sink
Custodial closet

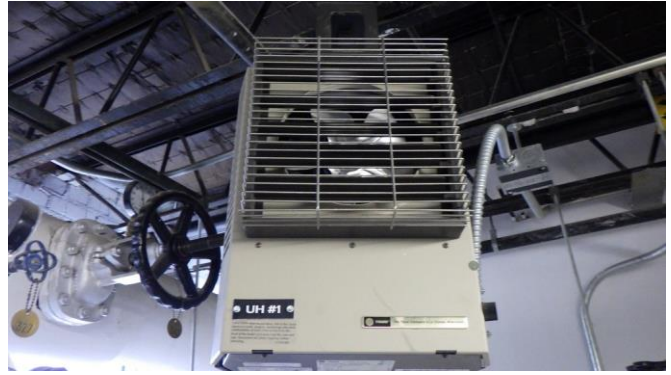
047025e 1/26/2023
Electric unit heater
Mechanical room G520

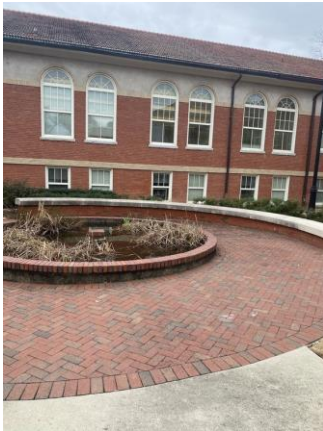
047026a 1/26/2023
Brick facade, clay tile roof, glazing
Courtyard

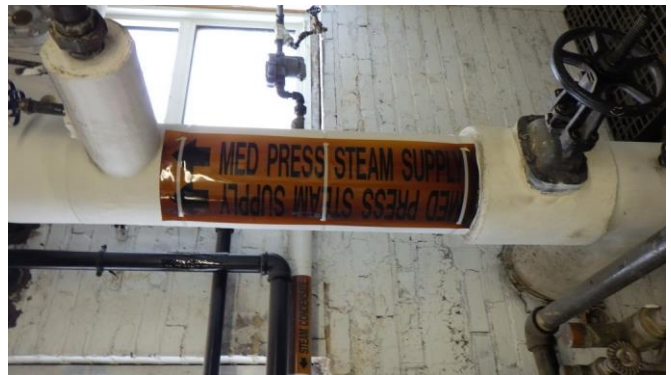
047026e 1/26/2023
Campus steam distribution network
Mechanical room G520

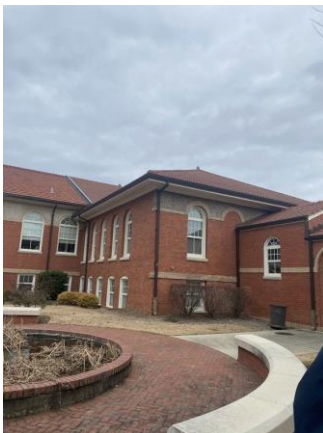
047027a 1/26/2023
Brick facade, clay tile roof, glazing
Courtyard

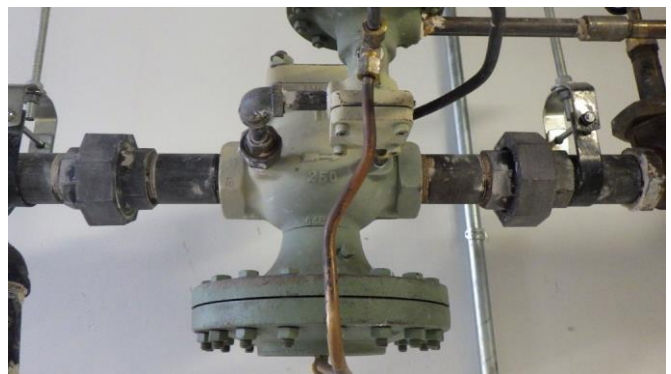
047027e 1/26/2023
Medium to service pressure PRV
Mechanical room G520

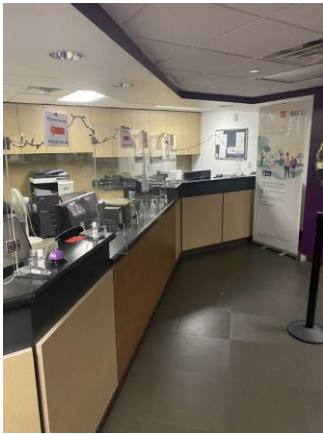
047028a 1/26/2023
Acoustical tile ceiling, tile flooring, casework
Office area

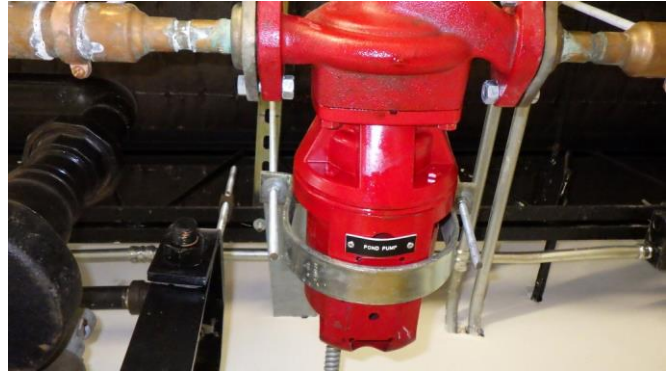
047028e 1/26/2023
Fountain pump
Mechanical room G520

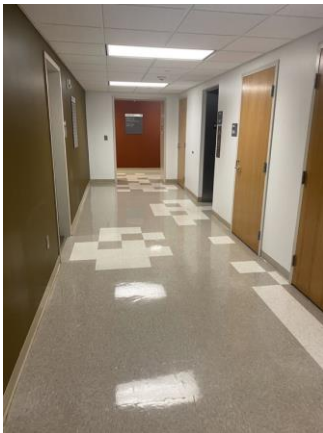
047029a 1/26/2023
Acoustical tile ceiling, vinyl tile floor, wood doors
Corridor

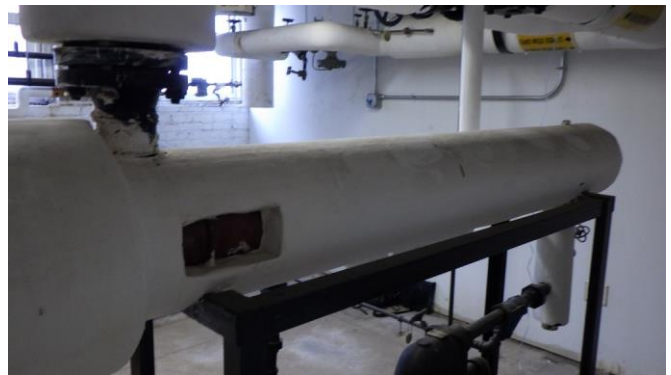
047029e 1/26/2023
Steam to hot water converter - shell-and-tube heat
exchanger
Mechanical room G520

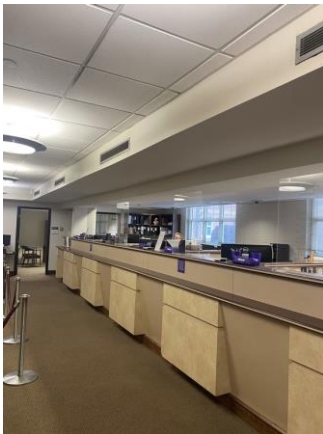
047030a 1/26/2023
Acoustical tile ceiling, carpeting, counter
Work area

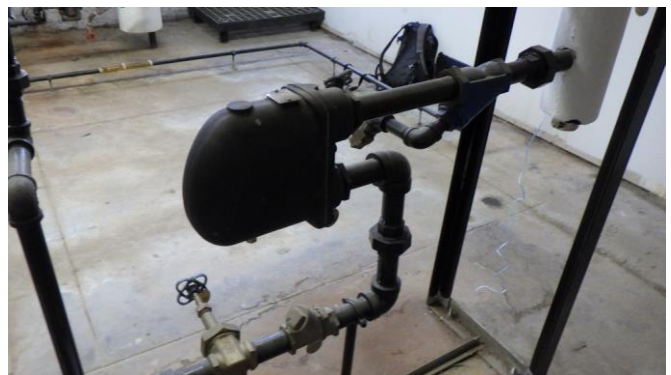
047030e 1/26/2023
HVAC distribution network steam trap
Mechanical room G520

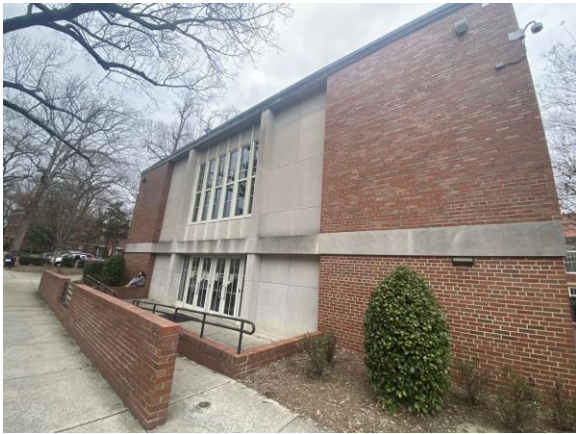
047031a 1/26/2023
Brick facade, glazing, glass entry doors
Exterior

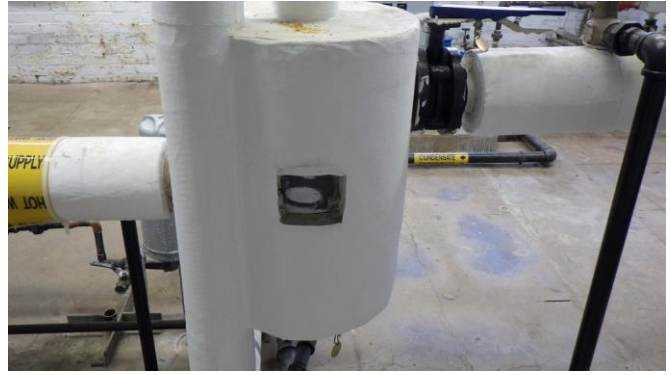
047031e 1/26/2023
HVAC distribution network hot water expansion tank
TAN001
Mechanical room G520

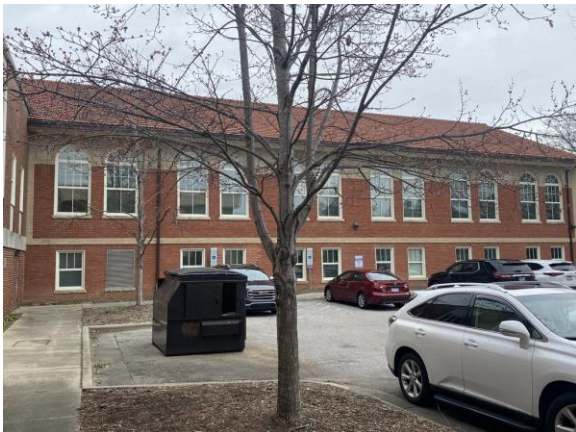
047032a 1/26/2023
Brick facade, glazing, mission tile roof
Exterior

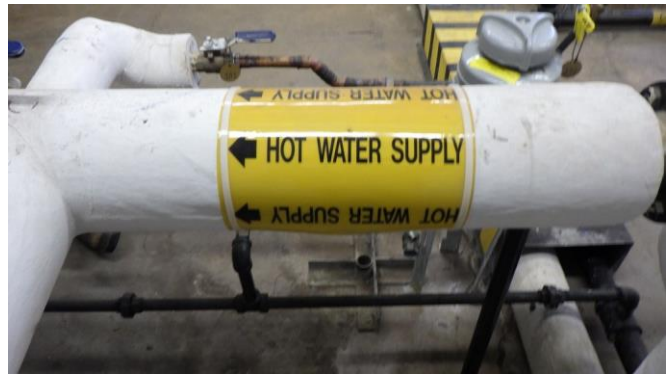
047032e 1/26/2023
HVAC distribution network heating hot water piping
Mechanical room G520

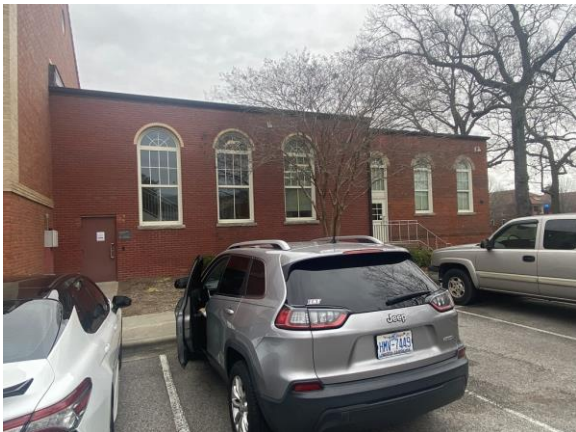
047033a 1/26/2023
Brick facade, glazing, hollow metal doors
Exterior

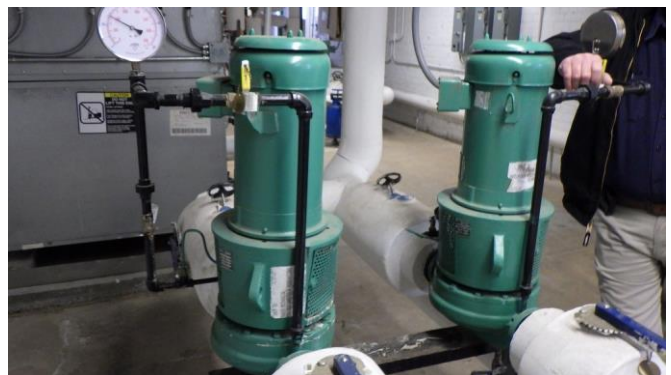
047033e 1/26/2023
HVAC distribution network heating hot water pumps 2, 3
Mechanical room G520

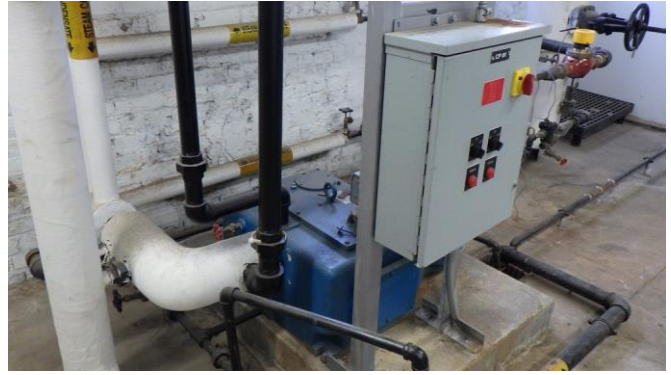
047034e 1/26/2023
Steam electric duplex condensate receiver CP#1
Mechanical room G520

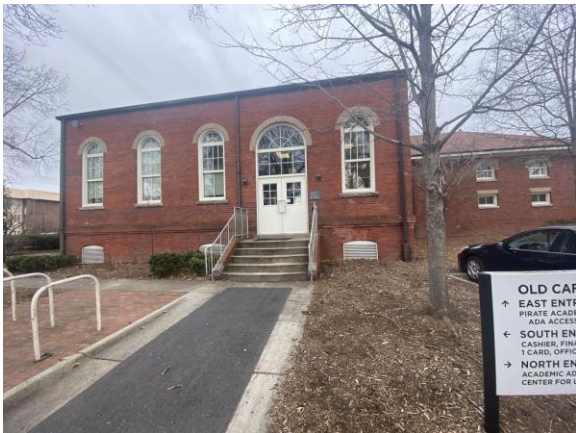
047035a 1/26/2023
Brick facade, glazing, metal and glass doors
Exterior

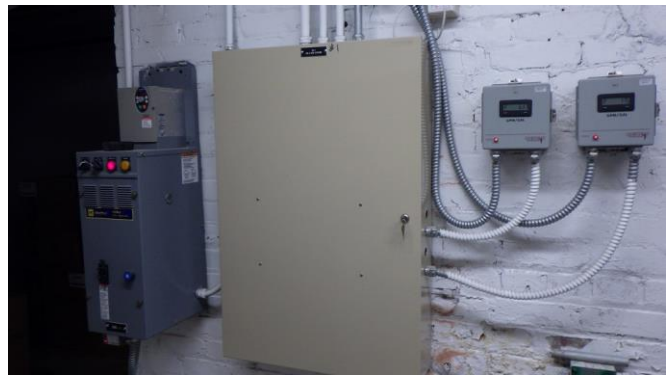
047035e 1/26/2023
HVAC controls panel, flow (energy) meters
Mechanical room G520

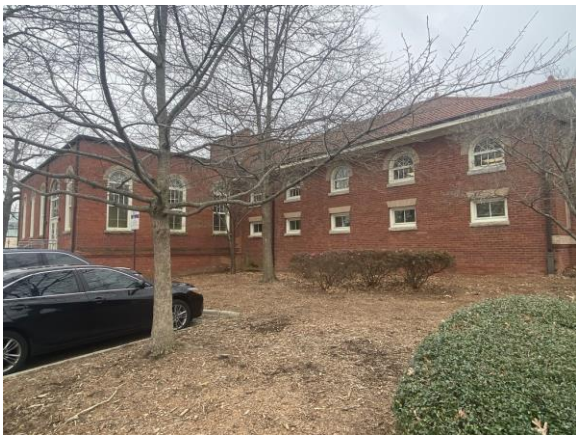
047036a 1/26/2023
Brick facade, glazing
Exterior

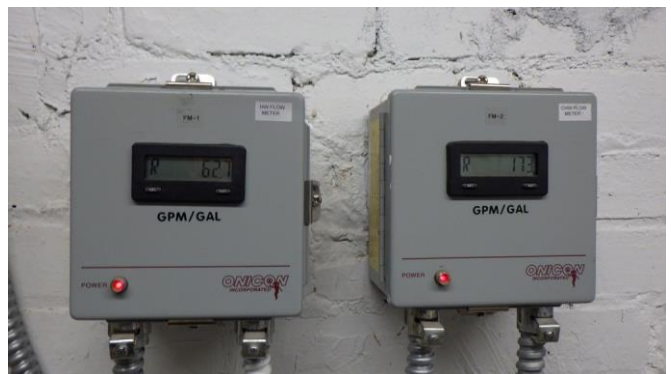
047036e 1/26/2023
HVAC chilled and heating hot water flow (energy) meters
Mechanical room G520

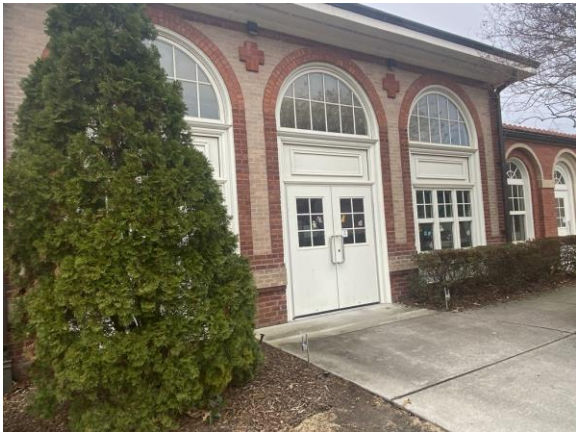
047037a 1/26/2023
Brick facade, glazing, metal and glass doors
Exterior

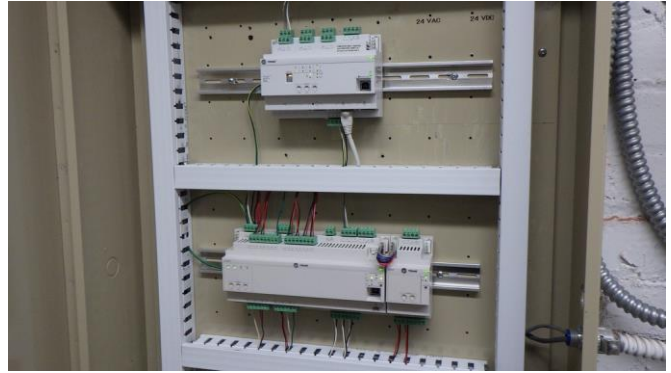
047037e 1/26/2023
HVAC DDC (Trane) controls panel
Mechanical room G520

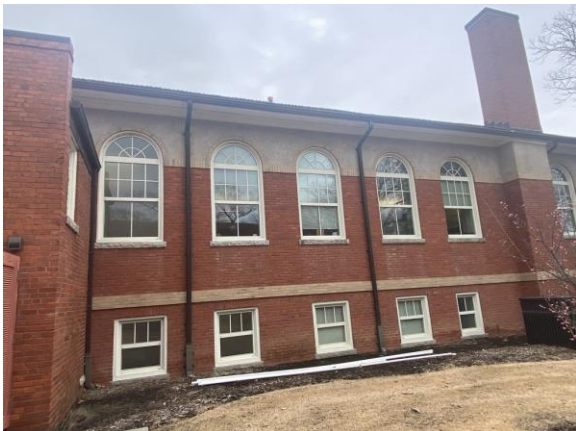
047038a 1/26/2023
Brick facade, glazing, tile roof, gutters and downspouts
Exterior

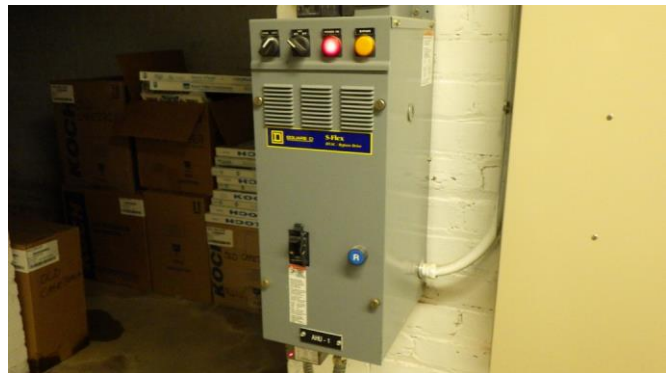
047038e 1/26/2023
AH#1 supply fan VFD Square D
Mechanical room G520

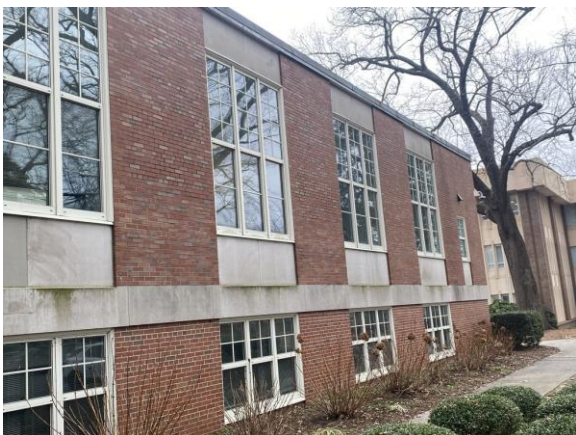
047039a 1/26/2023
Brick facade, glazing
Exterior

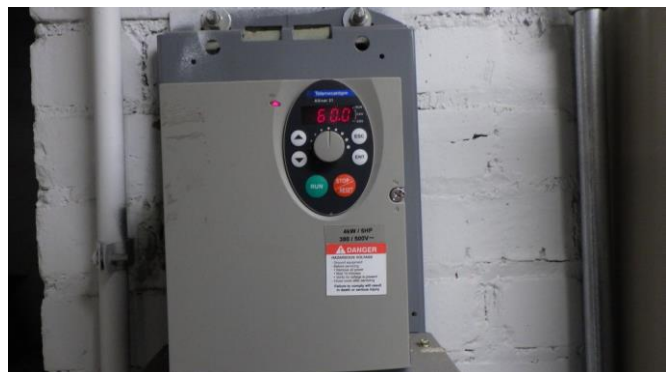
047039e 1/26/2023
AH#1 supply fan VFD Square D
Mechanical room G520

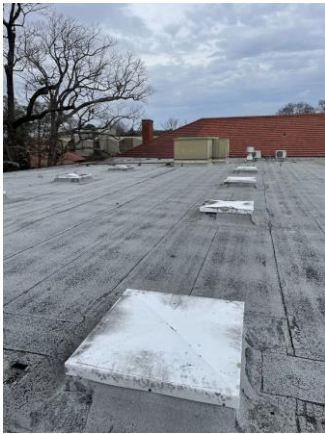
047040a 1/26/2023
Modified bitumen roof
Roof

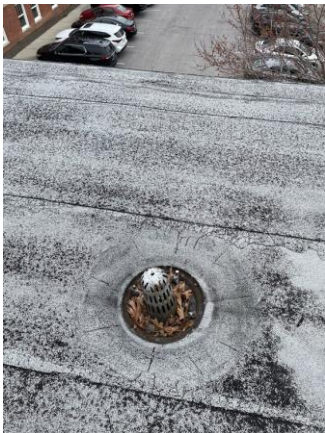
047041a 1/26/2023
Modified bitumen roof
Roof

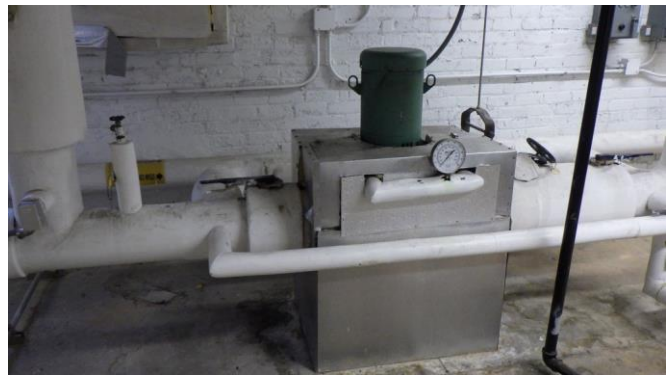
047041e 1/26/2023
HVAC distribution network chilled water pump 1
Mechanical room G520

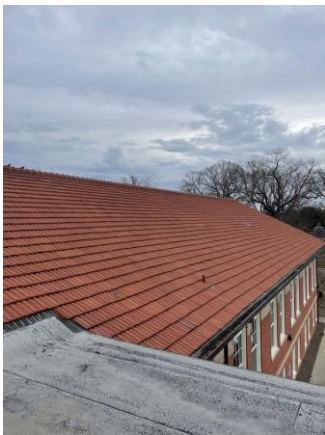
047042a 1/26/2023
Clay tile roof
Roof

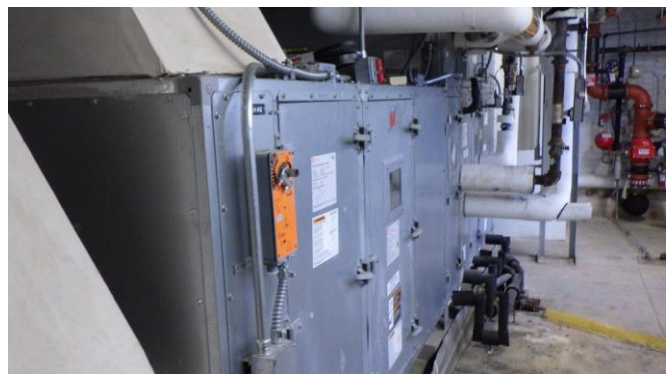
047042e 1/26/2023
Indoor AHU#2
Mechanical room G520

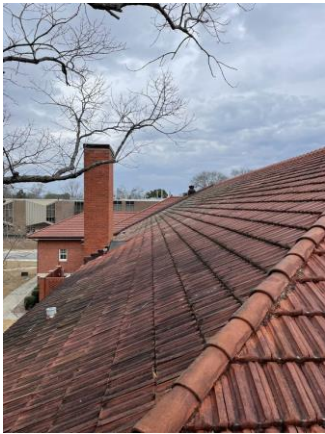
047043a 1/26/2023
Clay tile roof
Roof

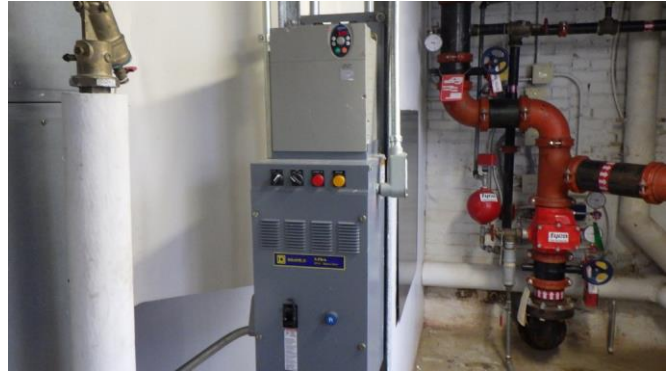
047043e 1/26/2023
AH#2 supply fan VFD, Square D
Mechanical room G520

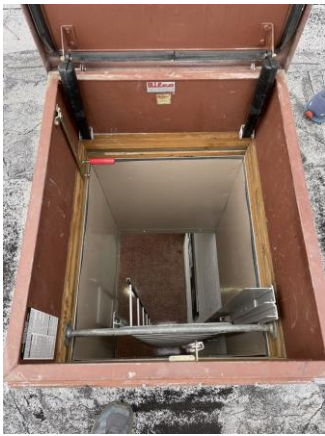
047044a 1/26/2023
Roof hatch
Roof

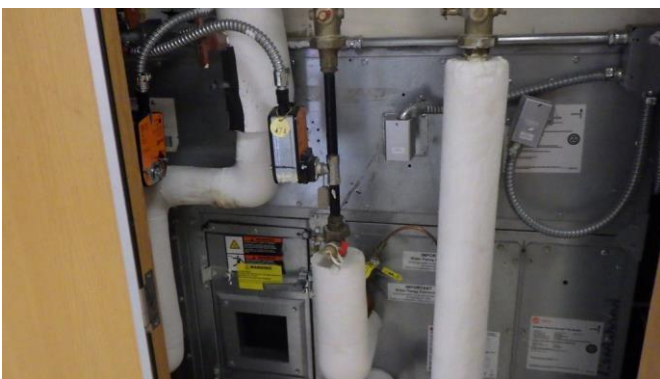
047051e 1/26/2023
HVAC distribution network chilled and heating hot water
piping
Mechanical room G403C

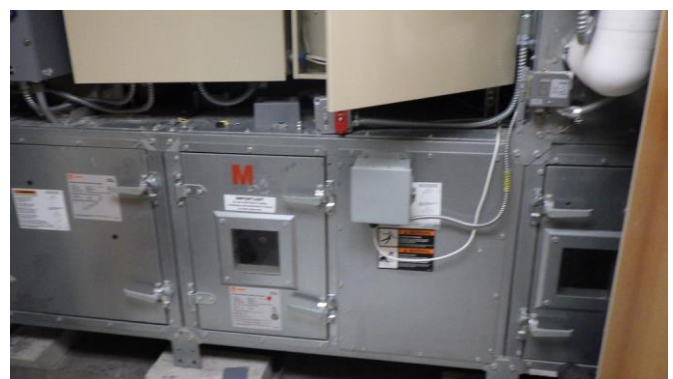
047052e 1/26/2023
Indoor AH#3
Mechanical room G410

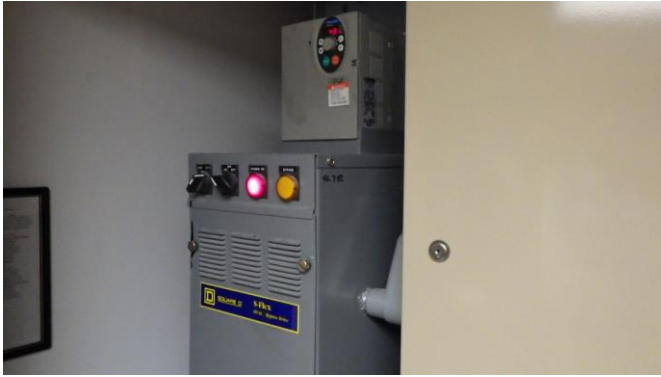
047053e 1/26/2023
AH supply fan VFD, Square D
Mechanical room G410

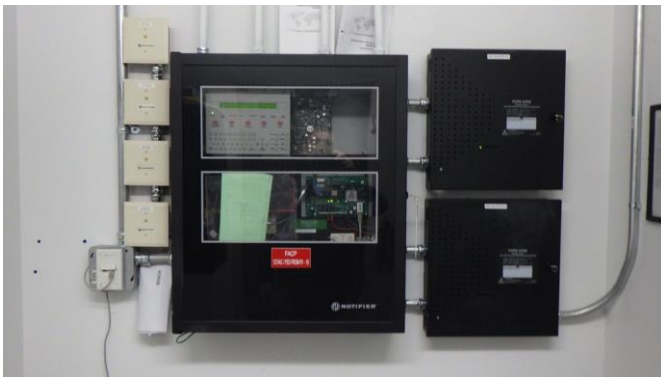
047055e 1/26/2023
Main fire alarm control panel FACP
Electrical room G204

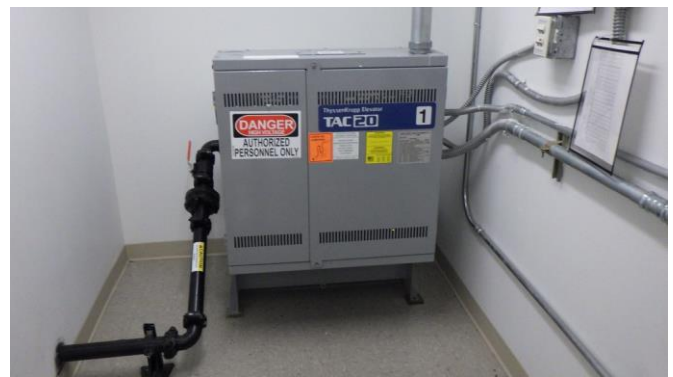
047056e 1/26/2023
Hydraulic passenger elevator #1 machine and controller
Elevator room G206

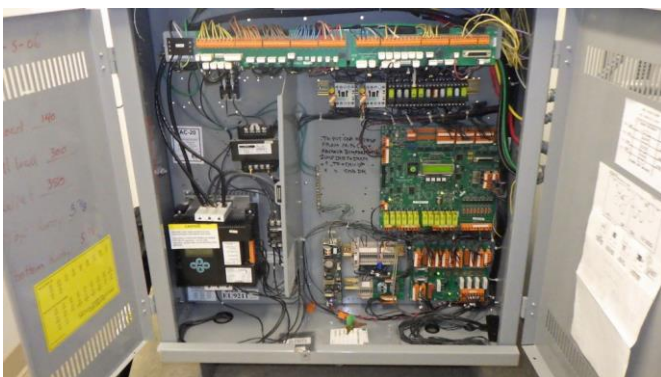
047057e 1/26/2023
Solid state elevator controller
Elevator room G206

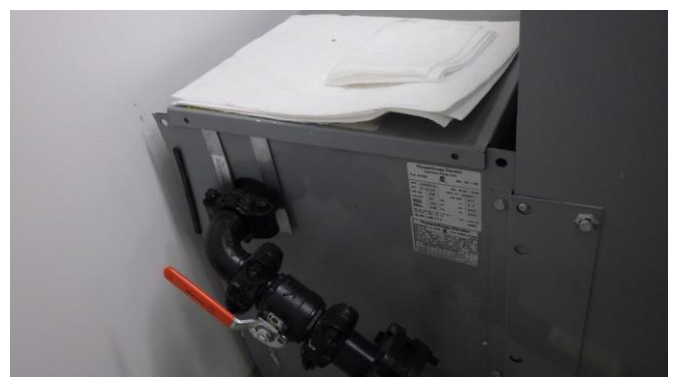
047058e 1/26/2023
Hydraulic passenger elevator #1 machine
Elevator room G206

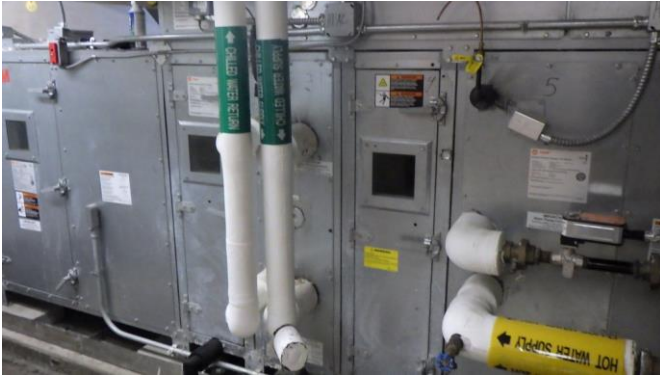
047059e 1/26/2023
Indoor AH#4
Mechanical room G301

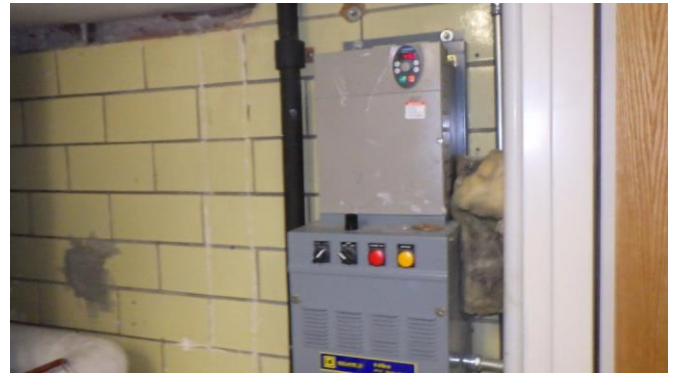
047060e 1/26/2023
AH#4 supply fan VFD, Square D
Mechanical room G301

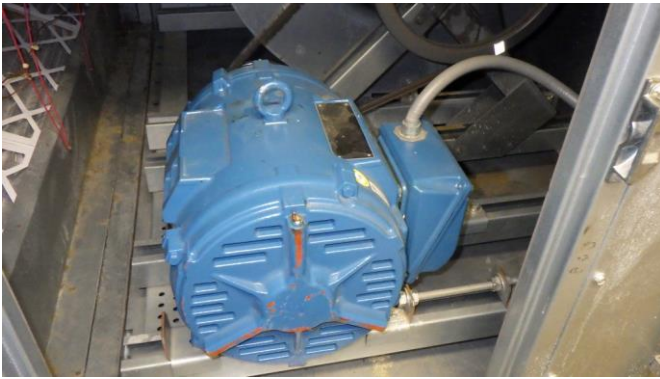
047061e 1/26/2023
AH#4 supply fan motor
Mechanical room G301

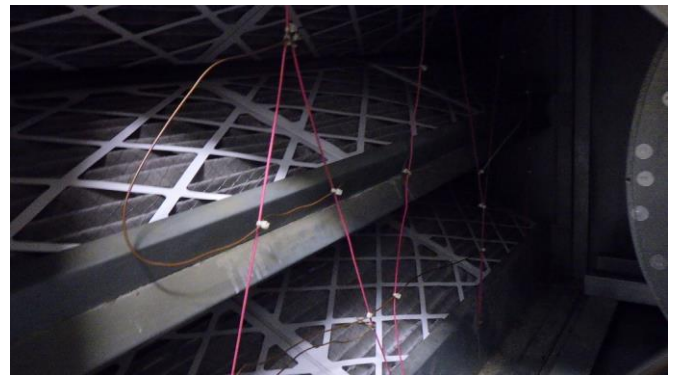
047062e 1/26/2023
AH#4 filtration section
Mechanical room G301

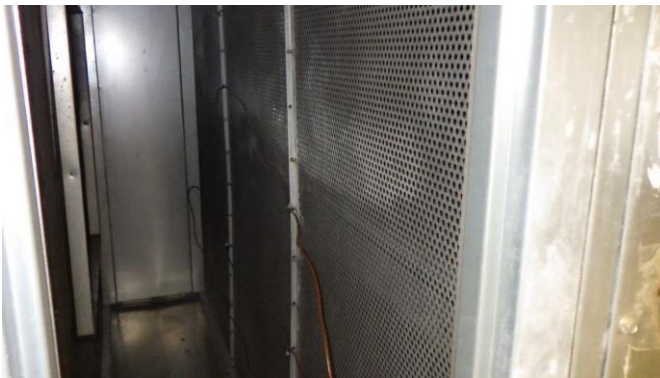
047063e 1/26/2023
AH#4 cooling coil section
Mechanical room G301

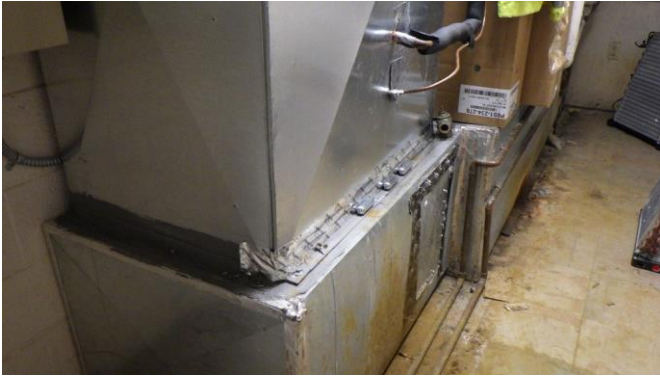
047065e 1/26/2023
Old built-in place air handler
Mechanical room G137

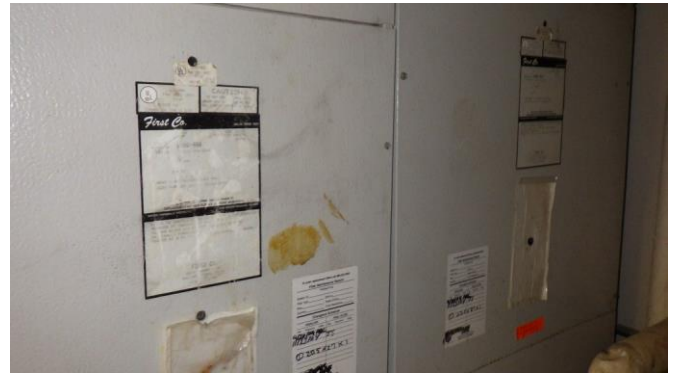
047066e 1/26/2023
Old built-in place air handler
Mechanical room G137

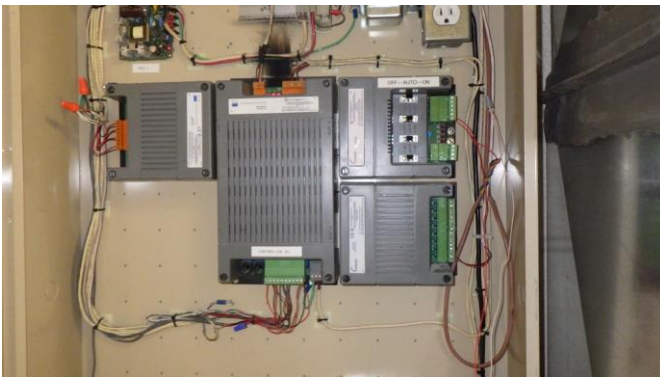
047067e 1/26/2023
HVAC controls panel
Mechanical room G137

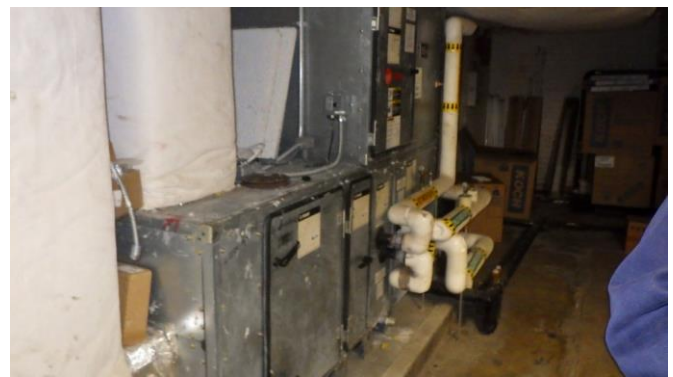
047068e 1/26/2023
Indoor AH#11
Mechanical room G134

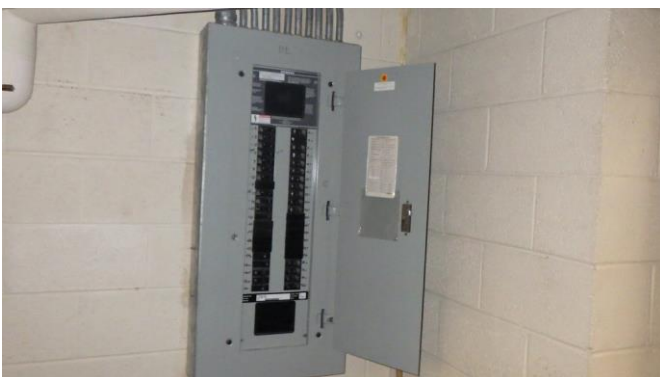
047069e 1/26/2023
Secondary electrical distribution panel DL
Mechanical room G134

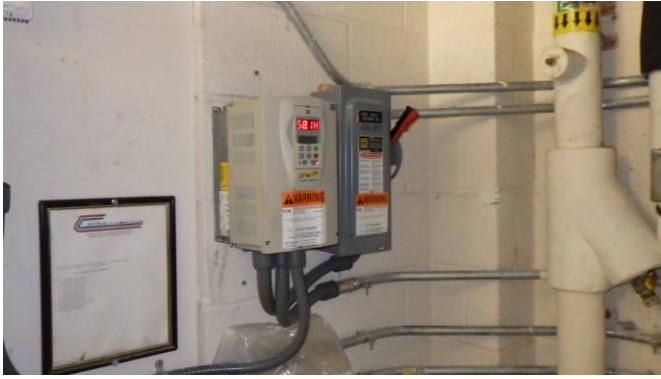
047071e 1/26/2023
AH#11 supply fan VFD, Square D
Mechanical room G134

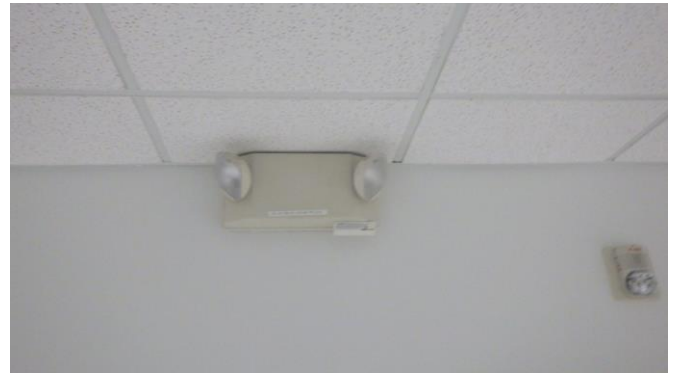
047072e 1/26/2023
Battery backup emergency exit light fixture
Corridor G100A

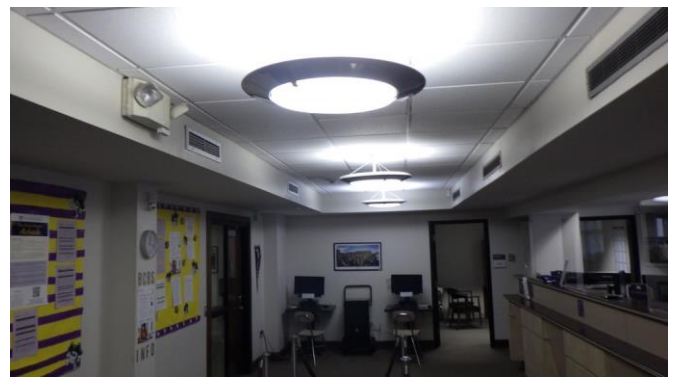
047074e 1/26/2023
Suspended LED interior light fixtures
Office suite G120

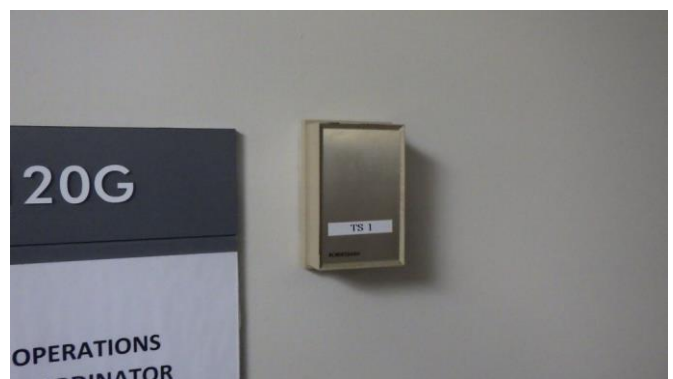
047076e 1/26/2023
HVAC sensor
Office suite G120

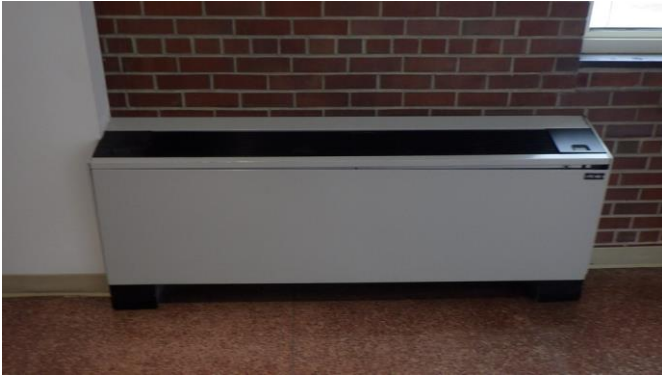
047077e 1/26/2023
Fan coil unit #2
Second floor, stair A

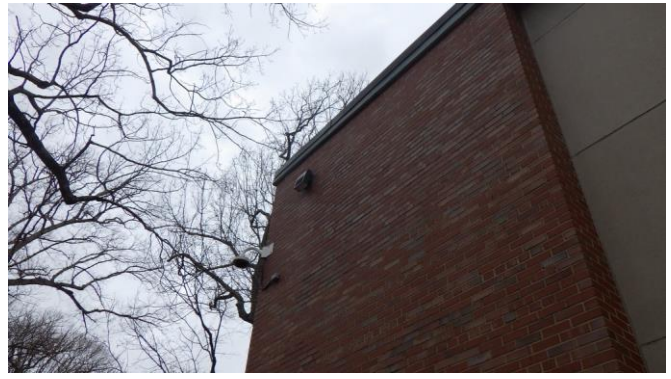
047078e 1/26/2023
LED wall pack exterior light fixture
Southwest corner

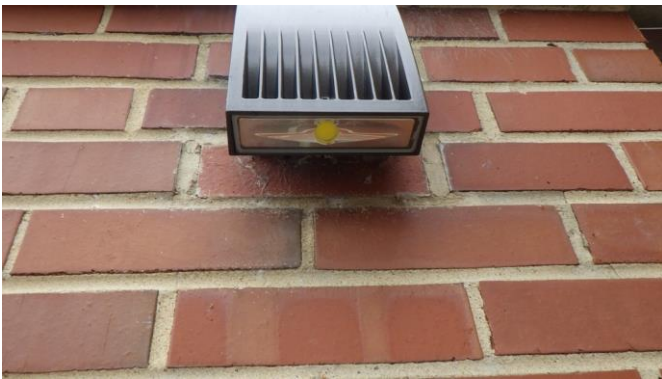
047079e 1/26/2023
LED wall pack exterior light fixture
South exterior

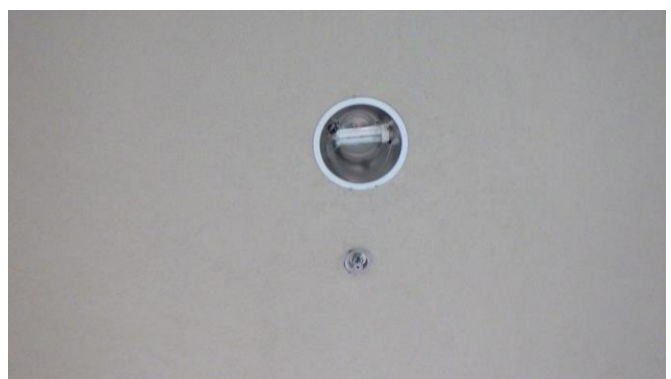
047082e 1/26/2023
Recessed CFL exterior light fixture
North side covered walk

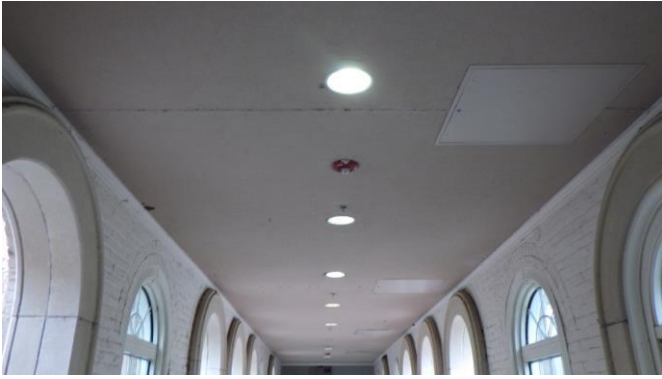
047083e 1/26/2023
Recessed CFL exterior light fixtures
North side covered walk

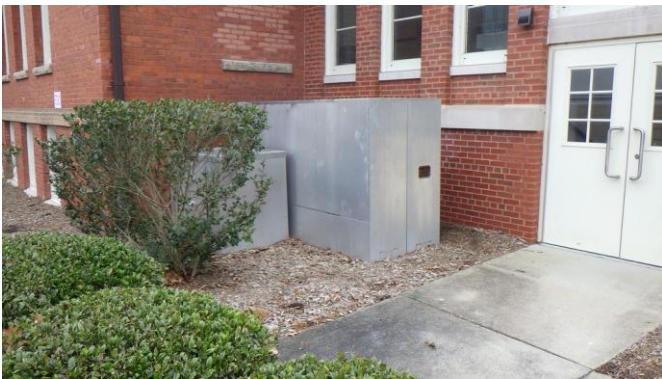
047085e 1/26/2023
Fire suppression system backflow preventer insulated
box
North exterior

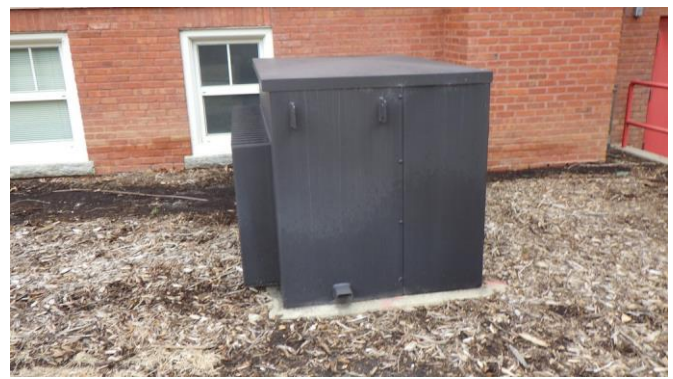
047086e 1/26/2023
Primary electrical distribution transformer
West exterior

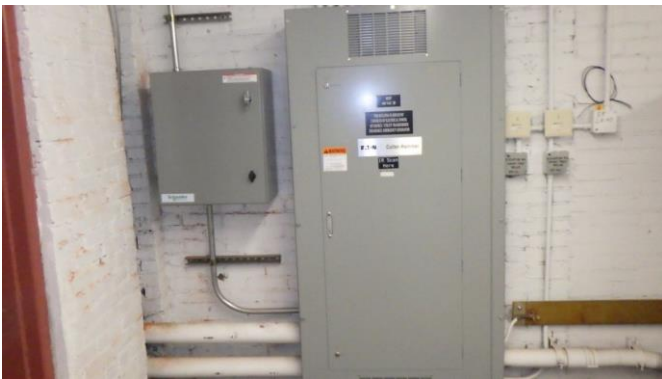
047087e 1/26/2023
Main electrical distribution panel MDP
Electrical room G401

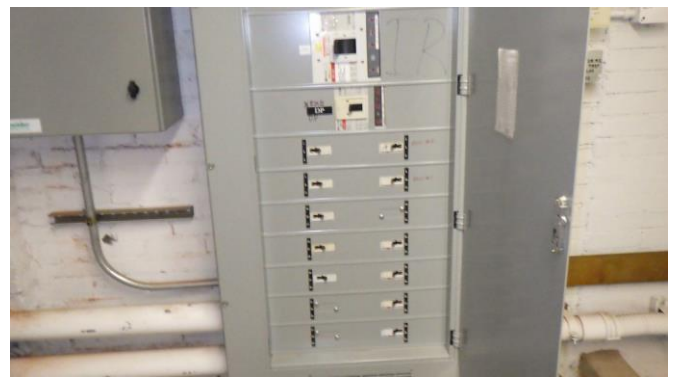
047088e 1/26/2023
Main electrical distribution panel MDP
Electrical room G401

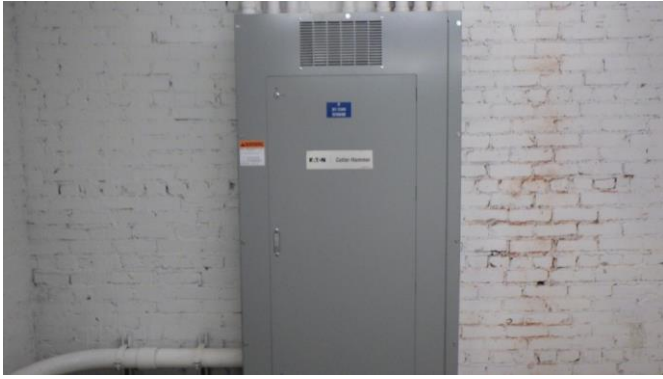
047089e 1/26/2023
Main electrical distribution panel DP
Electrical room G401
