EAST CAROLINA UNIVERSITY

Facility Condition Assessment

Old Cafeteria Complex

Inspected January 26, 2023

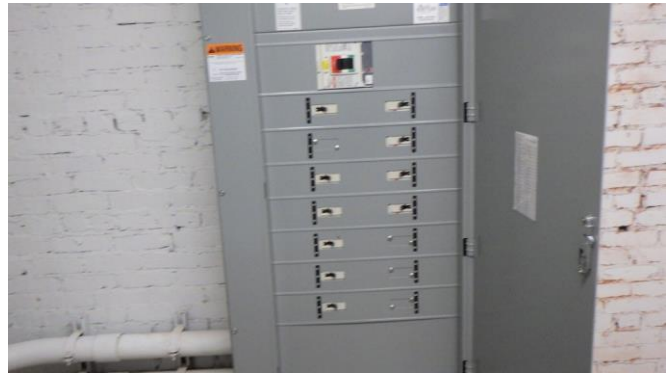
047090e 1/26/2023
Main electrical distribution panel DP
Electrical room G401

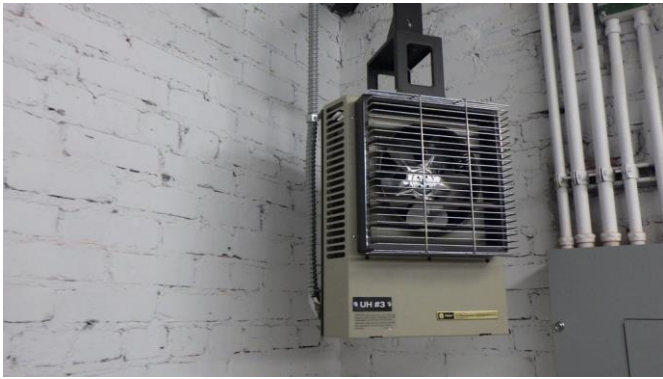
047091e 1/26/2023
Electric unit heater UH#3
Electrical room G401

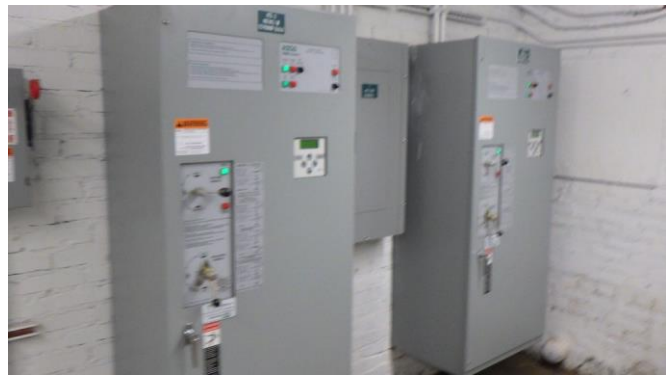
047092e 1/26/2023
Emergency power ATS-1 and ATS-2
Electrical room G401

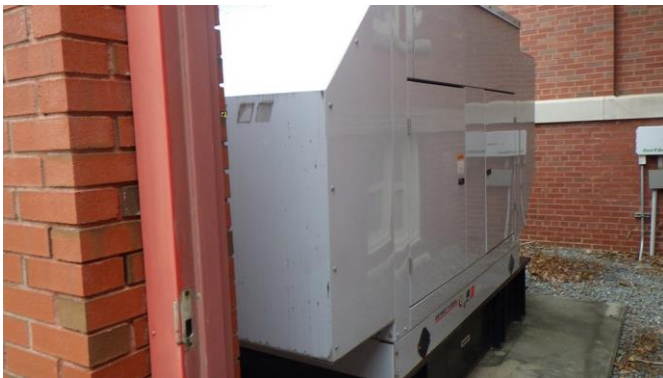
047093e 1/26/2023
Diesel fuel emergency generator
West exterior
