# EAST CAROLINA UNIVERSITY

Facility Condition Assessment

Physicians Quad N

Inspected January 26, 2023

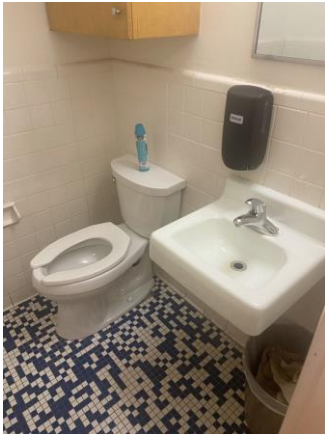
119001a 1/26/2023  
Tile walls and floor, wall-hung lavatory and tank-type  
toilet  
Restroom

The restrooms are not fully ADA compliant. The installation of accessible fixtures and accessories is recommended. Also, the single-level drinking fountain should be replaced with a dual-level unit set in an alcove or with a tapered lower cabinet design.

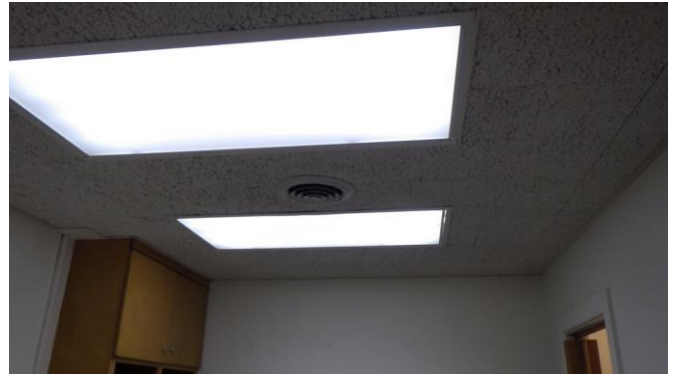
119001e 1/26/2023  
T5 fluorescent lay-in troffer lighting  
Commons area

The lighting configuration consists of lay-in and surface-mounted T8 fluorescent fixtures and aging incandescent fixtures. All have depleted their lifecycle and are recommended for replacement. Also install occupancy sensors in select areas for additional energy conservation.

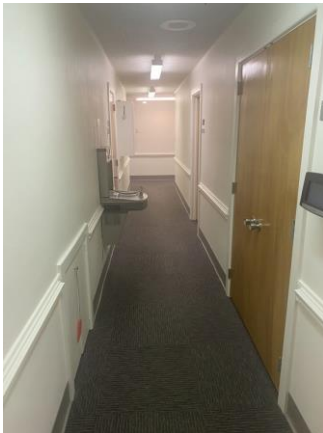
119005a 1/26/2023  
Painted walls and ceiling, carpeting, wood doors with  
knob  
Corridor

Accessibility legislation requires that door hardware be designed for those with little or no ability to grasp objects with their hands. To comply with the intent of this legislation, it is recommended that lever handle hardware be installed on all doors that still have knobs.

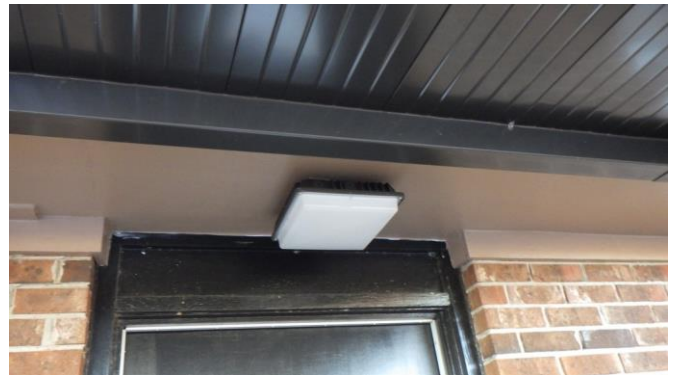
Nighttime illumination is provided by incandescent lights and a surface-mounted LED fixture. While the LED fixture should outlast the report scope, the older incandescent lights are due for replacement. The illumination level was not easily verified during this daytime inspection, but it appears additional lighting is needed. Install additional exterior light fixtures to ensure a safe environment for building users, and place all new lighting on photocell activation.

119005e 1/26/2023  
Incandescent surface-mounted light  
Main entry

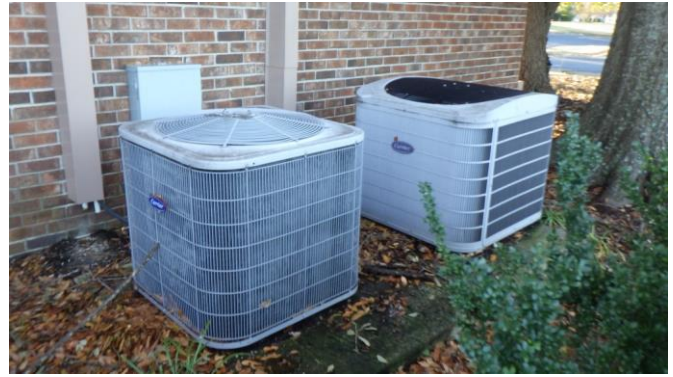
Heating and cooling are provided by two split DX systems equipped with electric furnaces. Air-cooled condensers are located at the exterior, and indoor air handlers with furnaces are in the attic. The systems vary in age, and the older condenser and evaporator units will be due for replacement within the next ten years. The newer system should remain serviceable beyond the scope of this assessment. Forced air distribution is uninsulated or internally insulated flexible metal ductwork that appears to be original. The ductwork is deteriorated and should be replaced. The fractional horsepower exhaust fans in each bathroom are well beyond their useful lifecycle and should be replaced.

119010e 1/26/2023  
Heat pump condensing units 1 and 2  
East exterior

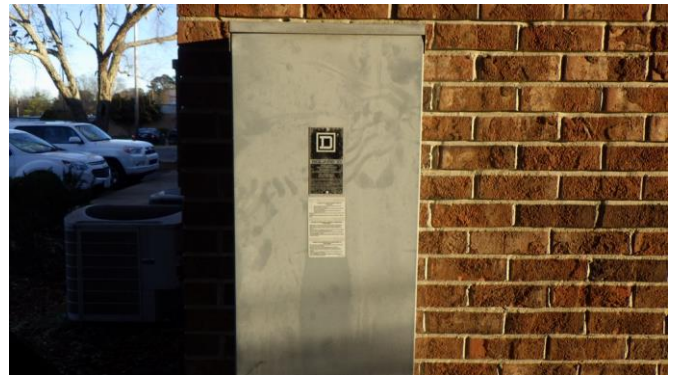
electrical distribution network supplies 120/240 volt power throughout the building. Aging components, such as the circuit breakers, are potential fire hazards if they fail to open a circuit in an overload or short circuit condition. Remove aged electrical components and branch circuitry. Install new power panels, switches, raceways, conductors, and devices. Provide molded case thermal magnetic circuit breakers and HACR circuit breakers for HVAC equipment. Redistribute electrical loads to the appropriate areas to ensure safe and reliable power to building occupants. Provide ground fault circuit interrupter (GFCI) protection where required, and clearly label all panels for circuit identification.

119011e 1/26/2023  
Main electrical disconnect  
East exterior

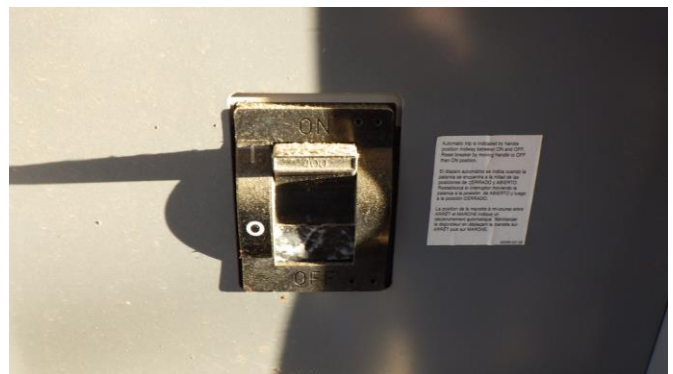
119012e 1/26/2023  
Main electrical disconnect 400 amp breaker  
East exterior

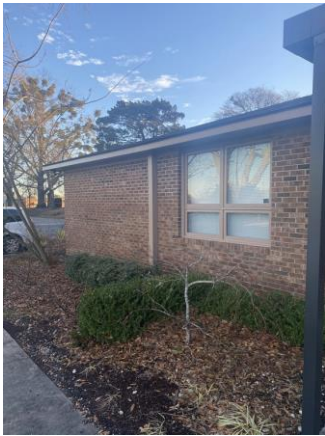
The brick exterior is in fair condition and should be cleaned and repointed to preserve the integrity and aesthetics of the wall finish. Windows are original single-pane, wood frame units and are recommended for upgrade to energy-efficient dual-pane windows. Exterior doors are wood and appear to be original. They are due for replacement. The pitched asphalt shingle roof was replaced in 2021 and should outlast the report scope.

119014a 1/26/2023  
Brick exterior and glazing  
Exterior

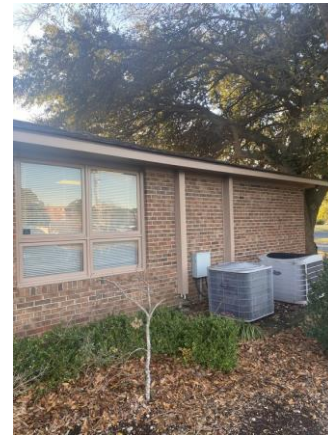
119015a 1/26/2023  
Brick exterior and glazing  
Exterior

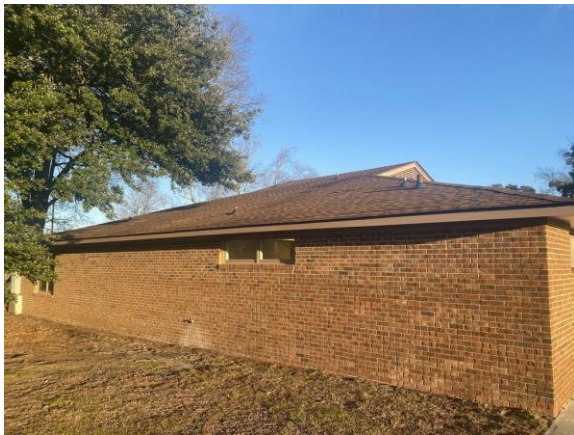
119016a 1/26/2023  
Brick exterior, glazing, asphalt shingle roof  
Exterior

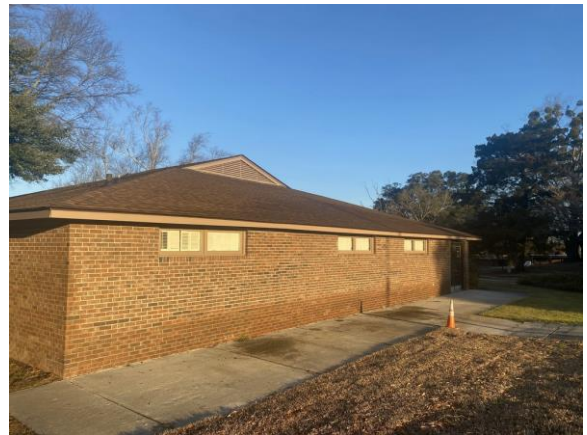
119017a 1/26/2023  
Brick exterior, glazing, asphalt shingle roof  
Exterior

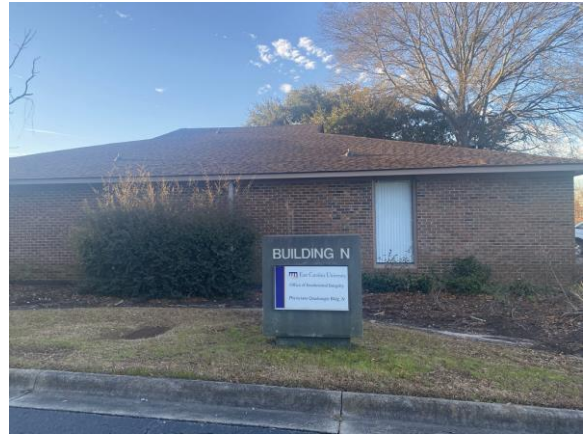
119019a 1/26/2023  
Brick exterior, glazing, asphalt shingle roof  
Exterior
