EAST CAROLINA UNIVERSITY

AUSTIN BUILDING

FACILITY CONDITION ANALYSIS

AUGUST 25, 2010

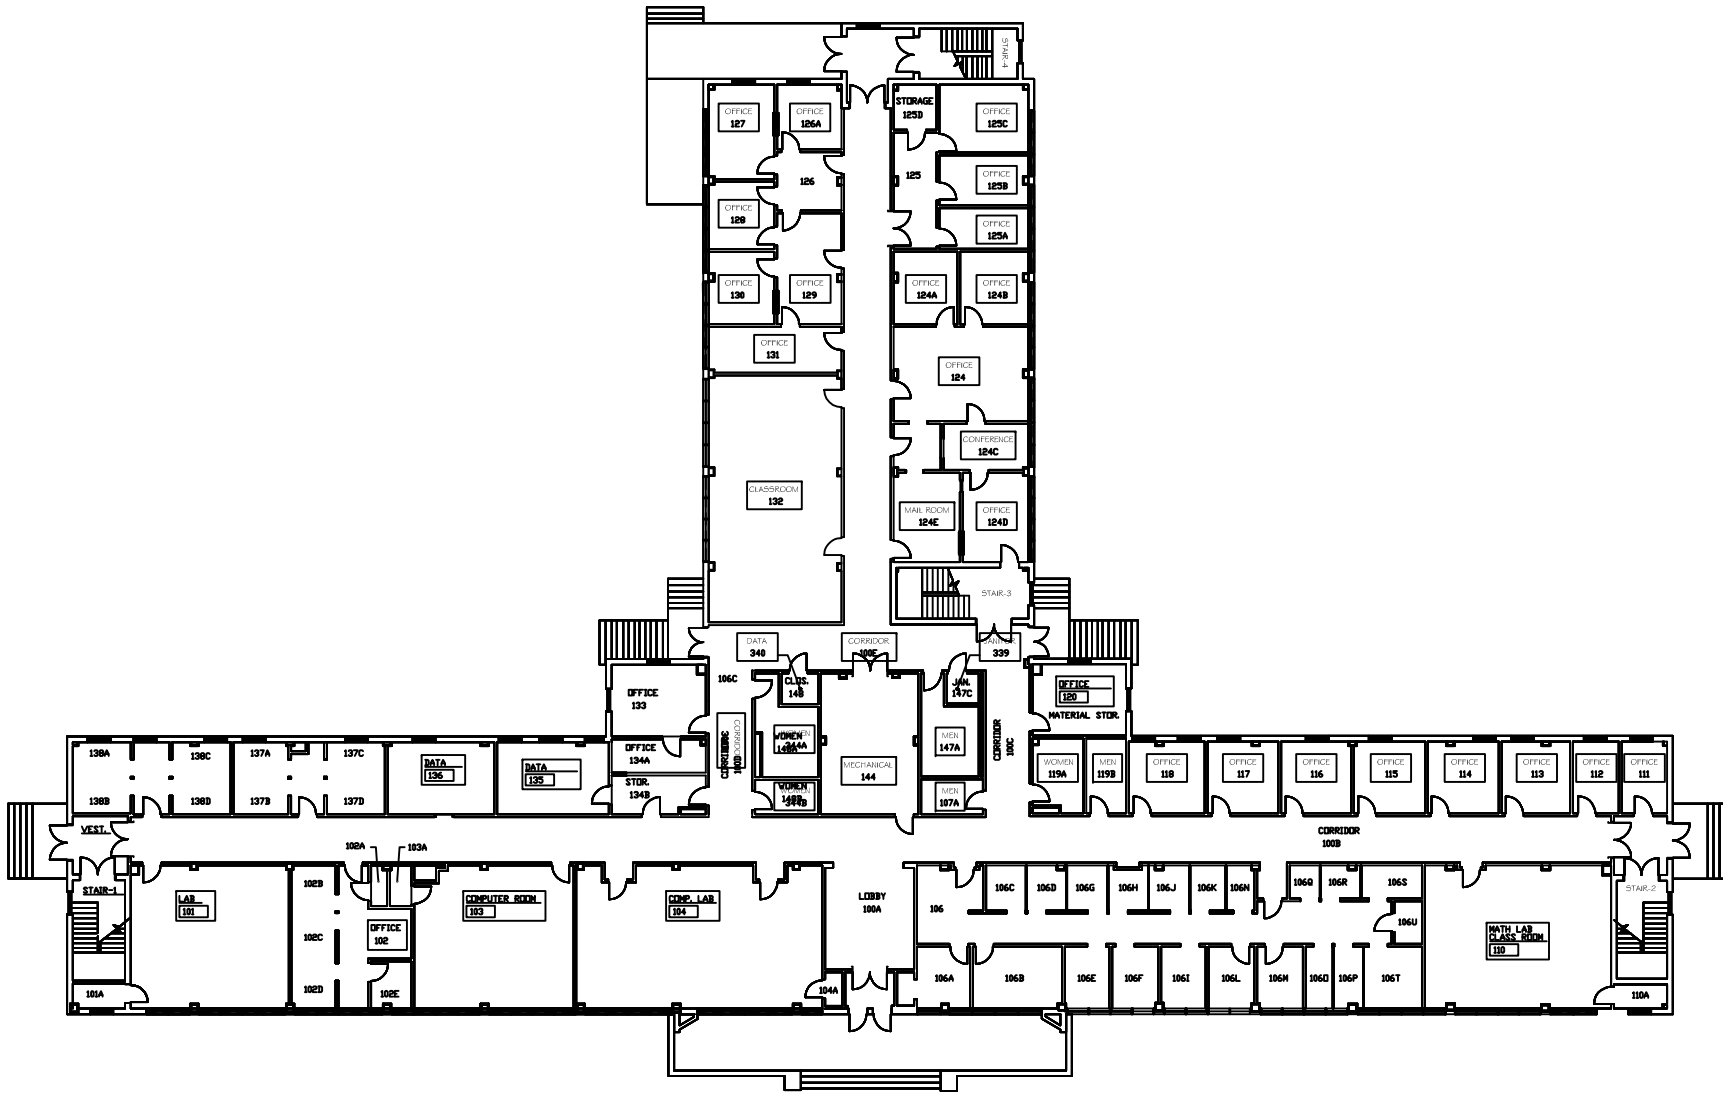
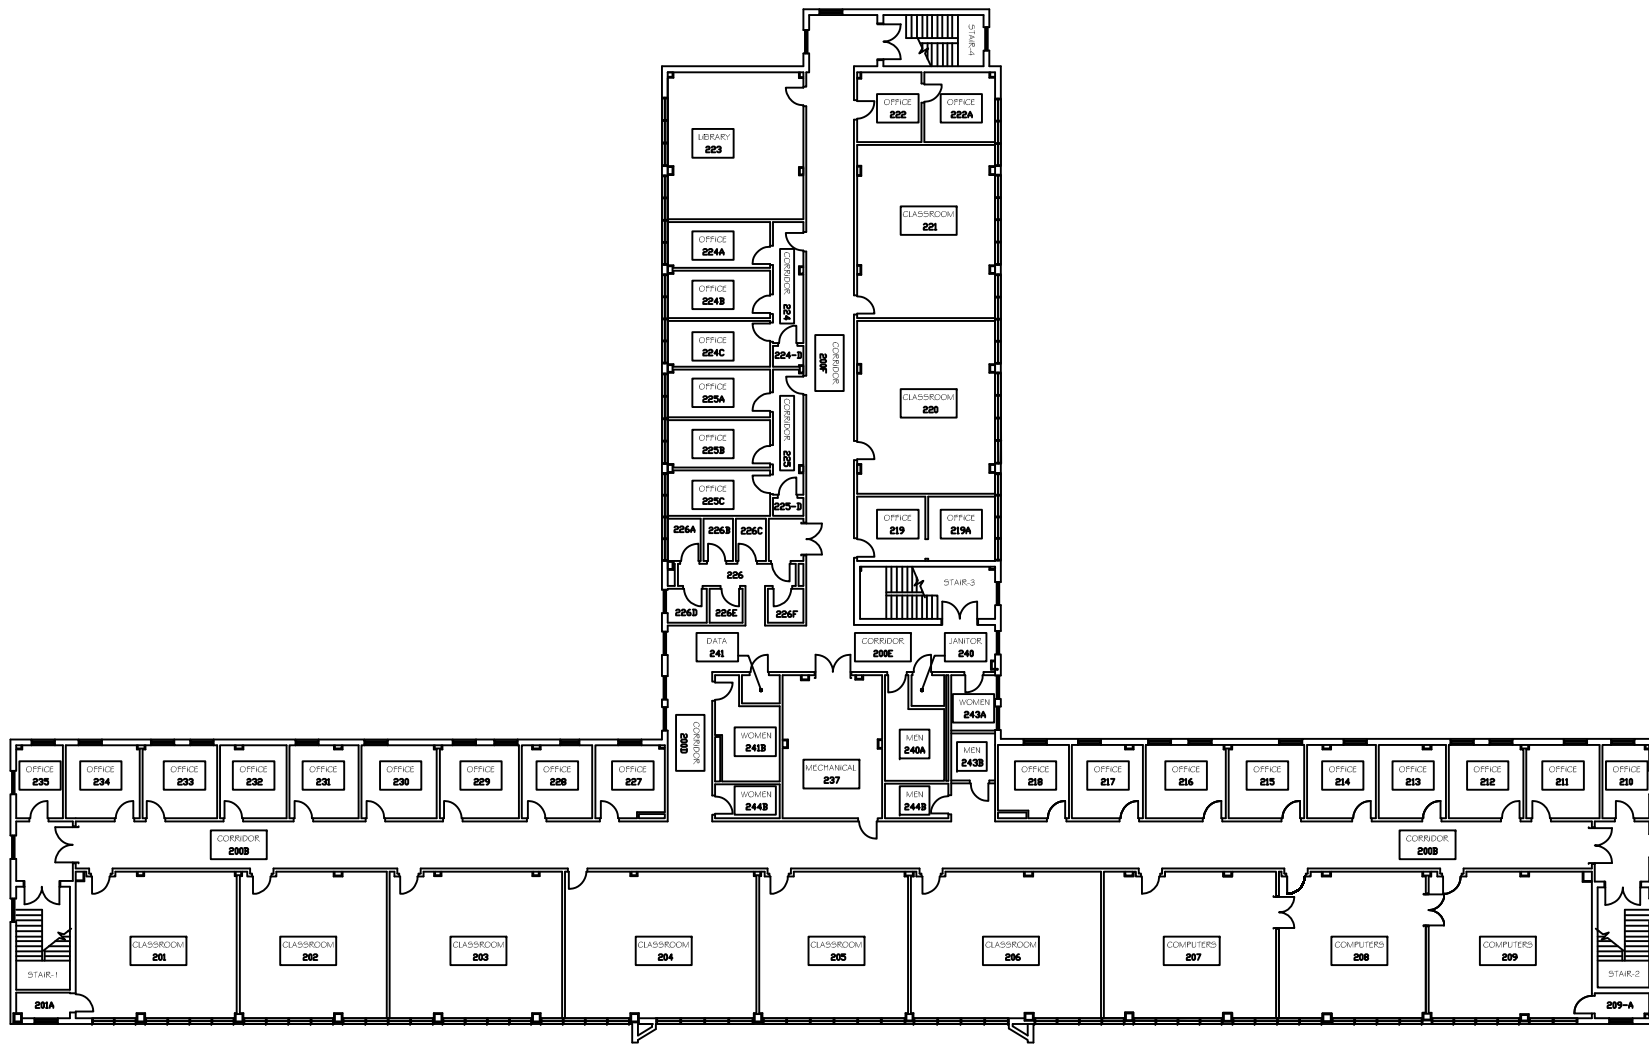
FIRST FLOOR PLAN

- PROJECT NUMBER APPLIES TO ONE ROOM ONLY
- PROJECT NUMBER APPLIES TO ONE ITEM ONLY
- PROJECT NUMBER APPLIES TO ENTIRE BUILDING
- PROJECT NUMBER APPLIES TO ENTIRE FLOOR
- PROJECT NUMBER APPLIES TO A SITUATION OF UNDEFINED EXTENTS
- PROJECT NUMBER APPLIES TO AREA AS NOTED

- AC01
- SI01
- EL05
- ES01
- ES02
- AC02
- EL01
- EL03
- EL04
- FS01
- FS02
- FS03
- HE01
- HV01
- IS01
- IS02
- IS03
- IS04
- IS05
- PL02
- PL03
