EAST CAROLINA UNIVERSITY

AYCOCK RESIDENCE HALL

FACILITY CONDITION ANALYSIS

OCTOBER 30, 2009

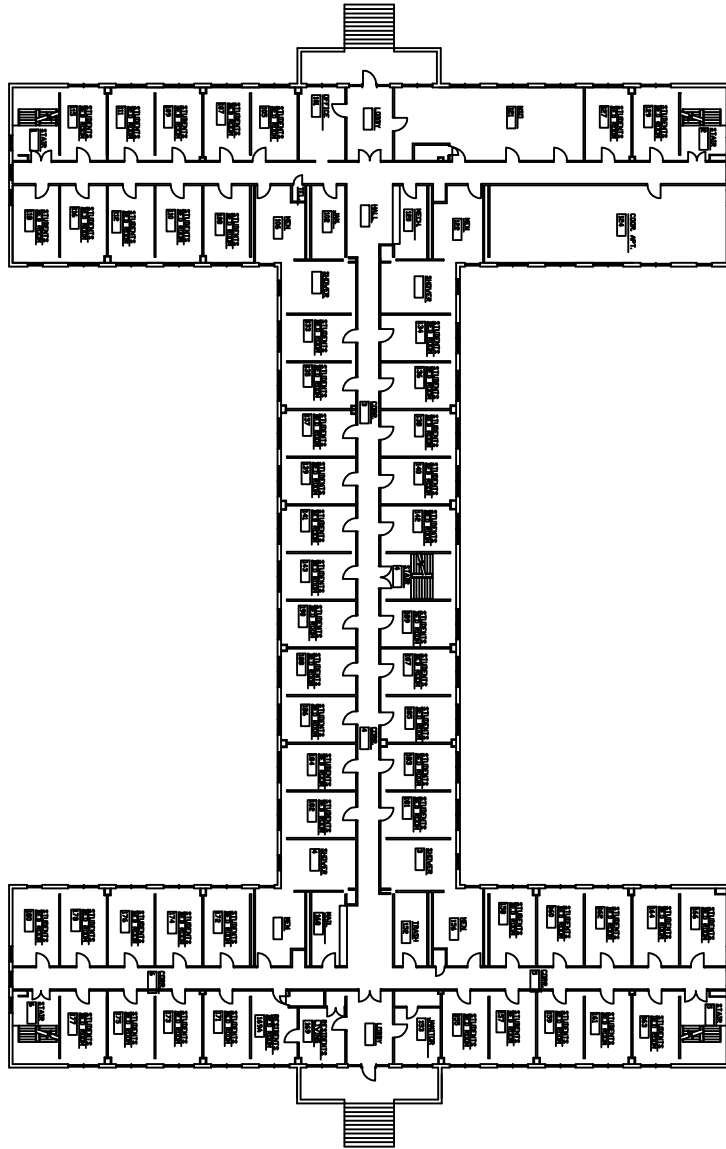
SECOND
FLOOR
PLAN

Sheet No.
3 of 5
