EAST CAROLINA UNIVERSITY

HAROLD H. BATE BUILDING

FACILITY CONDITION ANALYSIS

AUGUST 25, 2010

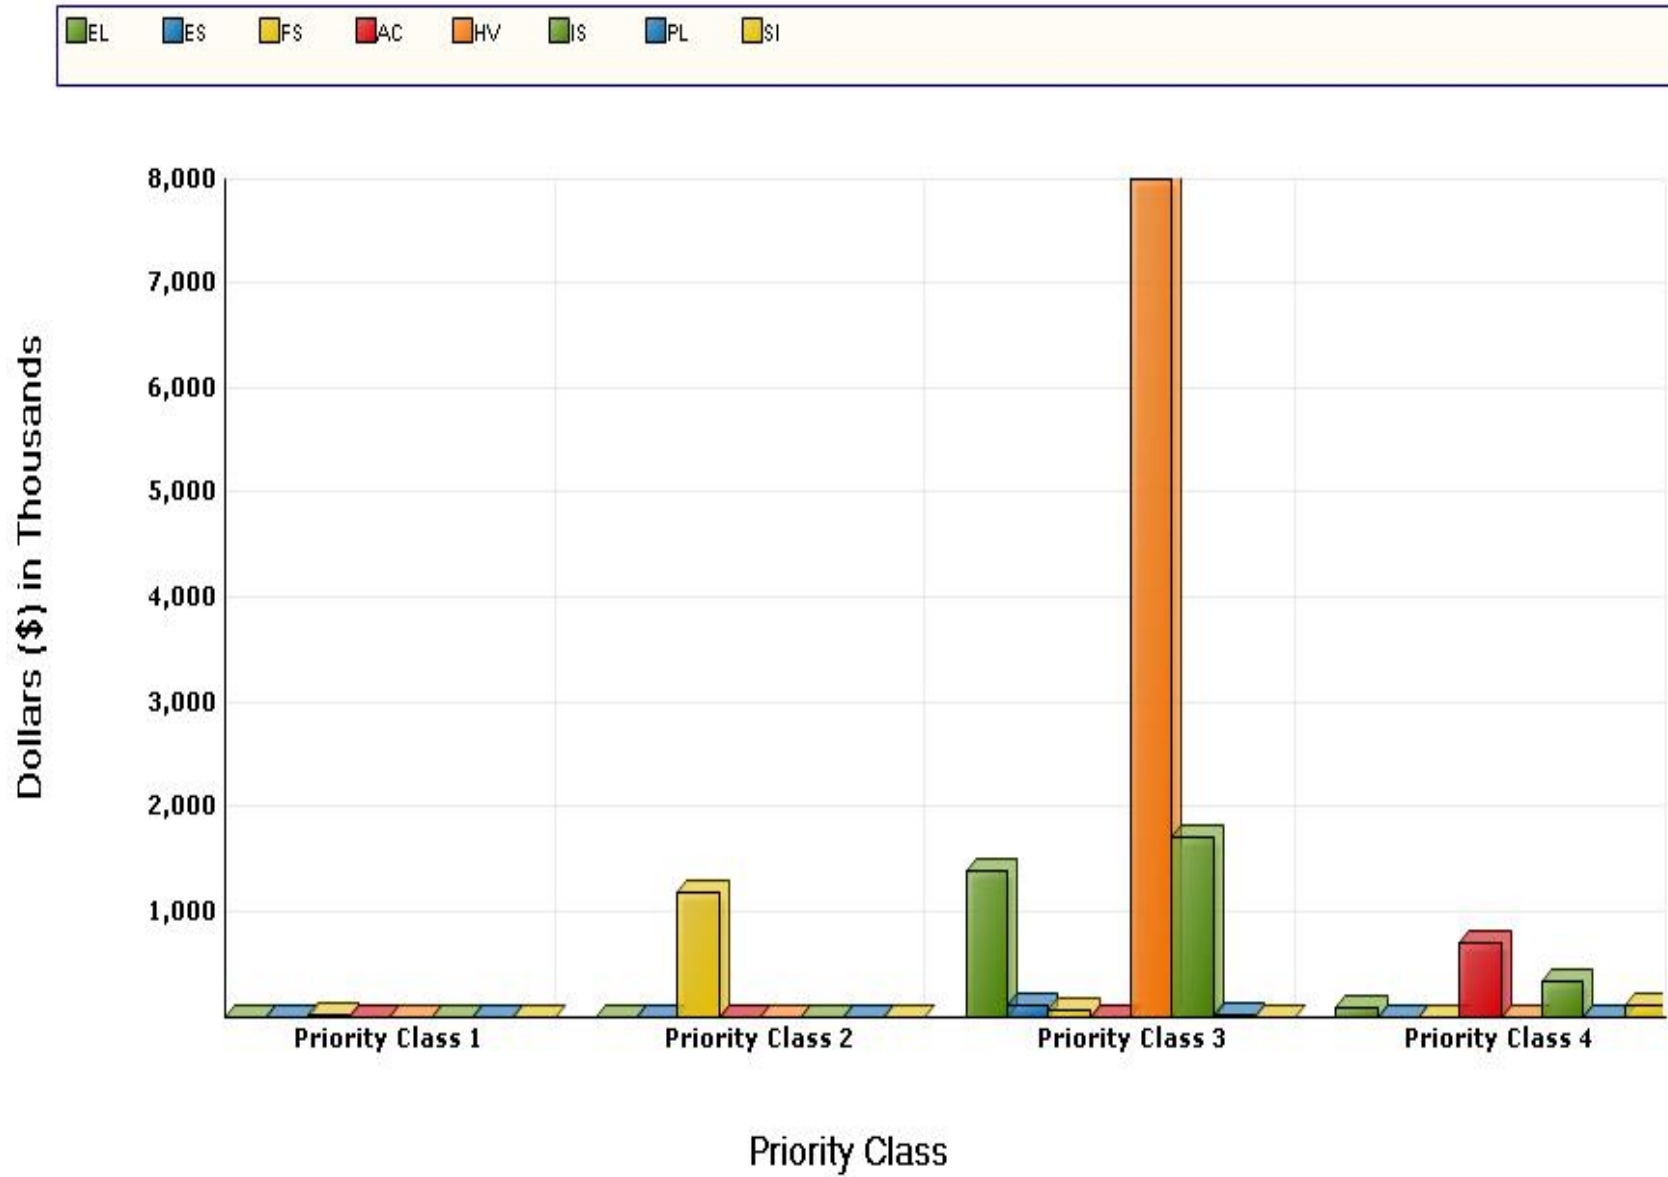
System Code by Priority Class

System Code	System Description	Project Classes			Subtotal
		Capital Renewal	Deferred Maintenance	Plant Adaption	
AC	ACCESSIBILITY	0	0	715,385	715,385
EL	ELECTRICAL	187,179	1,298,667	0	1,485,846
ES	EXTERIOR	119,718	0	0	119,718
FS	FIRE/LIFE SAFETY	0	13,842	1,262,561	1,276,404
HV	HVAC	8,000,000	0	0	8,000,000
IS	INTERIOR/FINISH SYS.	355,036	1,727,743	0	2,082,779
PL	PLUMBING	0	17,433	0	17,433
SI	SITE	120,609	0	0	120,609
	TOTALS	8,782,542	3,057,685	1,977,947	13,818,174

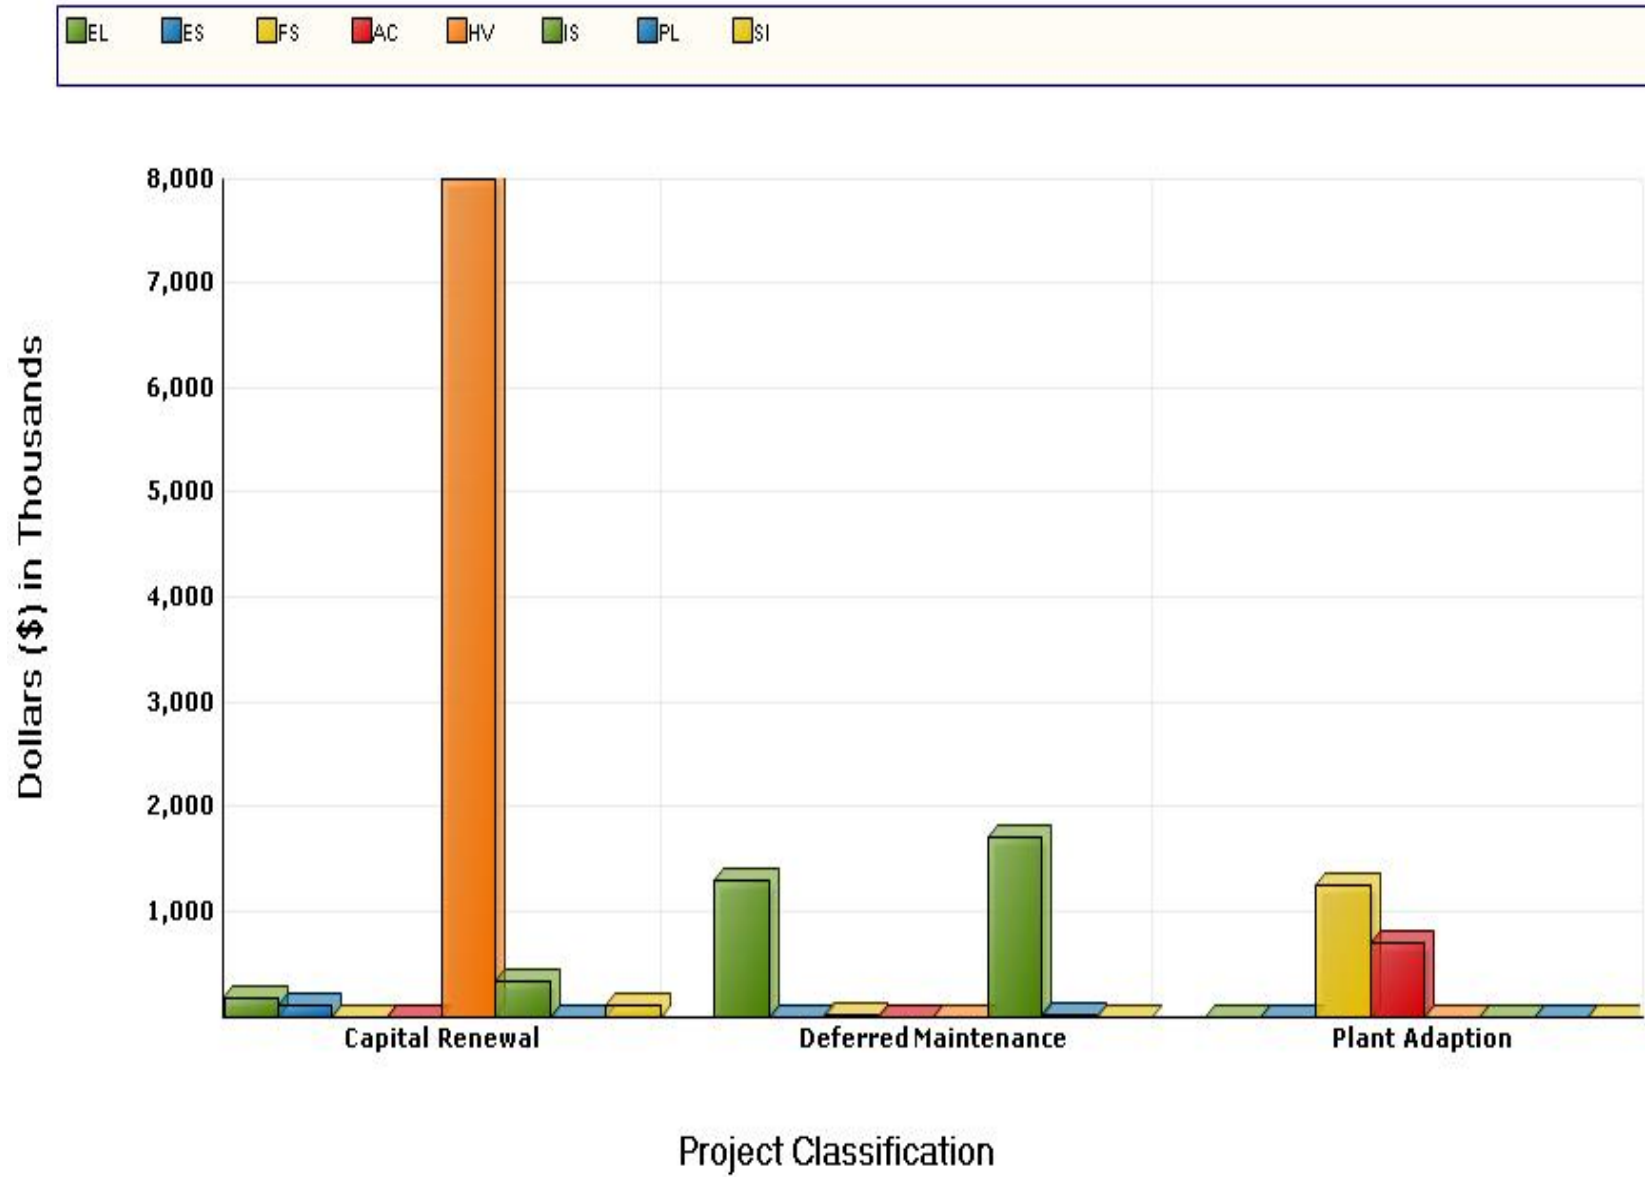
System Code by Project Class

Project Class	Priority Classes				Subtotal
	1	2	3	4	
Capital Renewal	0	0	8,210,863	571,679	8,782,542
Deferred Maintenance	0	0	3,057,685	0	3,057,685
Plant Adaption	16,877	1,192,770	52,914	715,385	1,977,947
TOTALS	16,877	1,192,770	11,321,463	1,287,064	13,818,174

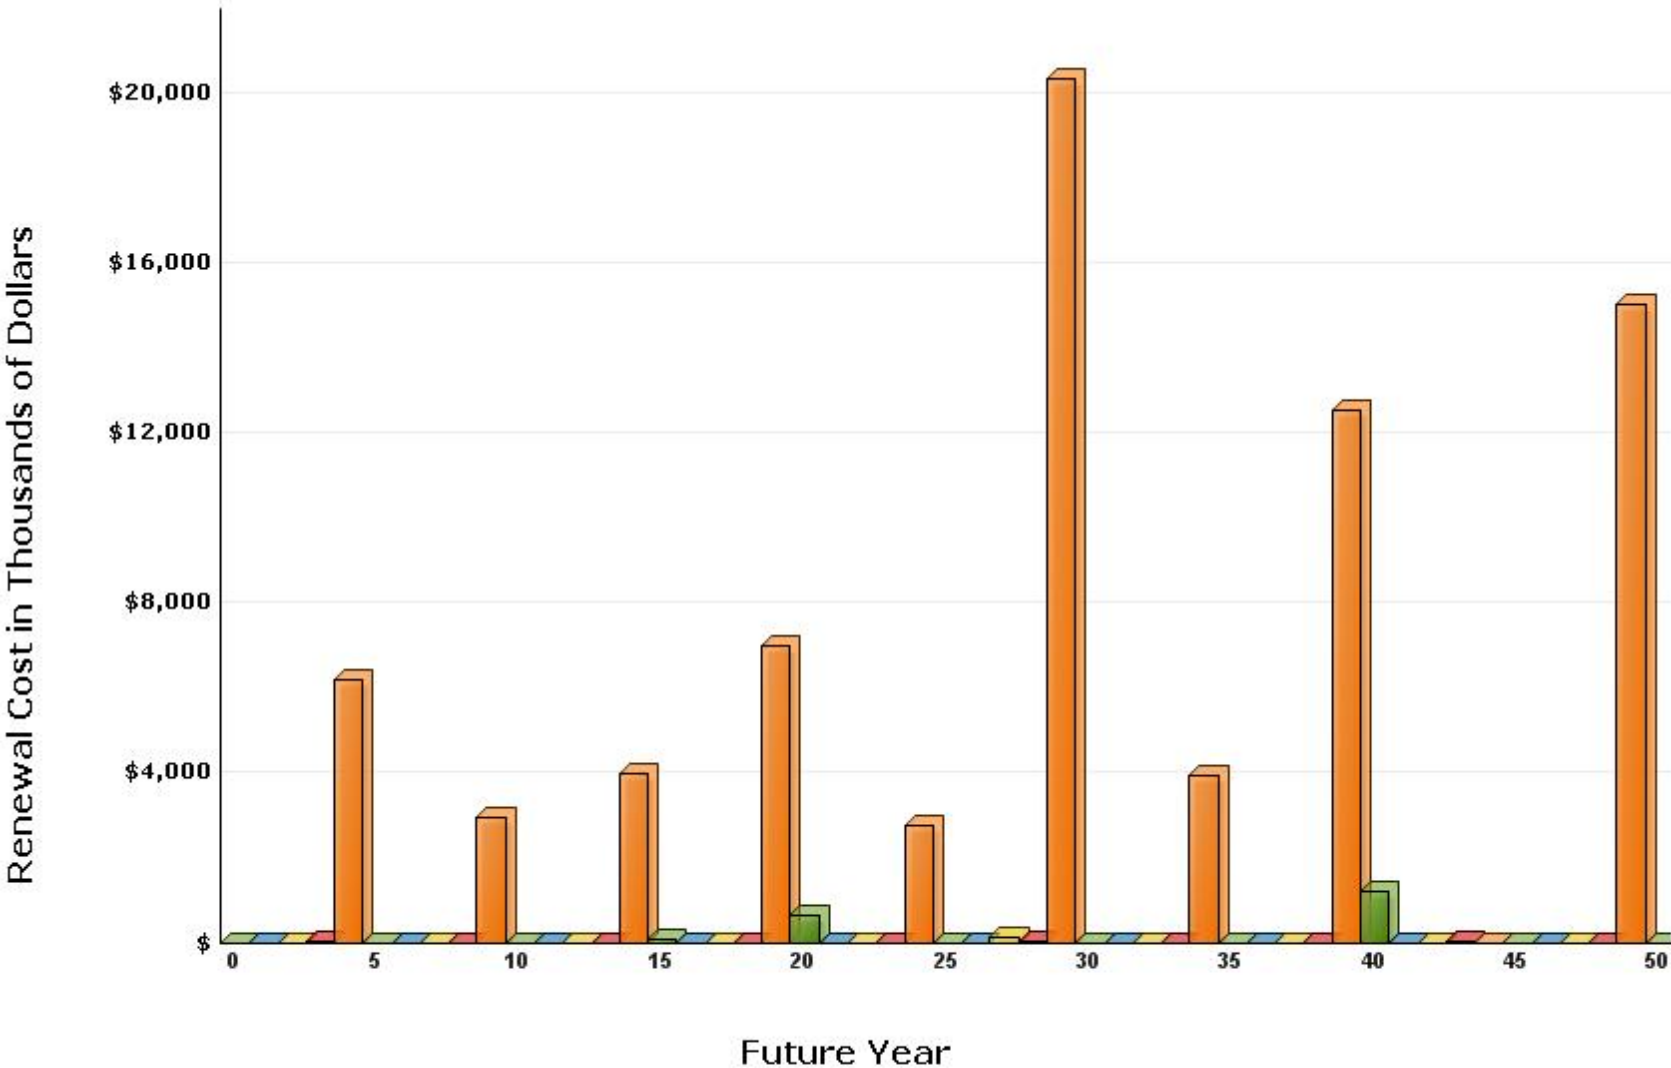
Life Cycle Model Expenditure Projections

Average Annual Renewal Cost Per SqFt \$4.15
