EAST CAROLINA UNIVERSITY

BELK RESIDENCE HALL

FACILITY CONDITION ANALYSIS

OCTOBER 30, 2009

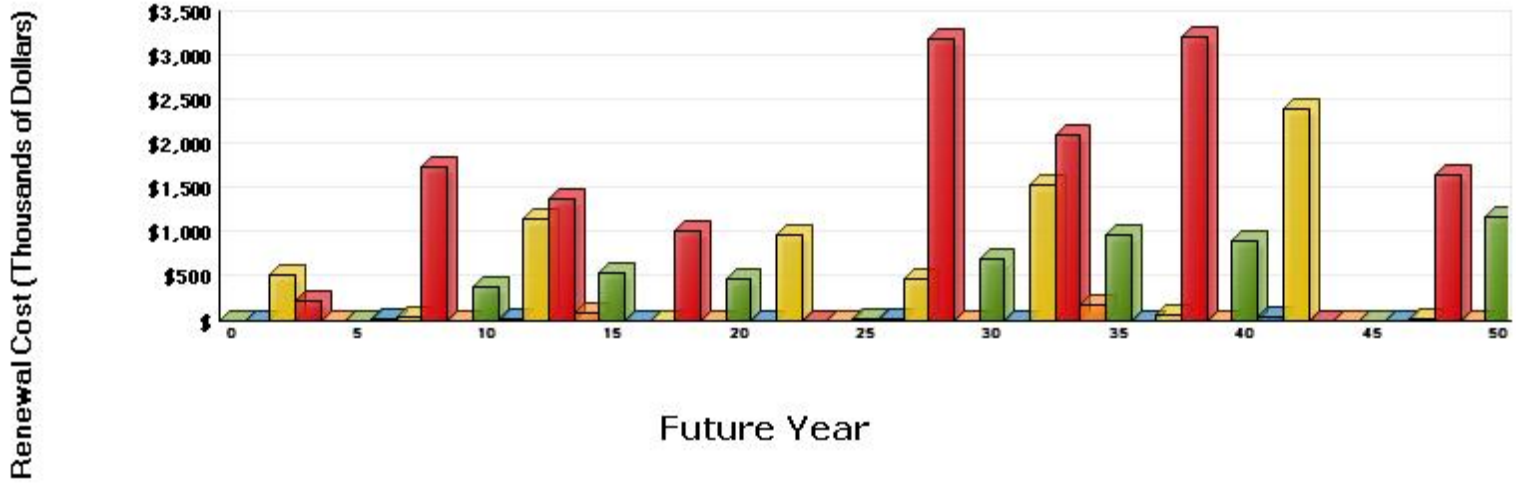
LIFE CYCLE MODEL EXPENDITURE PROJECTIONS

Average Annual Renewal Cost Per SqFt \$3.06

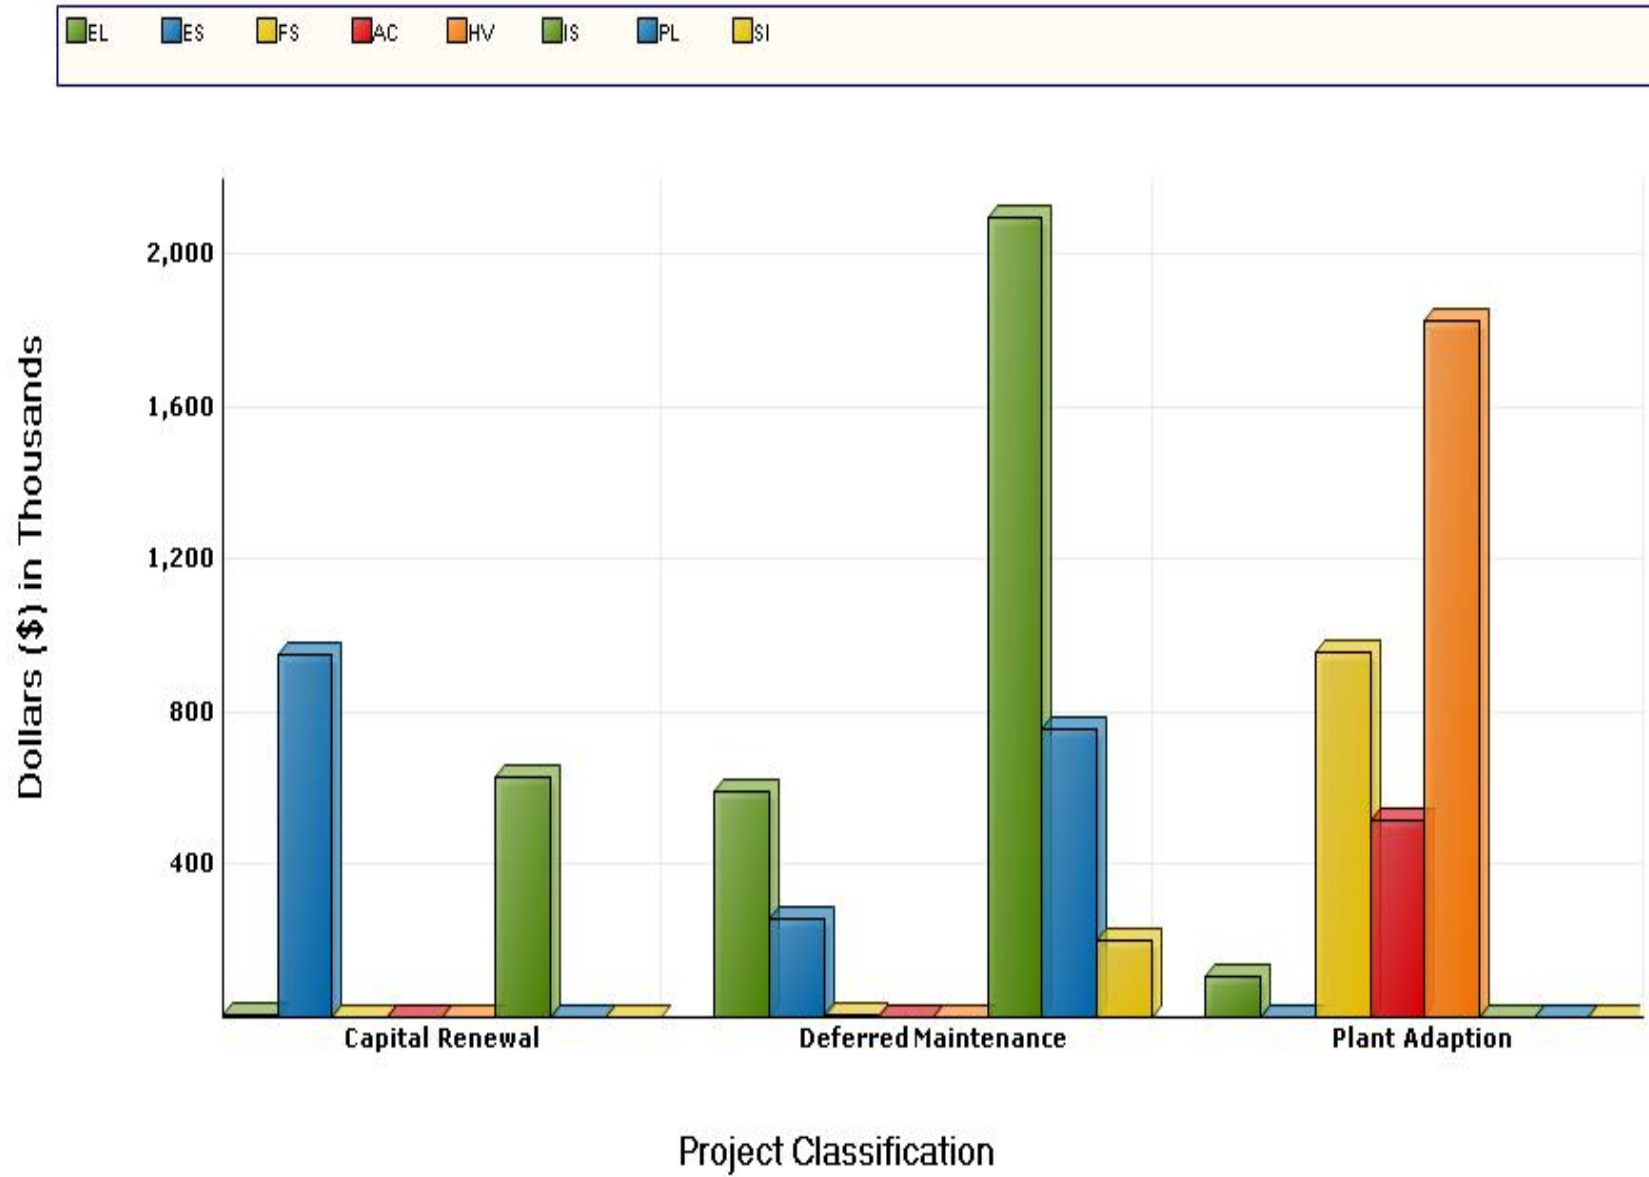
System Code by Project Class

System Code	System Description	Project Classes				Subtotal
		Capital Renewal	Deferred Maintenance	FCAP	Plant Adaption	
AC	ACCESSIBILITY	0	0	0	519,385	519,385
EL	ELECTRICAL	9,862	595,959	0	106,471	712,293
ES	EXTERIOR	952,508	260,887	0	0	1,213,395
FS	FIRE/LIFE SAFETY	0	5,017	0	958,910	963,926
HV	HVAC	0	0	0	1,825,041	1,825,041
IS	INTERIOR/FINISH SYS.	629,000	2,097,865	0	0	2,726,865
PL	PLUMBING	0	757,983	0	0	757,983
SI	SITE	0	199,900	0	0	199,900
	TOTALS	1,591,370	3,917,611	0	3,409,806	8,918,788

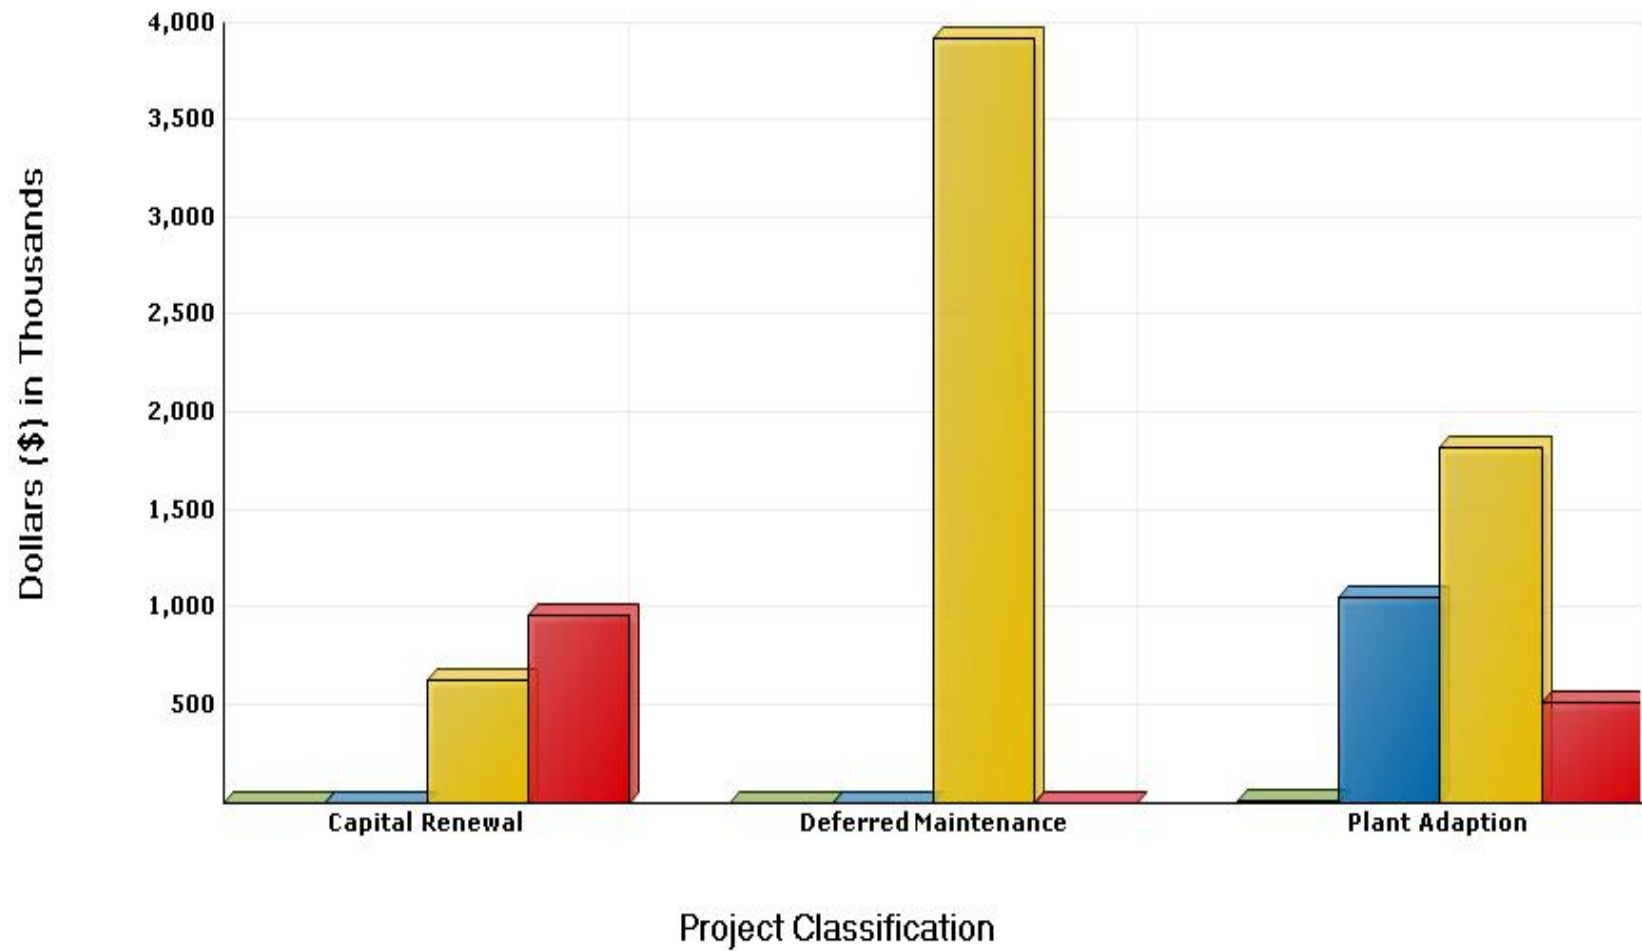
Project Class by Priority Class

Project Class	Priority Classes				Subtotal
	1	2	3	4	
Capital Renewal	0	0	629,000	962,370	1,591,370
Deferred Maintenance	0	0	3,917,611	0	3,917,611
Plant Adaption	8,029	1,057,352	1,825,041	519,385	3,409,806
TOTALS	8,029	1,057,352	6,371,652	1,481,755	8,918,788

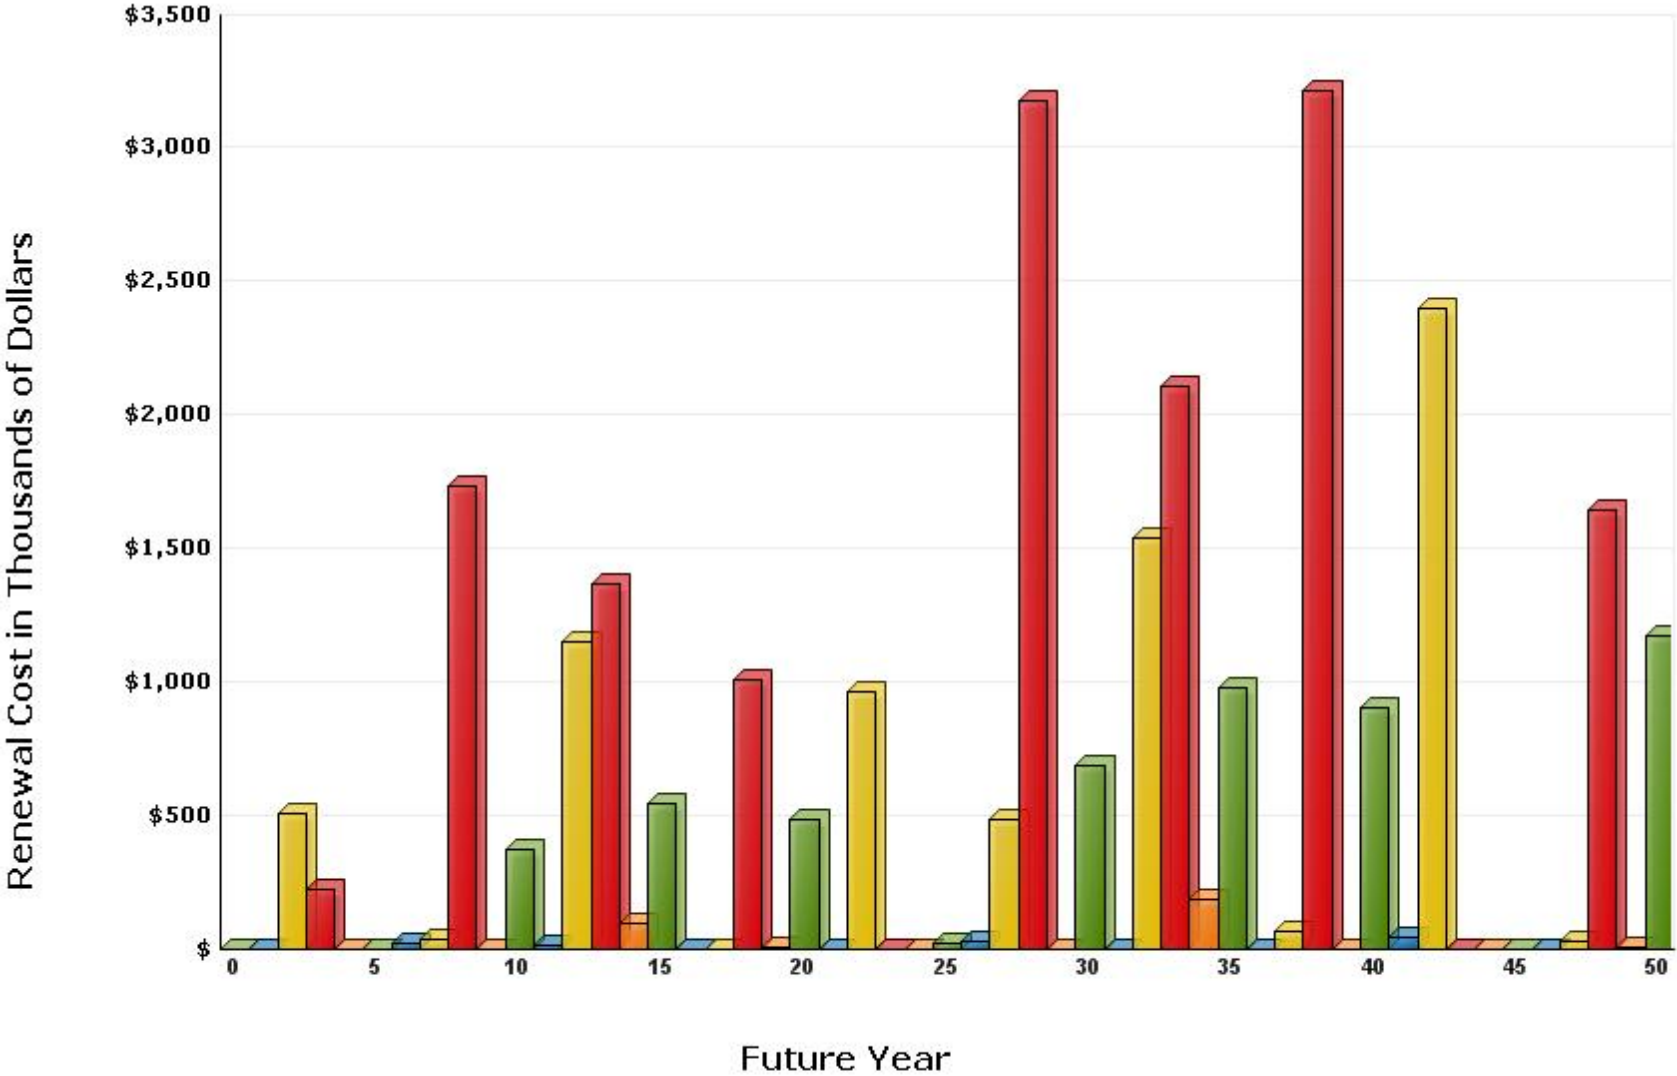
Life Cycle Model Expenditure Projections

Average Annual Renewal Cost Per SqFt \$3.06
