# EAST CAROLINA UNIVERSITY

## BIOTECHNOLOGY BUILDING

FACILITY CONDITION ANALYSIS

OCTOBER 30, 2009

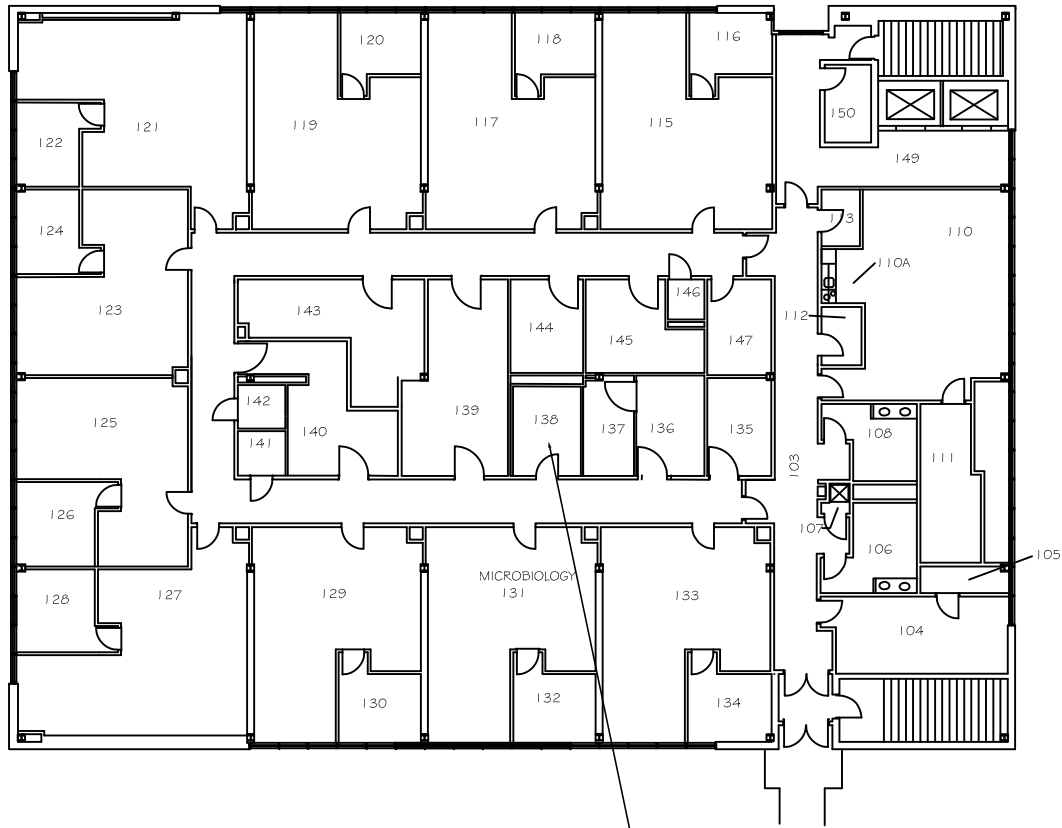
FIRST  
FLOOR  
PLAN

ROOF  
ES03 HV01

- SI01
- EL03
- ES01
- ES02
- AC01
- AC02
- AC03
- EL01
- EL02
- FS01
- FS02
- FS03
- HV01
- HV02
- IS01
- IS02
- IS03
- IS04
