# **EAST CAROLINA UNIVERSITY**

## **ERWIN HALL**

**FACILITY CONDITION ANALYSIS**

**NOVEMBER 4, 2009**

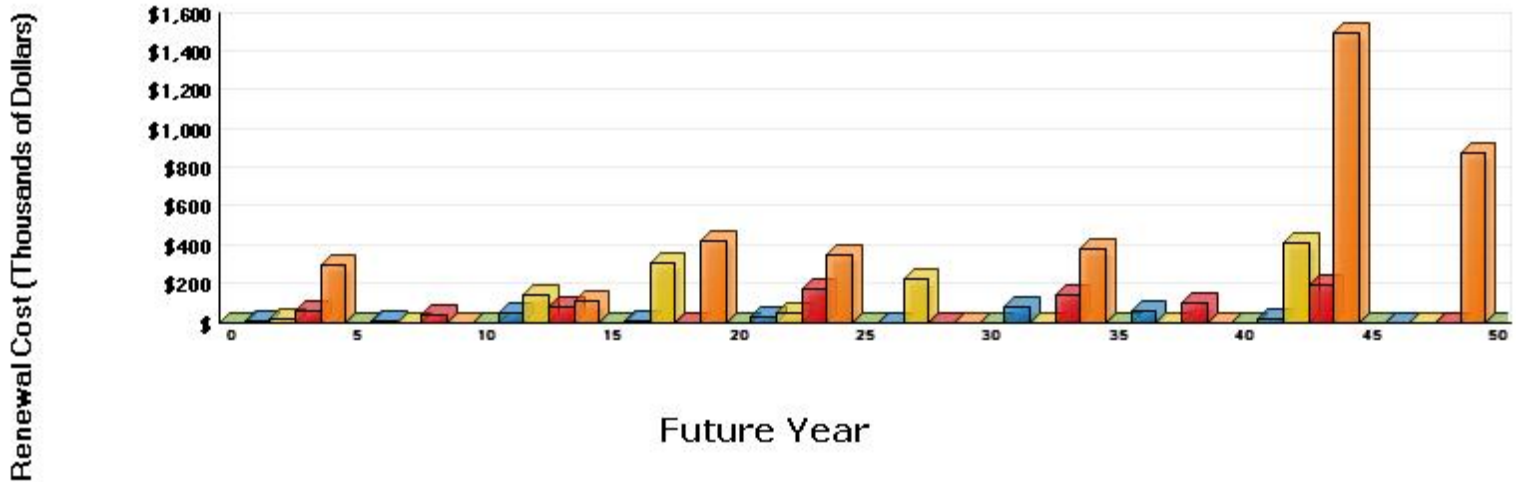
#### LIFE CYCLE MODEL EXPENDITURE PROJECTIONS

Average Annual Renewal Cost Per SqFt \$3.52

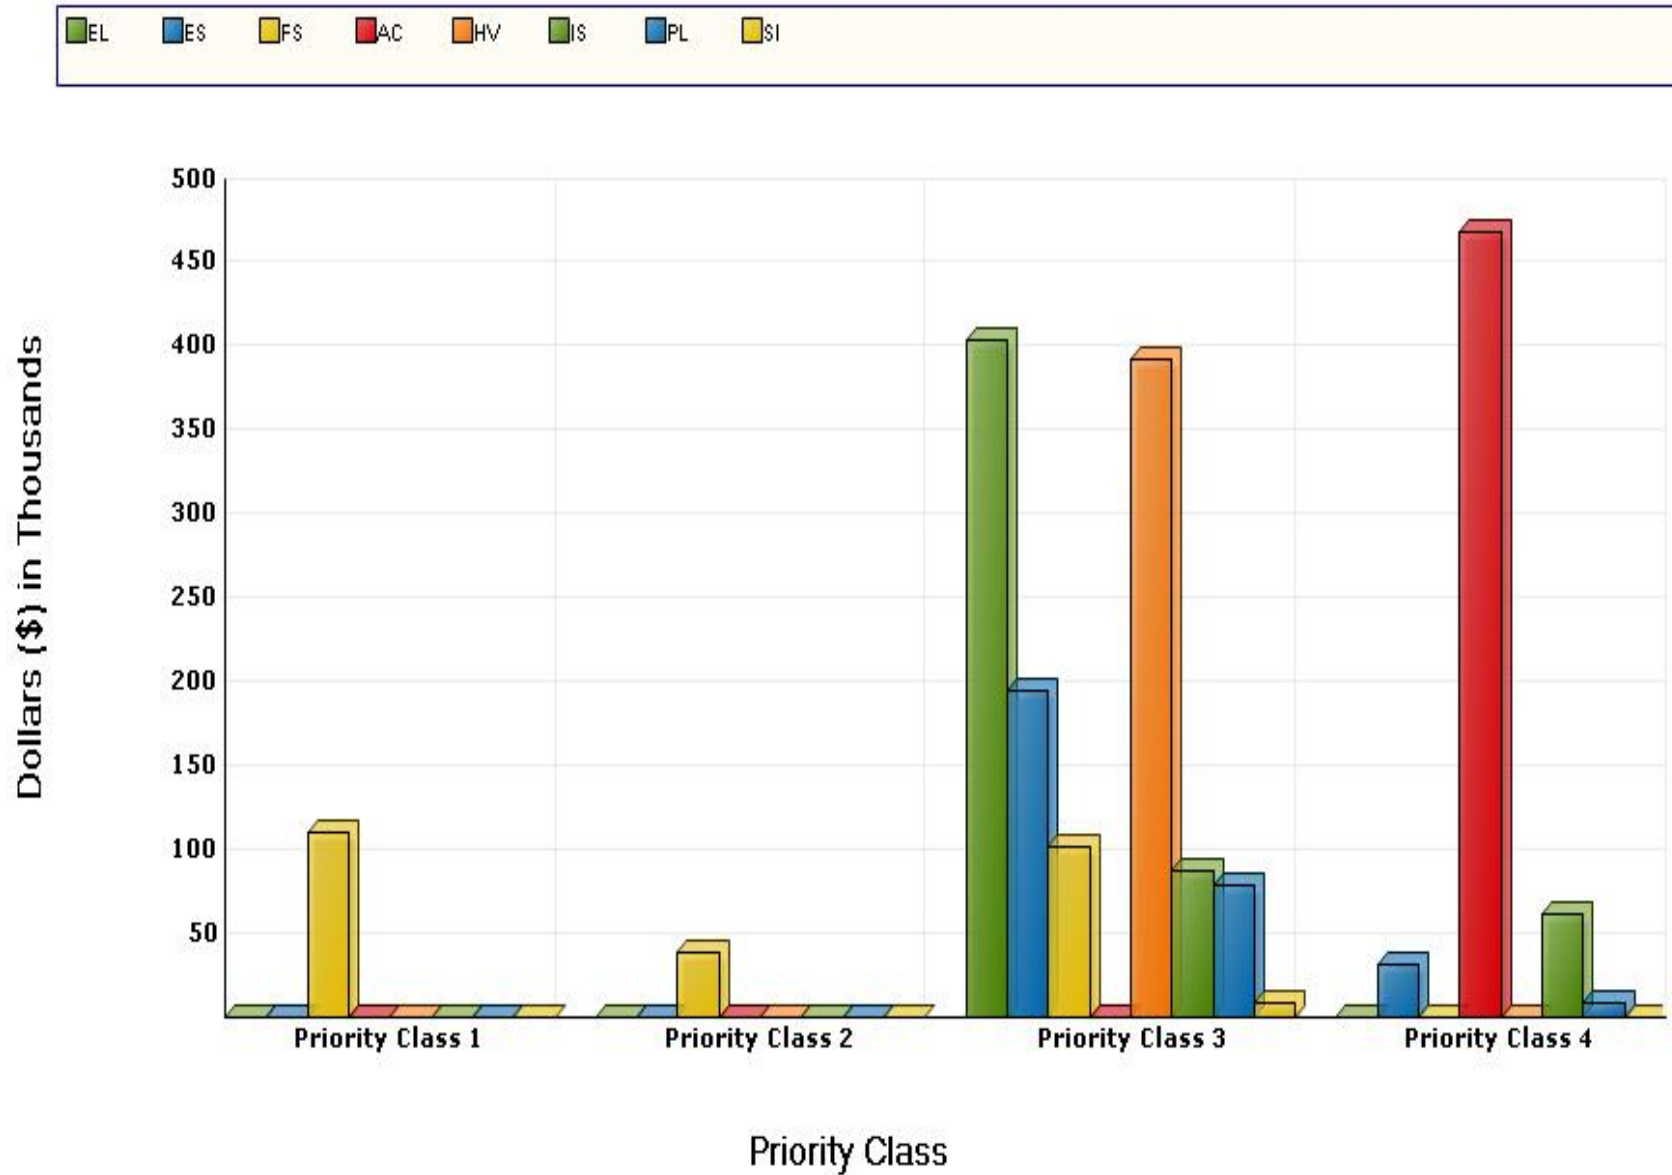
## System Code by Priority Class

System Code	System Description	Project Classes				Subtotal
		Capital Renewal	Deferred Maintenance	FCAP	Plant Adaption	
AC	ACCESSIBILITY	0	0	0	469,778	469,778
EL	ELECTRICAL	118,952	285,103	0	0	404,056
ES	EXTERIOR	31,954	195,029	0	0	226,983
FS	FIRE/LIFE SAFETY	102,703	0	0	150,097	252,800
HV	HVAC	371,302	20,866	0	0	392,168
IS	INTERIOR/FINISH SYS.	31,713	117,302	0	0	149,015
PL	PLUMBING	11,636	76,356	0	0	87,992
SI	SITE	0	8,458	0	0	8,458
	<b>TOTALS</b>	668,261	703,115	0	619,875	1,991,252

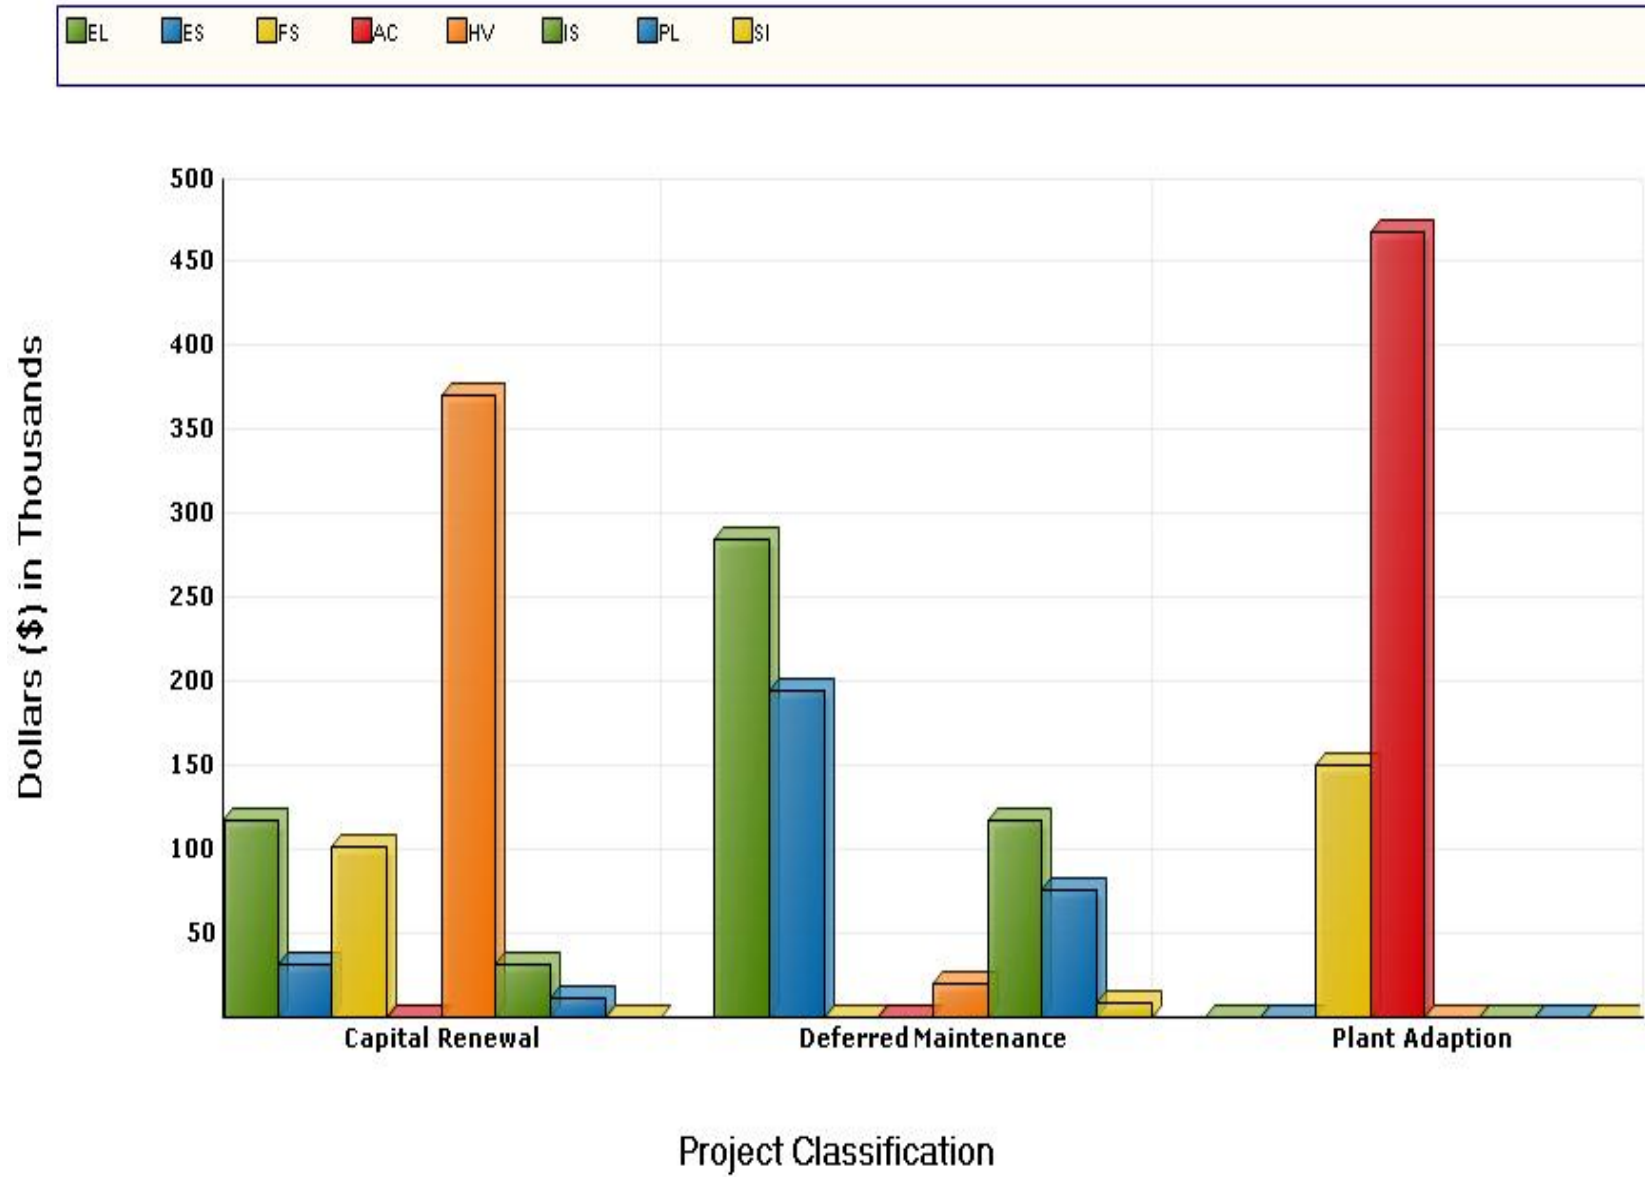
## System Code by Project Class

Project Class	Priority Classes				Subtotal
	1	2	3	4	
Capital Renewal	0	0	627,855	40,406	668,261
Deferred Maintenance	0	0	641,503	61,612	703,115
Plant Adaption	110,799	39,298	0	469,778	619,875
<b>TOTALS</b>	110,799	39,298	1,269,359	571,796	1,991,252

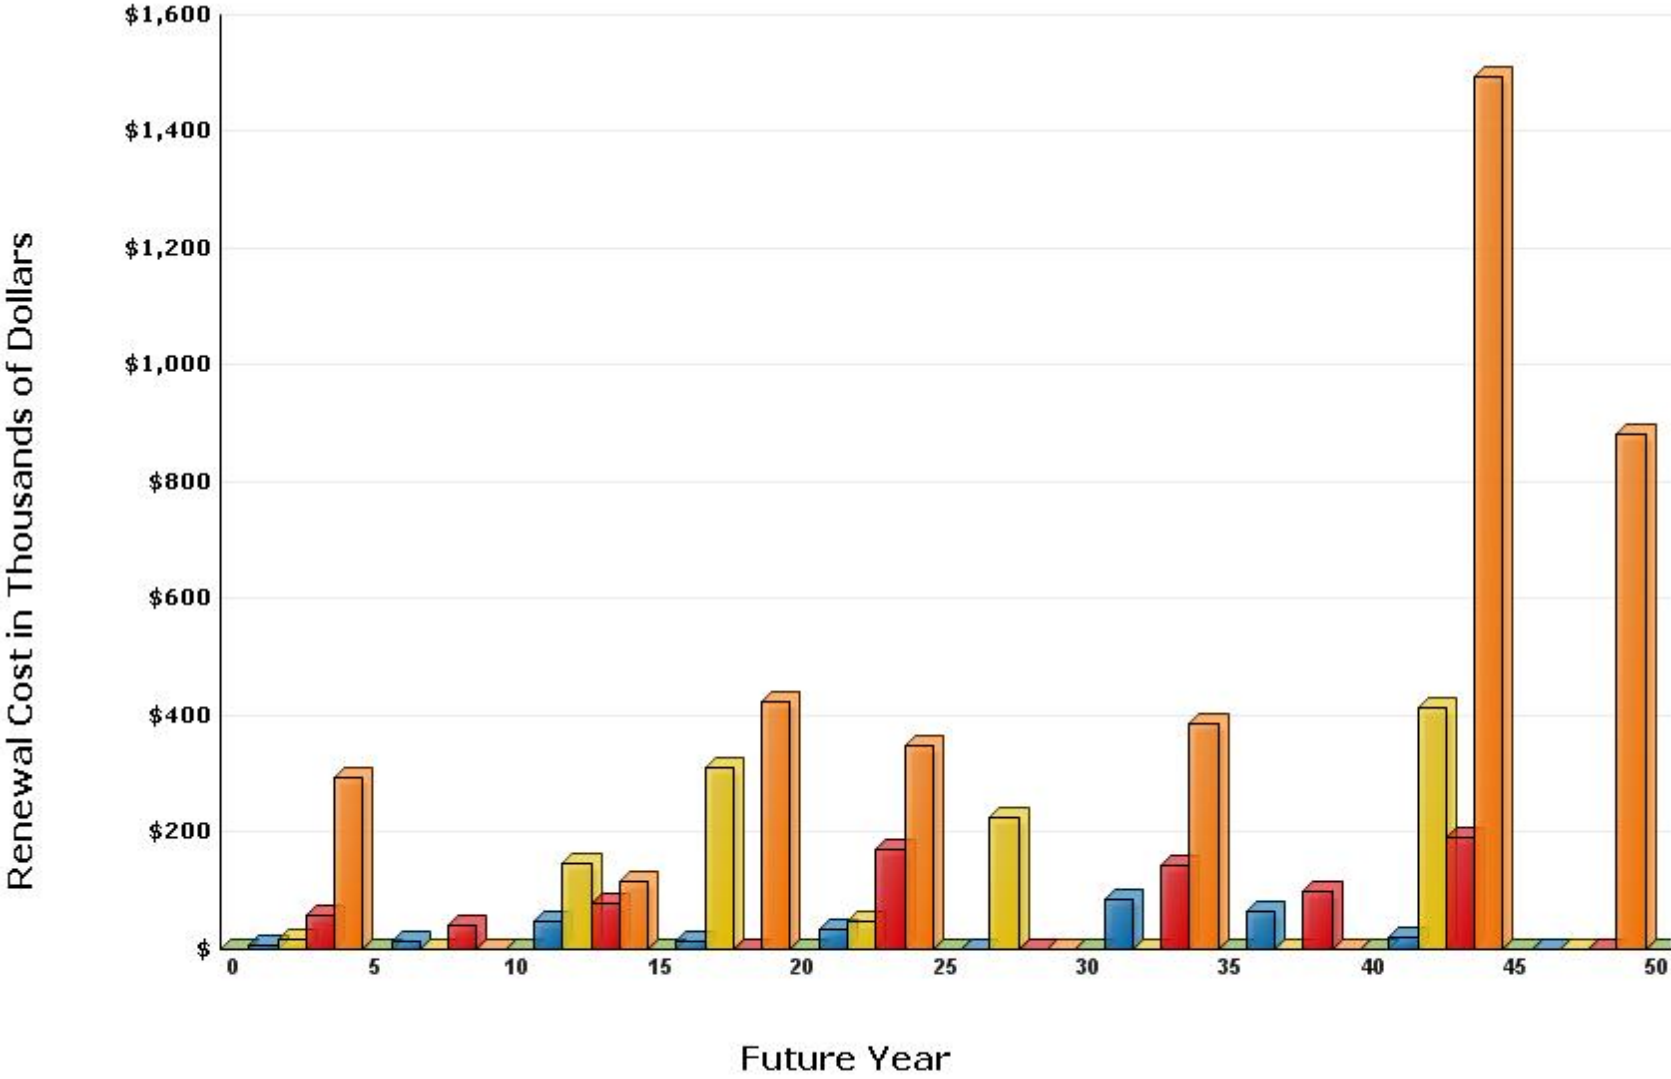
# Life Cycle Model Expenditure Projections

Average Annual Renewal Cost Per SqFt \$3.52
