# EAST CAROLINA UNIVERSITY

## GRAHAM BUILDING

FACILITY CONDITION ANALYSIS

DECEMBER 3, 2009

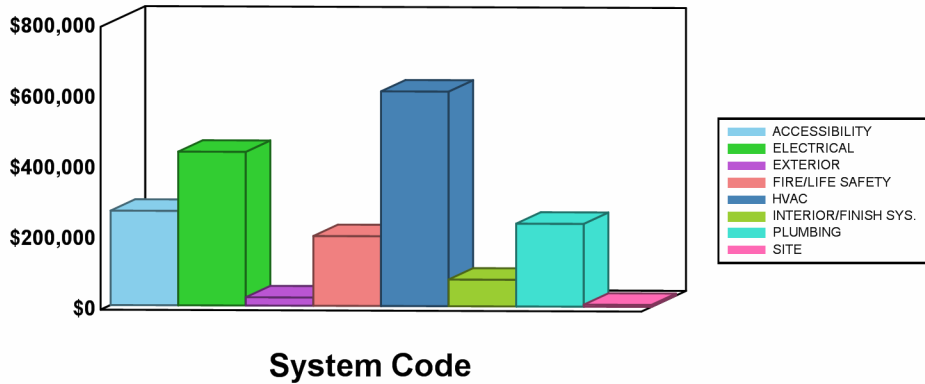
#### PROJECT COSTS BY SYSTEM CODE

System Code	System Description	Project Classes			Subtotal
		Capital Renewal	Deferred Maintenance	Plant Adaption	
AC	ACCESSIBILITY	0	0	267,028	267,028
EL	ELECTRICAL	112,360	322,221	0	434,581
ES	EXTERIOR	23,361	0	0	23,361
FS	FIRE/LIFE SAFETY	112,713	0	84,598	197,311
HV	HVAC	0	607,013	0	607,013
IS	INTERIOR/FINISH SYS.	67,646	7,898	0	75,544
PL	PLUMBING	0	234,314	0	234,314
SI	SITE	1,929	0	0	1,929
	<b>TOTALS</b>	318,010	1,171,446	351,627	1,841,082

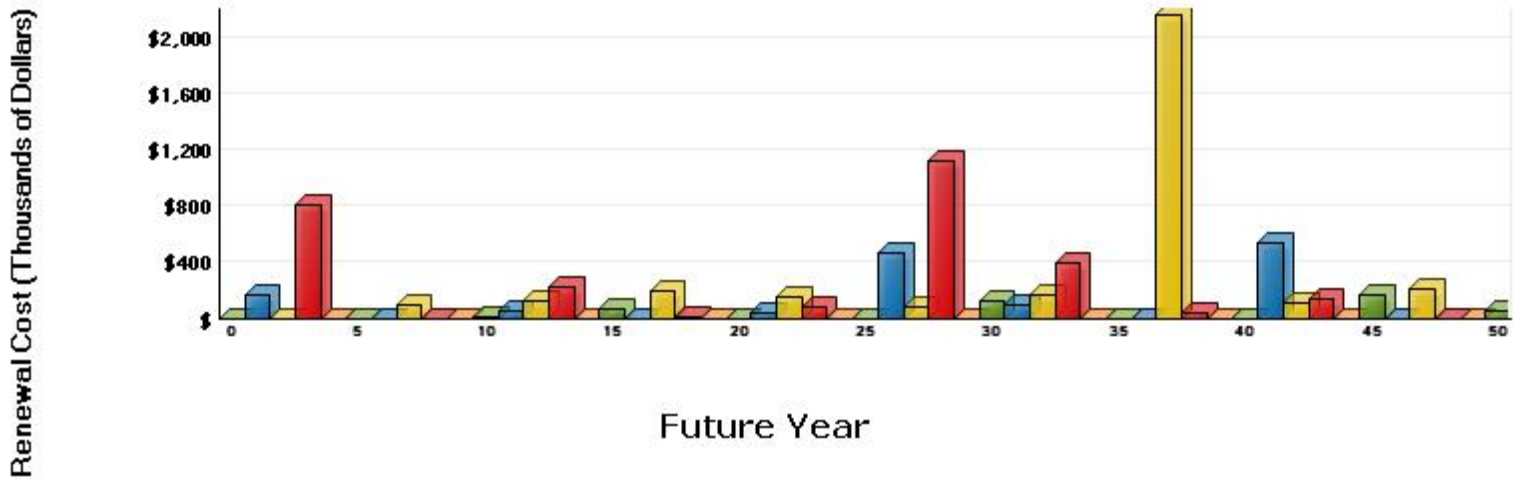
#### LIFE CYCLE MODEL EXPENDITURE PROJECTIONS

**Average Annual Renewal Cost Per SqFt \$4.67**

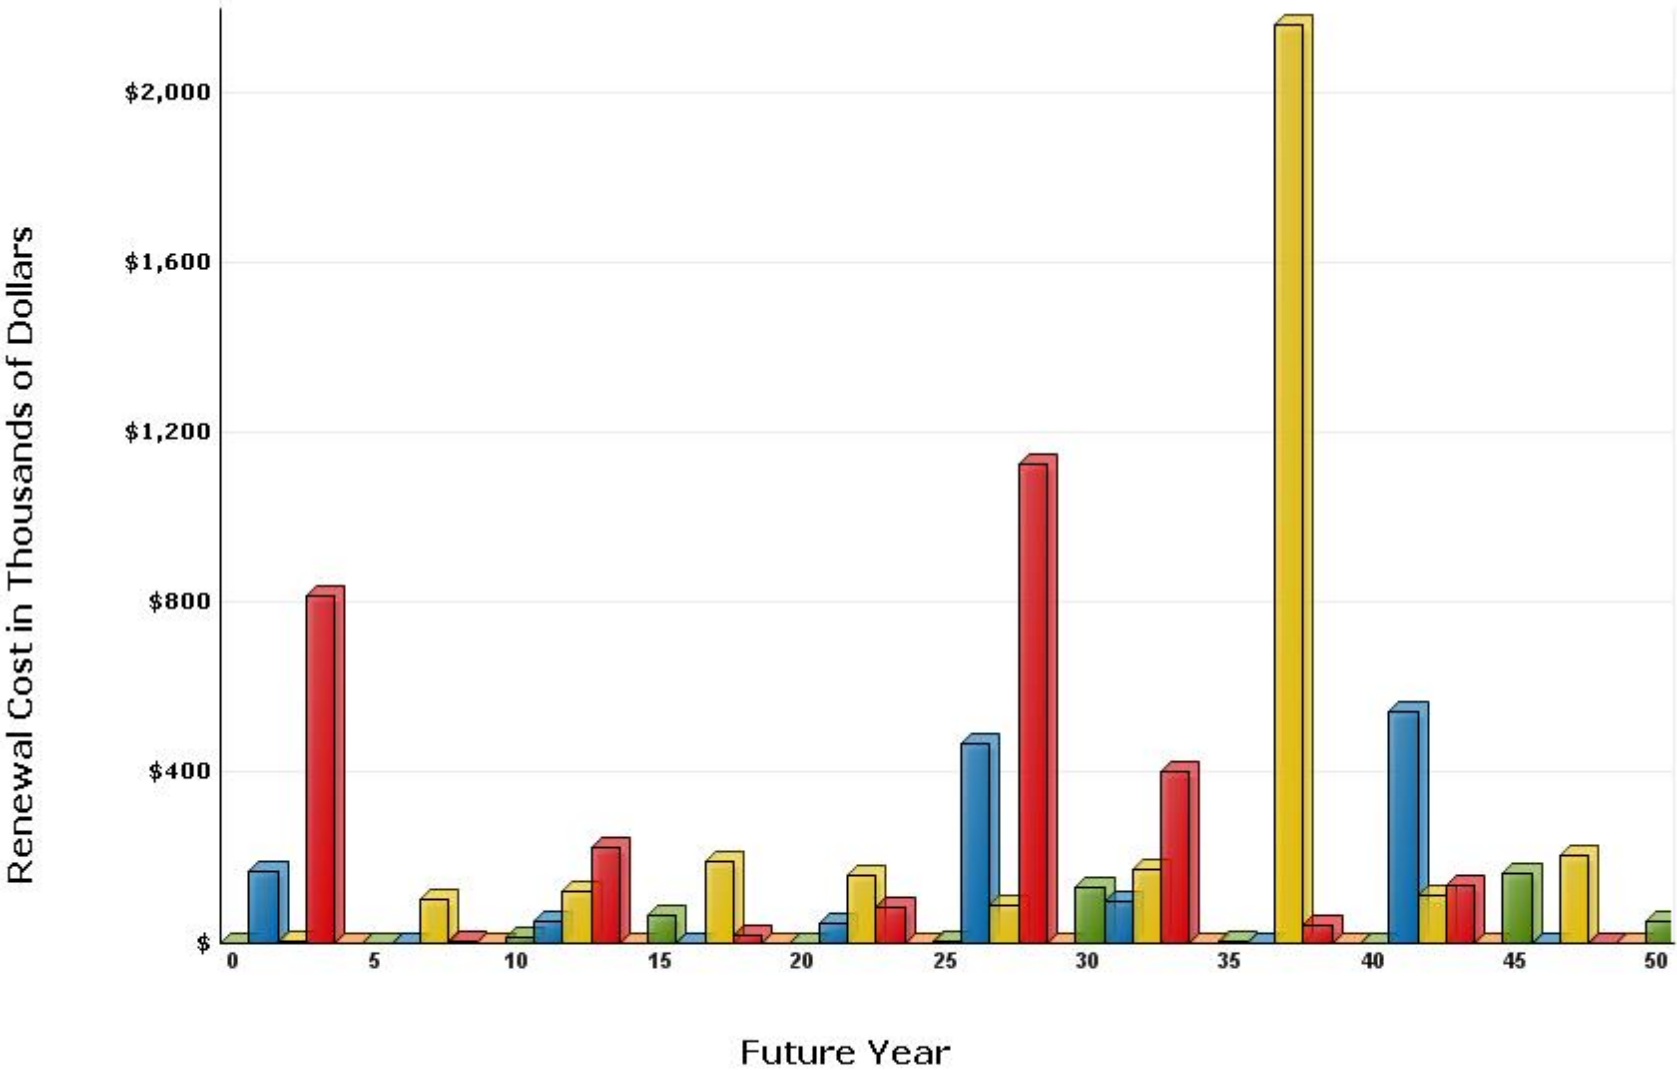
# Life Cycle Model Expenditure Projections

Average Annual Renewal Cost Per SqFt \$4.67
