# EAST CAROLINA UNIVERSITY

## JONES RESIDENCE HALL

FACILITY CONDITION ANALYSIS

DECEMBER 9, 2009

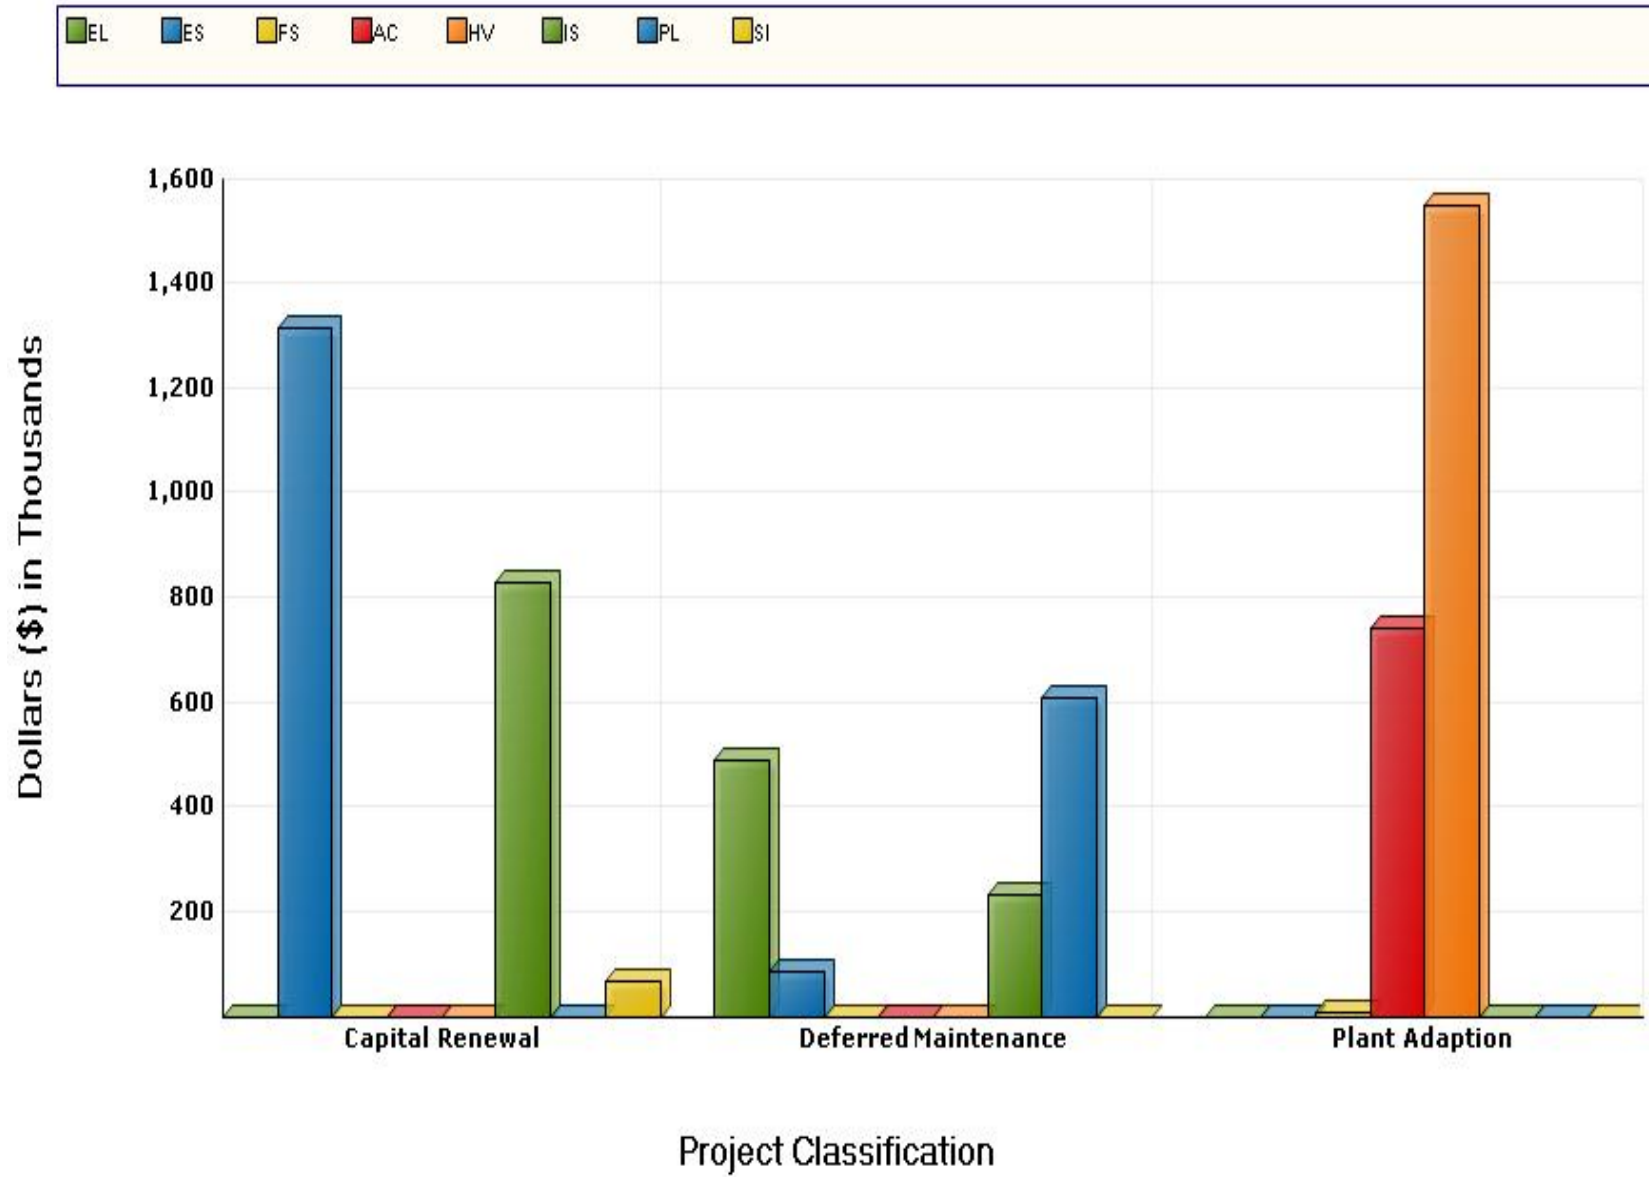
## System Code by Project Class

**Detailed Project Summary**  
**Facility Condition Analysis**  
**Project Class by Priority Class**  
**JONE : JONES RESIDENCE HALL**

Project Class	Priority Classes				Subtotal
	1	2	3	4	
Capital Renewal	0	0	1,878,366	340,085	2,218,451
Deferred Maintenance	0	0	1,417,954	0	1,417,954
Plant Adaption	10,267	0	1,549,228	743,165	2,302,660
<b>TOTALS</b>	10,267	0	4,845,548	1,083,250	5,939,065
