EAST CAROLINA UNIVERSITY

JOYNER EAST

FACILITY CONDITION ANALYSIS

DECEMBER 22, 2009

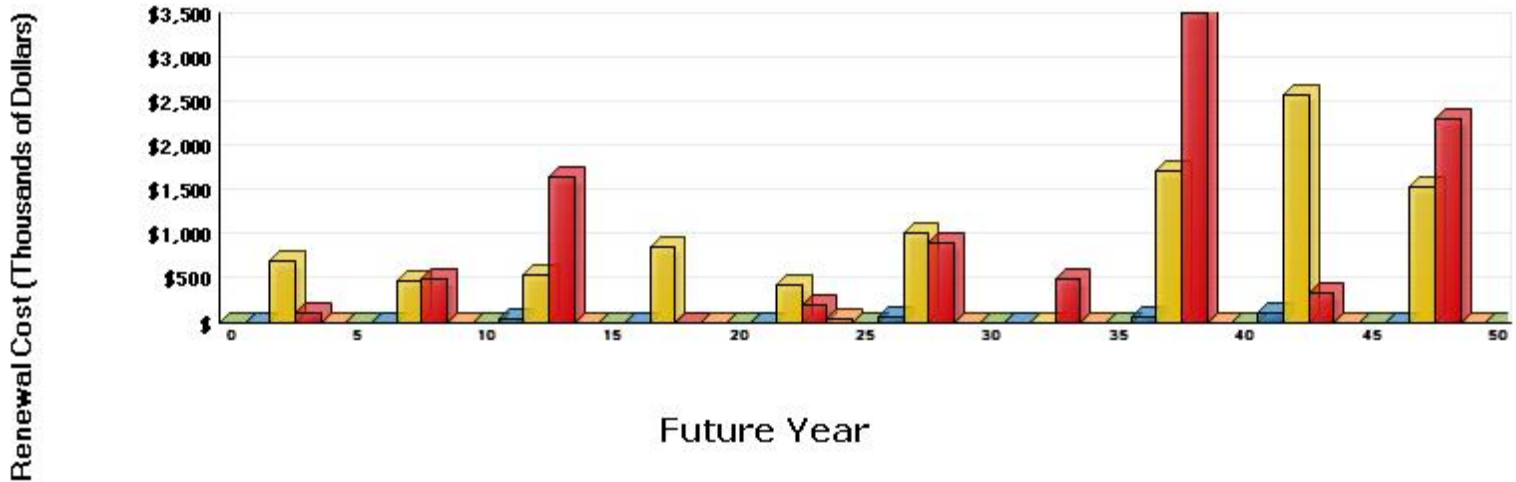
LIFE CYCLE MODEL EXPENDITURE PROJECTIONS

Average Annual Renewal Cost Per SqFt \$5.68

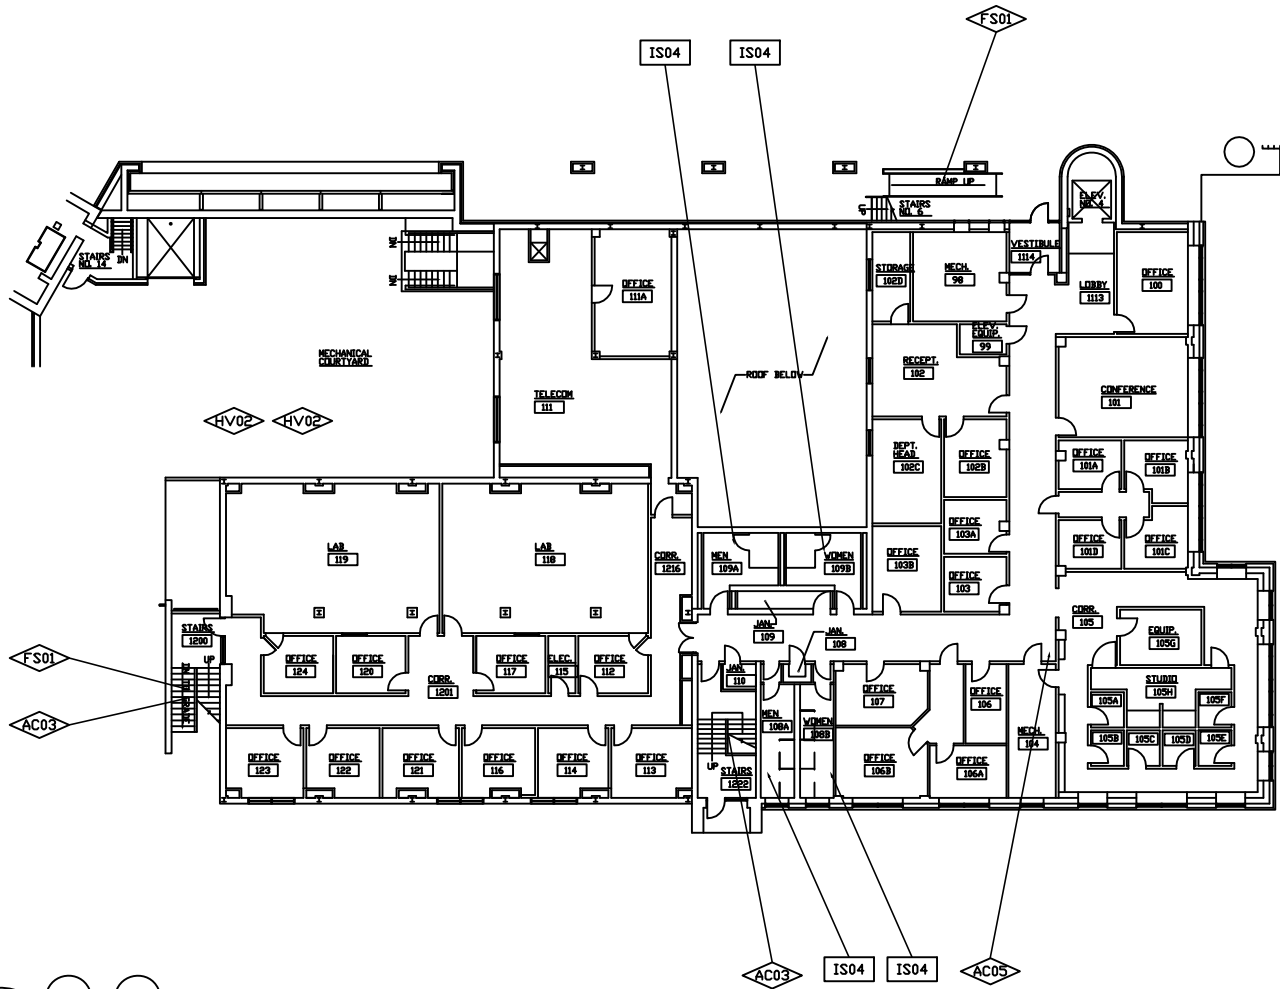
- PROJECT NUMBER APPLIES TO ONE ROOM ONLY
- PROJECT NUMBER APPLIES TO ONE ITEM ONLY
- PROJECT NUMBER APPLIES TO ENTIRE BUILDING
- PROJECT NUMBER APPLIES TO ENTIRE FLOOR
- PROJECT NUMBER APPLIES TO A SITUATION OF UNDEFINED EXTENTS
- PROJECT NUMBER APPLIES TO AREA AS NOTED

ROOF
 ES02 HV01

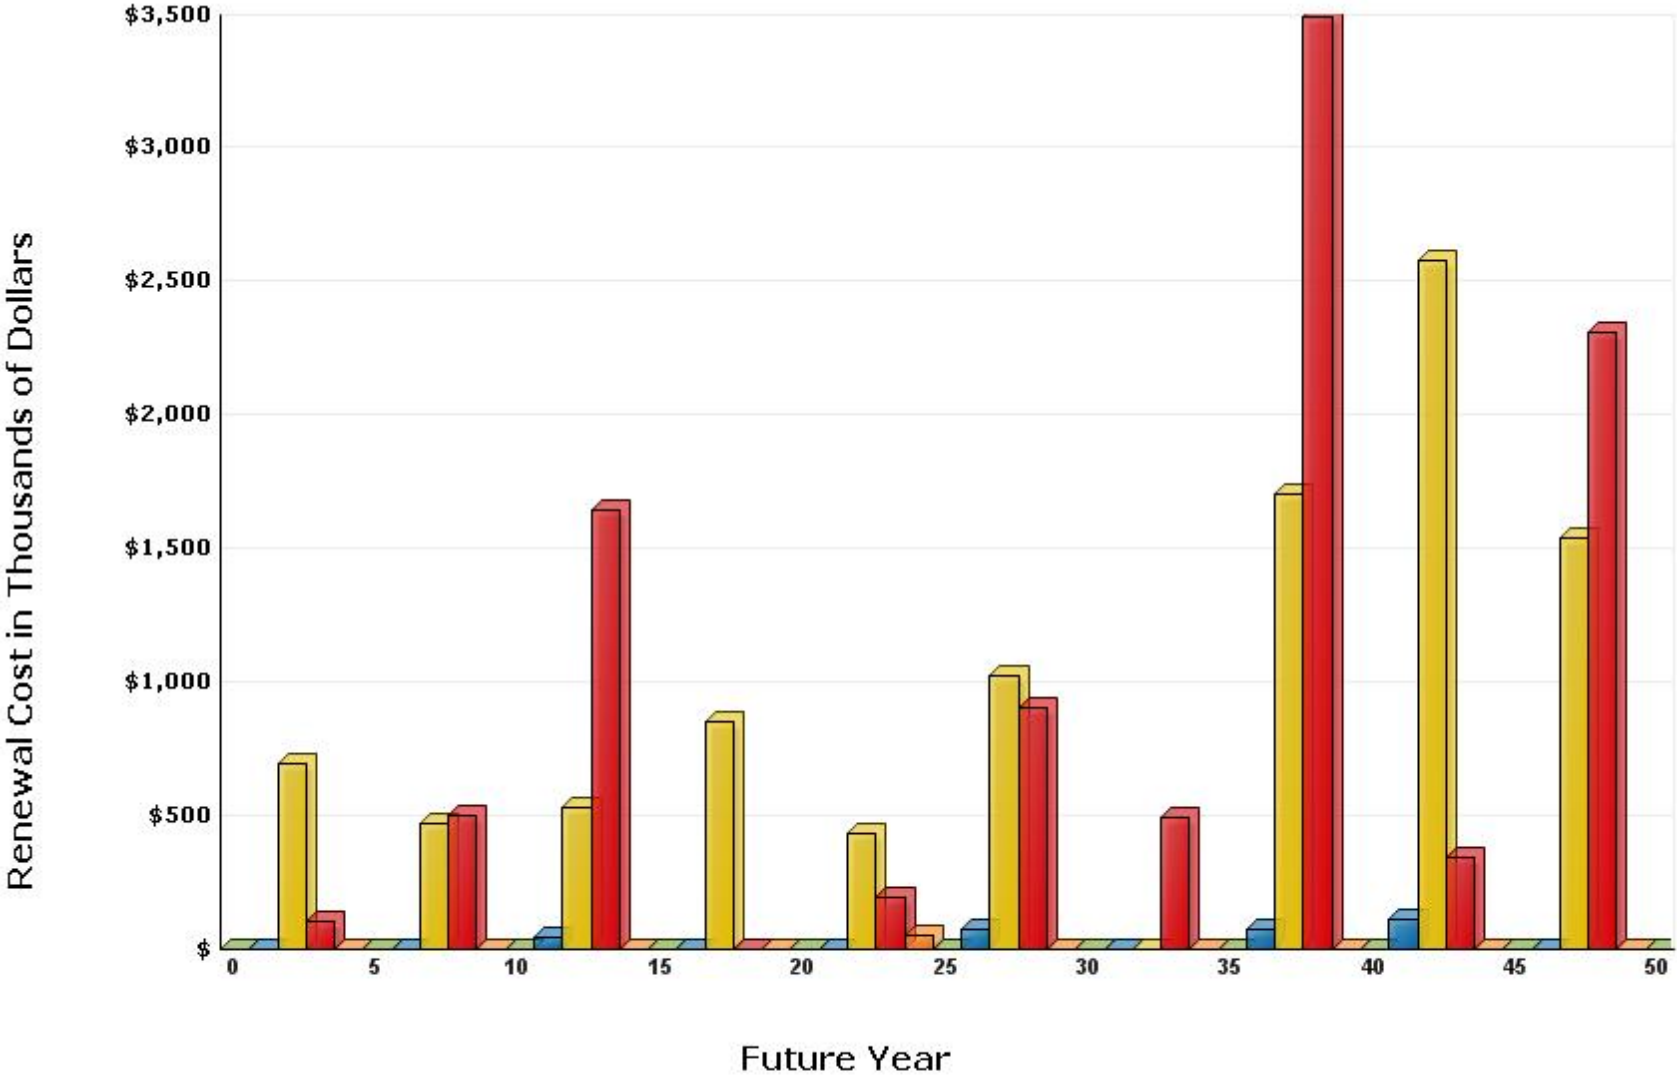
Life Cycle Model Expenditure Projections

Average Annual Renewal Cost Per SqFt \$5.68
