# EAST CAROLINA UNIVERSITY

## JOYNER LIBRARY

FACILITY CONDITION ANALYSIS

DECEMBER 22, 2009

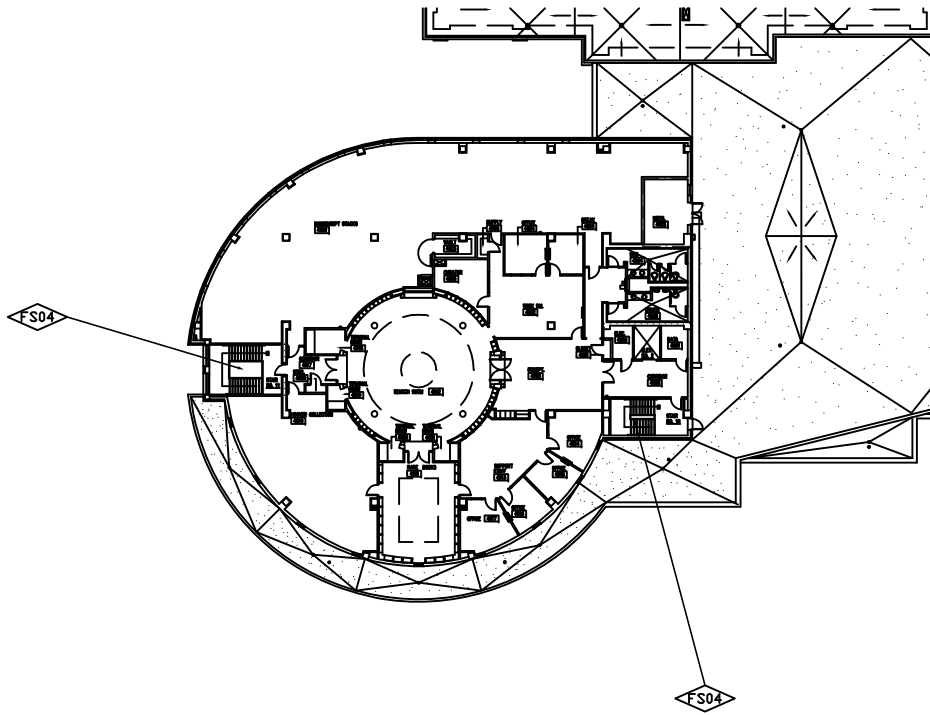
ROOF  
 ES03 HV01

AC02	EL02	EL03	FS01	FS02	FS05
HV01	IS01	IS02	IS03	IS04	PL02
PL03

The flat roof is covered with an unballasted single-ply system that is not expected to outlast the scope of this analysis. Future budget modeling should include a provision for the replacement of all failing roofing systems. Replace this roof with a similar application.
