EAST CAROLINA UNIVERSITY

McGINNIS SCENE SHOP

FACILITY CONDITION ANALYSIS

DECEMBER 30, 2009

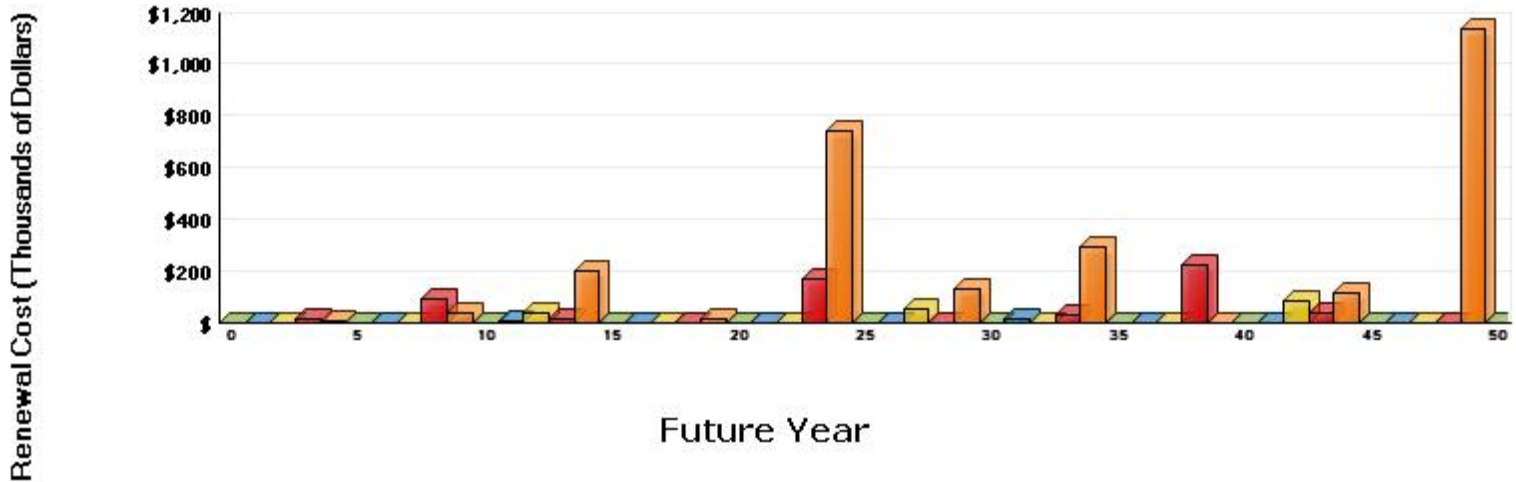
LIFE CYCLE MODEL EXPENDITURE PROJECTIONS

Average Annual Renewal Cost Per SqFt \$2.87

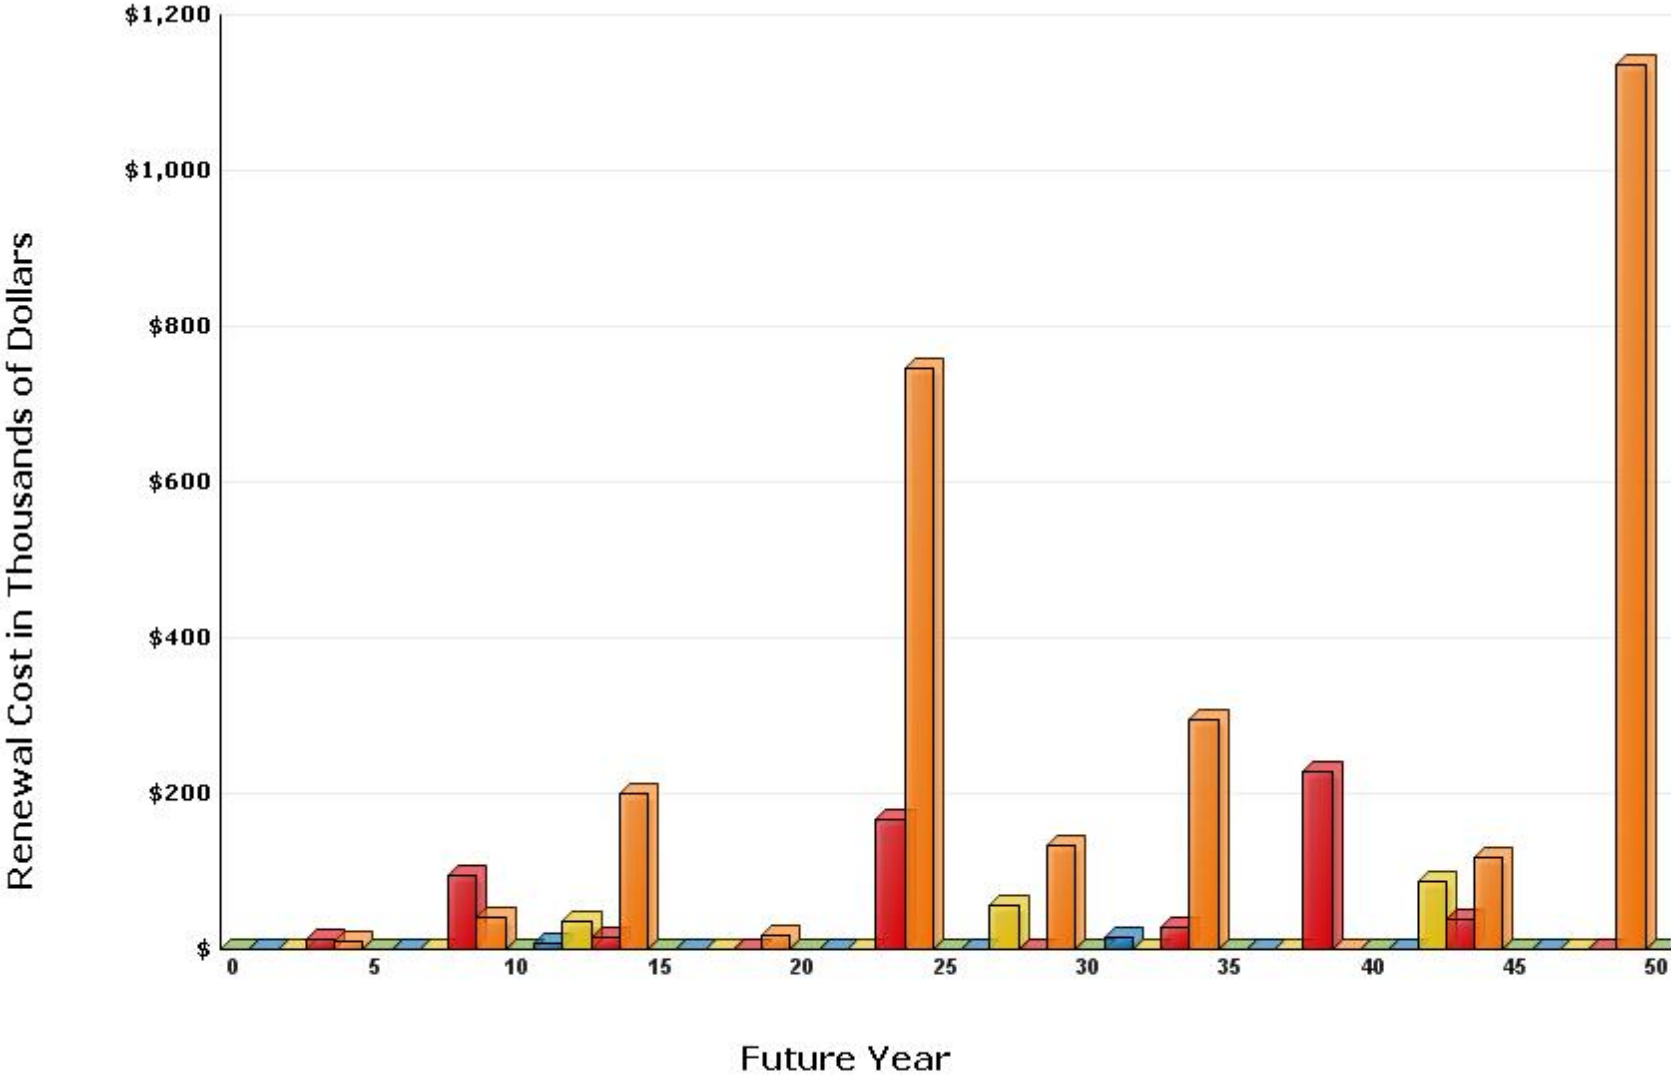
Life Cycle Model Expenditure Projections

Average Annual Renewal Cost Per SqFt \$2.87
