EAST CAROLINA UNIVERSITY

MESSICK THEATRE ARTS COMPLEX

FACILITY CONDITION ANALYSIS

DECEMBER 30, 2009

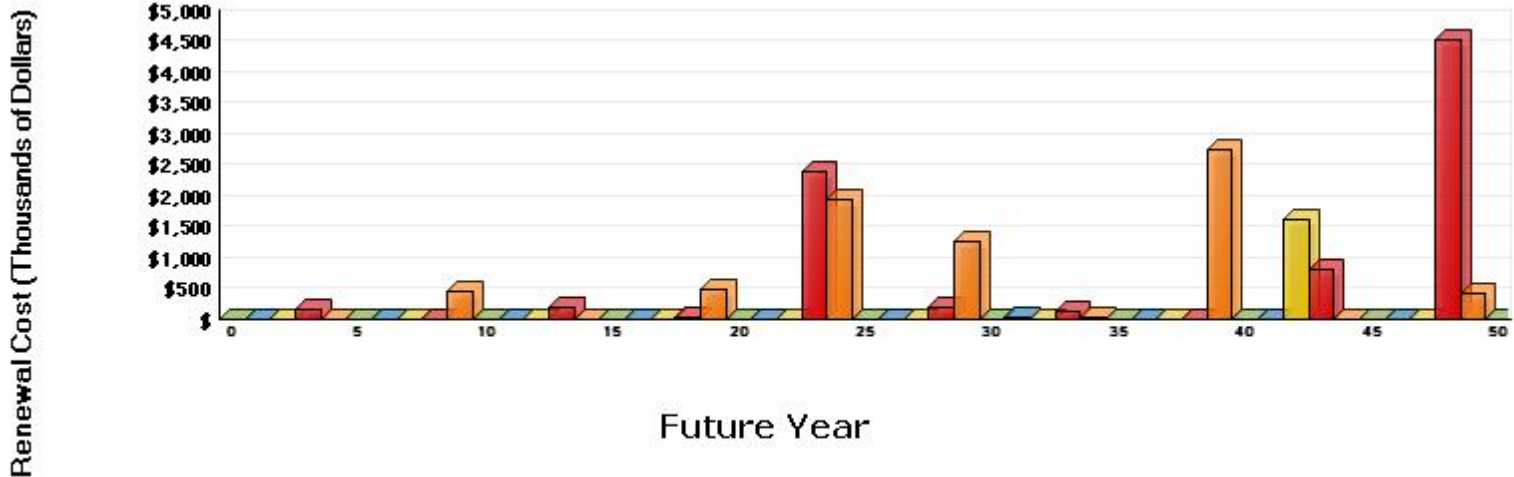
LIFE CYCLE MODEL EXPENDITURE PROJECTIONS

Average Annual Renewal Cost Per SqFt \$3.72

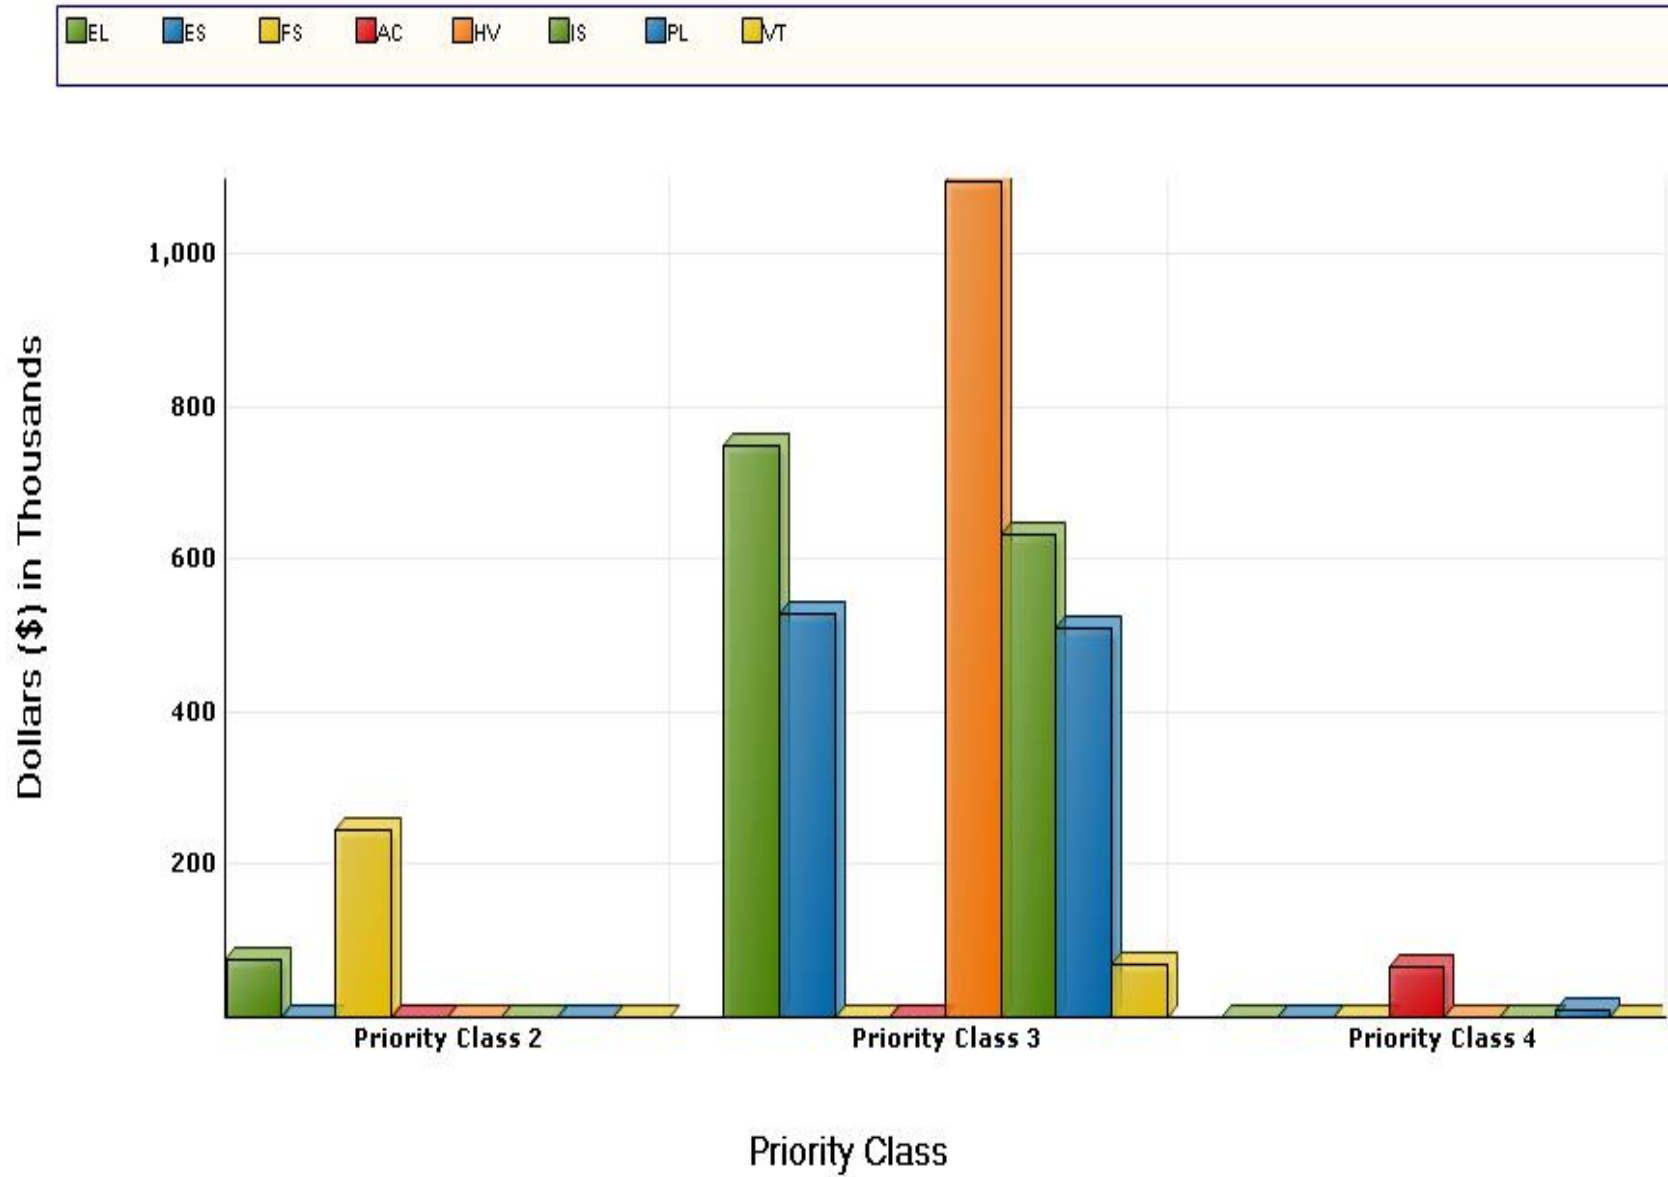
System Code by Priority Class

MESS : MESSICK THEATRE ARTS COMPLEX

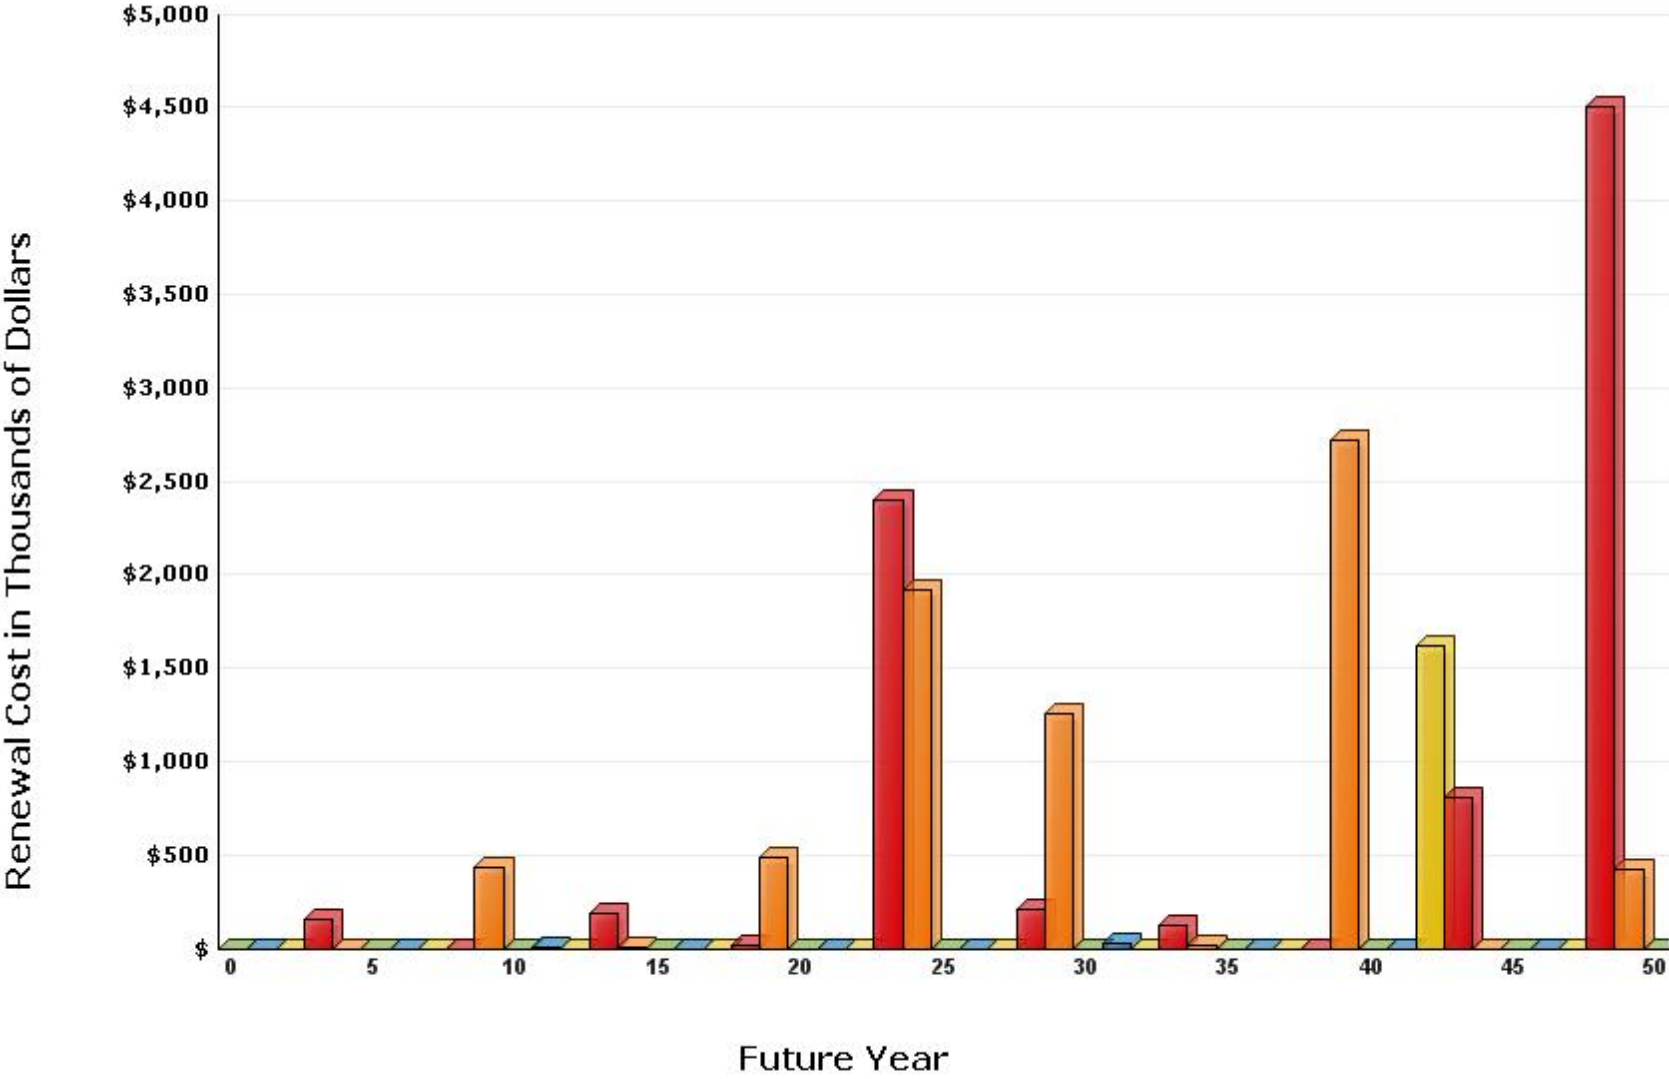
Life Cycle Model Expenditure Projections

Average Annual Renewal Cost Per SqFt \$3.72
