EAST CAROLINA UNIVERSITY

MINGES COLISEUM

FACILITY CONDITION ANALYSIS

DECEMBER 10, 2009

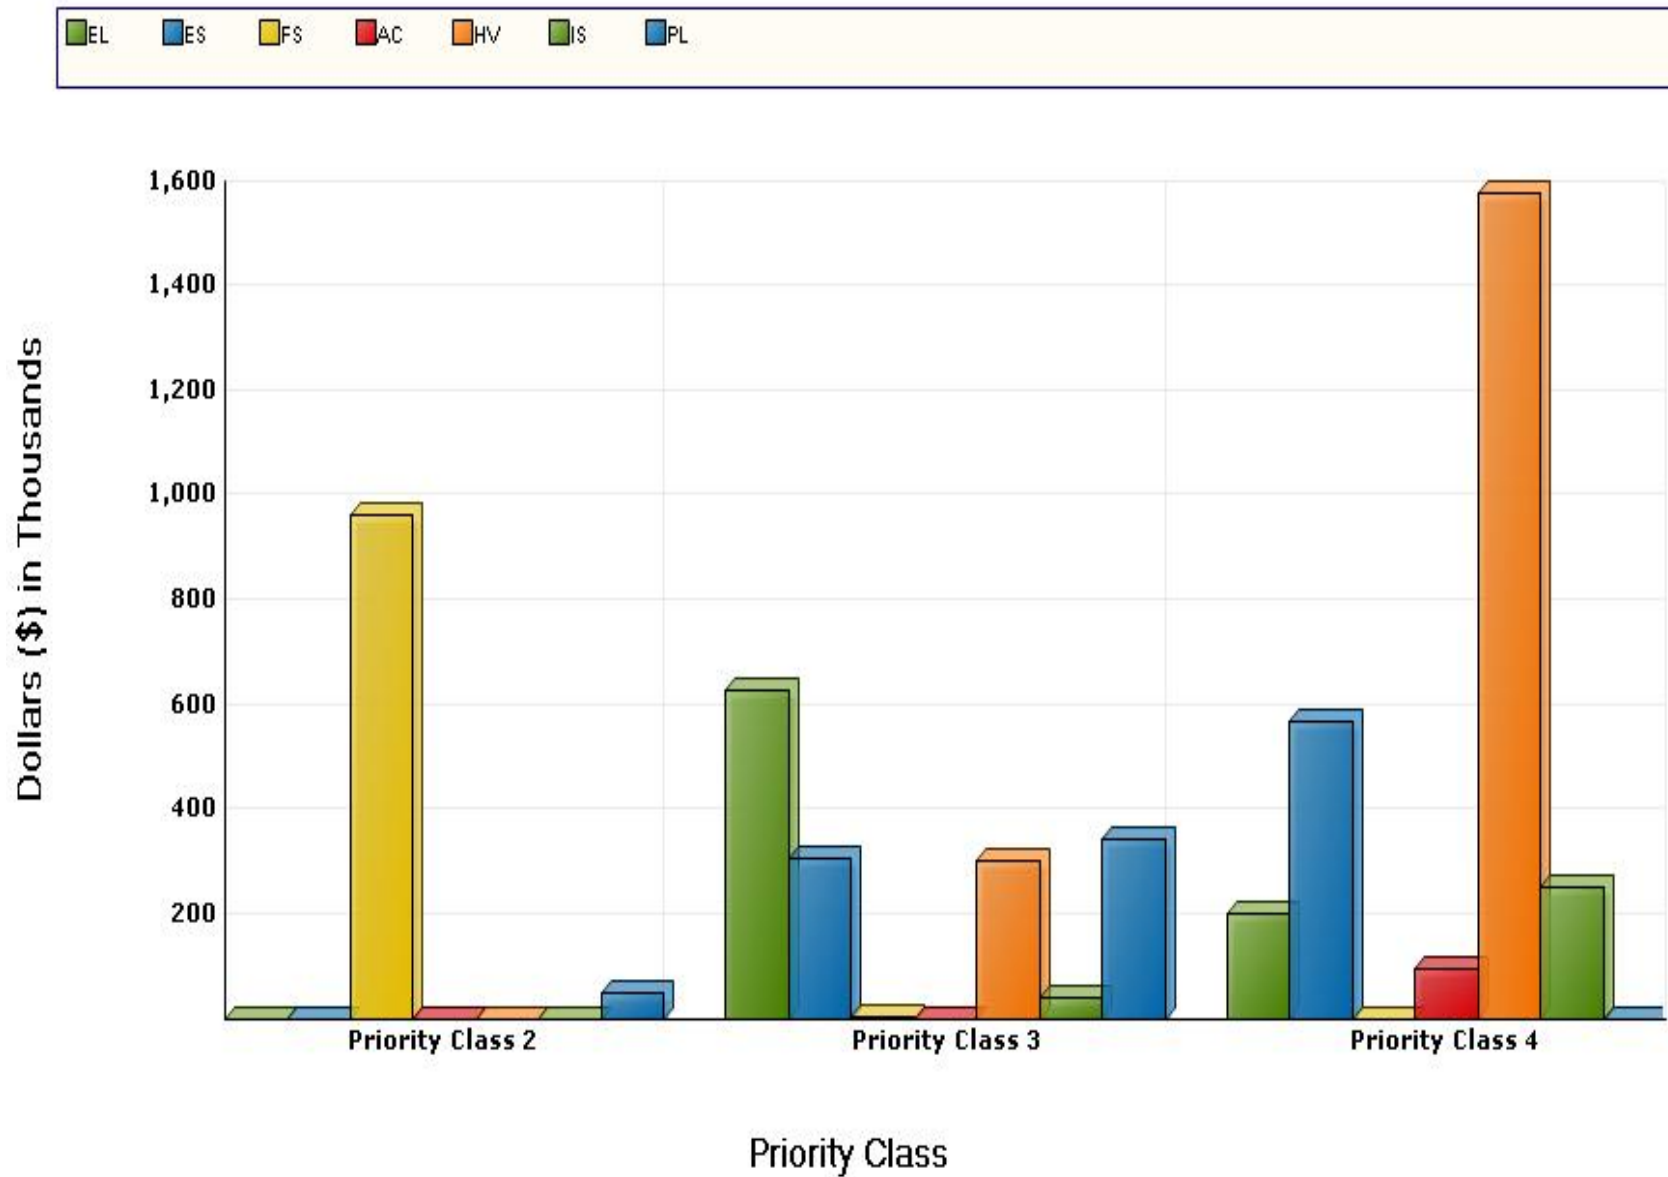
System Code by Priority Class

System Code	System Description	Project Classes			Subtotal
		Capitla Renewal	Deferred Maintenance	Plant Adaption	
AC	ACCESSIBILITY	0	0	94,973	94,973
EL	ELECTRICAL	202,794	626,922	0	829,716
ES	EXTERIOR	875,254	0	0	875,254
FS	FIRE/LIFE SAFETY	417,328	6,689	544,532	968,549
HV	HVAC	1,879,562	0	0	1,879,562
IS	INTERIOR/FINISH SYS.	252,285	43,706	0	295,991
PL	PLUMBING	0	393,604	0	393,604
	TOTALS	3,627,223	1,070,921	639,504	5,337,648

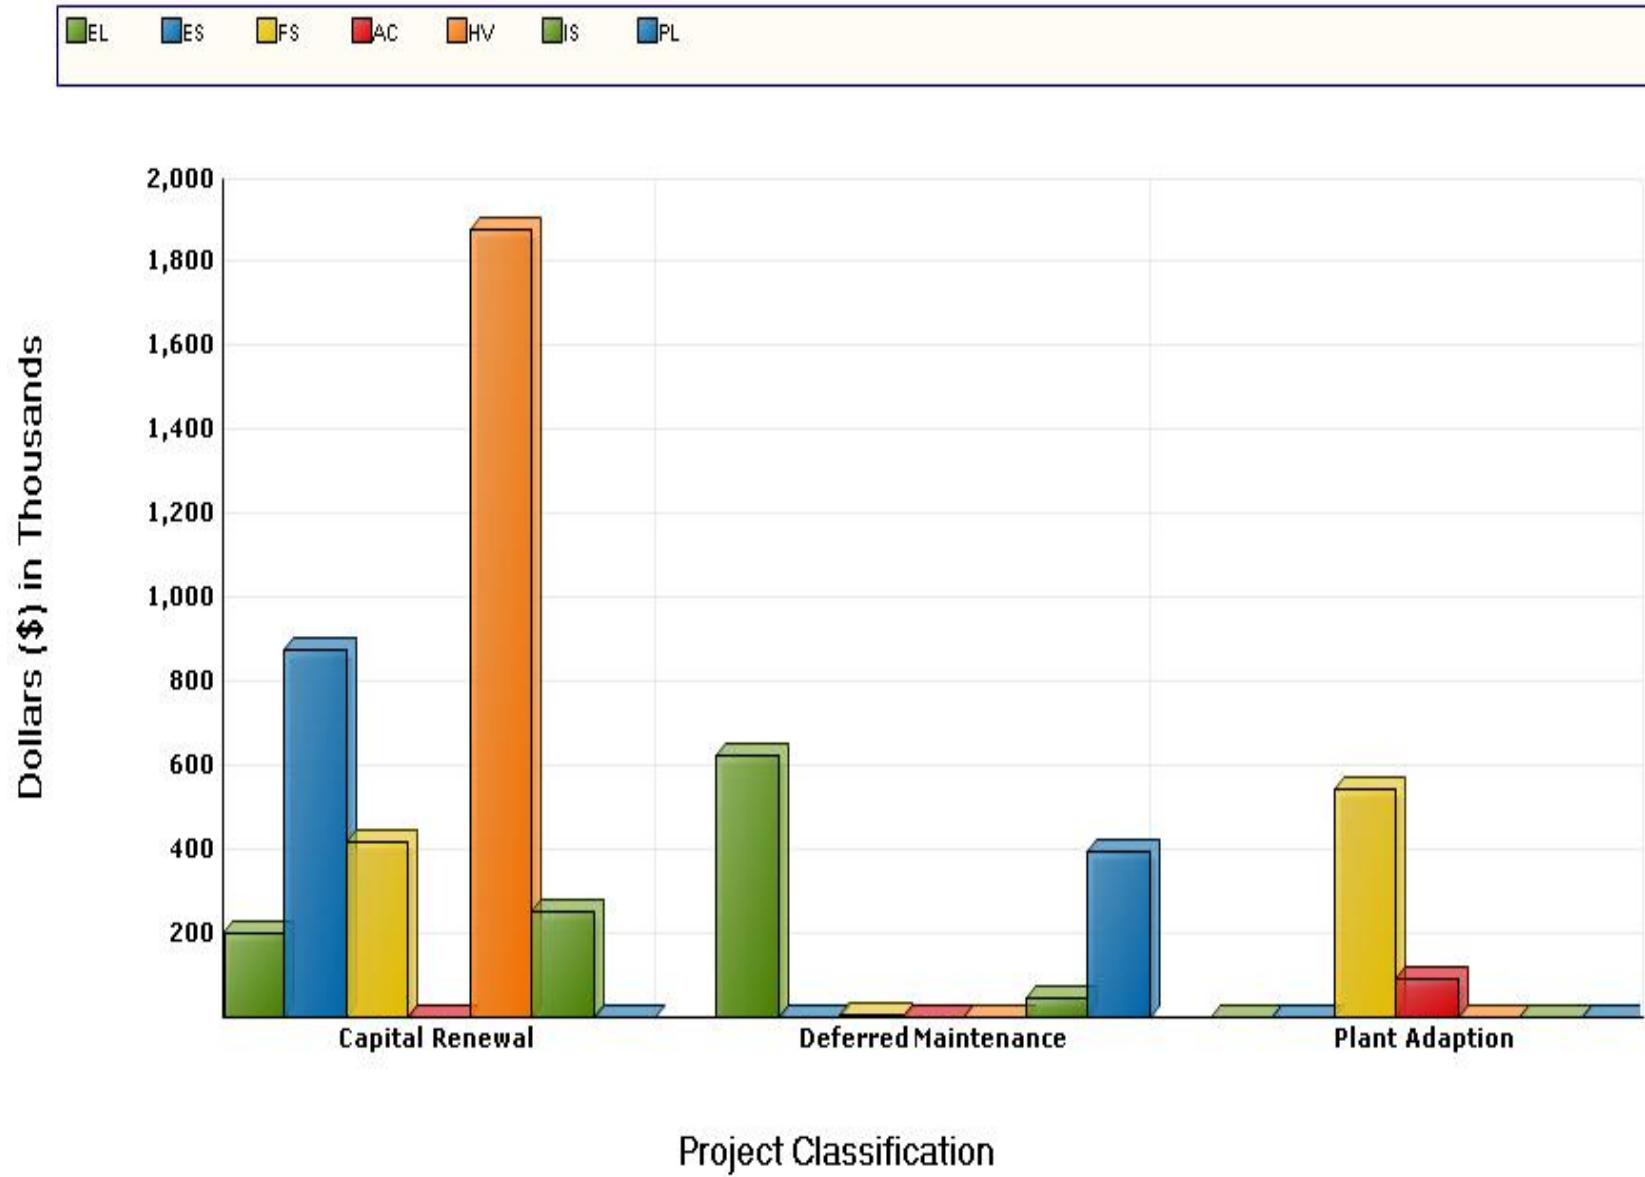
System Code by Project Class

Project Class	Priority Classes				Subtotal
	1	2	3	4	
Capital Renewal	0	417,328	609,863	2,600,031	3,627,223
Deferred Maintenance	0	50,880	1,020,041	0	1,070,921
Plant Adaption	0	544,532	0	94,973	639,504
TOTALS	0	1,012,740	1,629,904	2,695,004	5,337,648

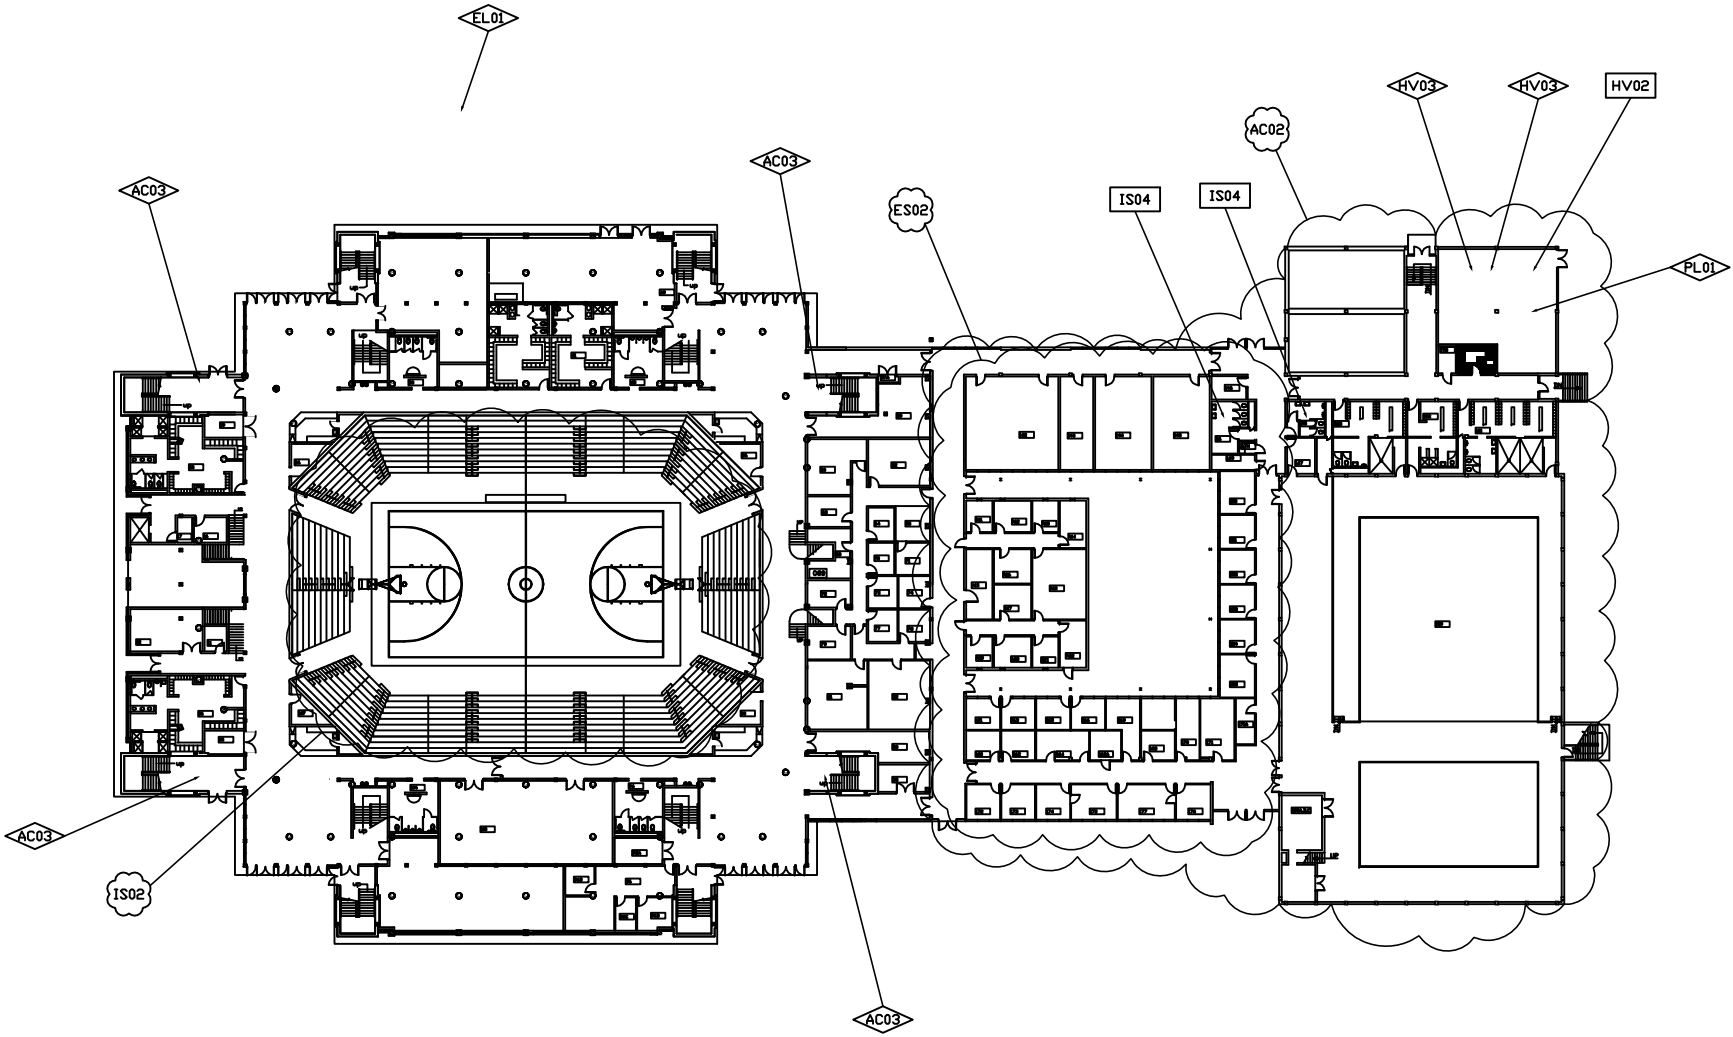
**DRAWINGS
AND PROJECT LOCATIONS**

ROOF
 ES03 ES04 HV01

ES01

AC01 EL02 EL03 FS01 FS02 FS03
 HV01 IS01 IS03 PL02 PL03

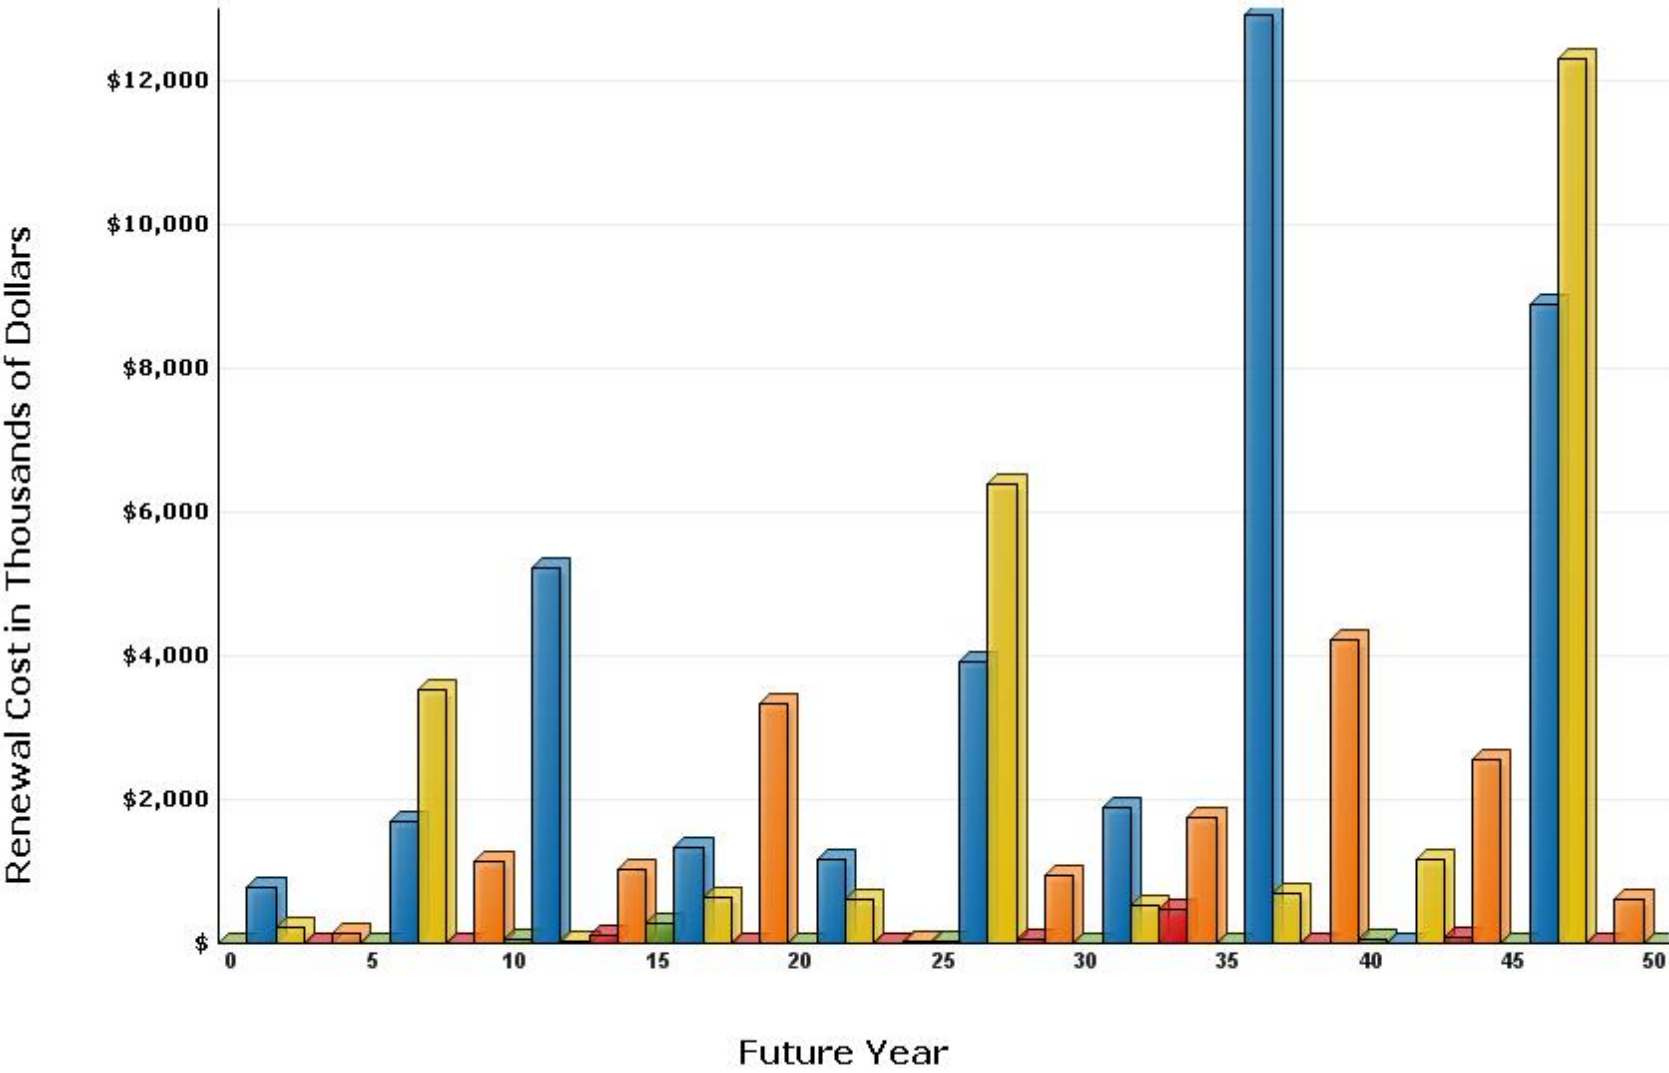
Life Cycle Model Expenditure Projections

Average Annual Renewal Cost Per SqFt \$4.45
