EAST CAROLINA UNIVERSITY

Facility Condition Assessment

MRI of Eastern Carolina

Inspected March 3, 2014

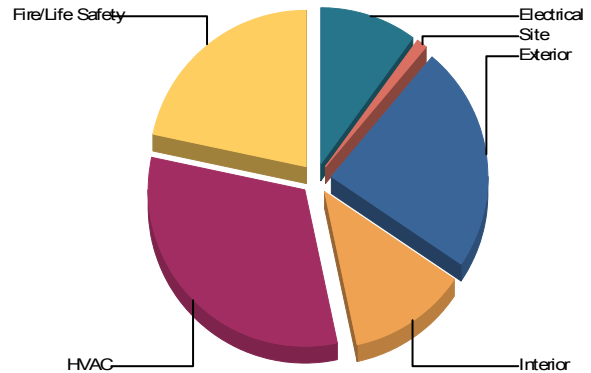
Recurring Facilities Renewal Cost By System

Exterior	\$64,316
Interior	\$33,886
Plumbing	\$0
HVAC	\$87,426
Fire/Life Safety	\$60,216
Electrical	\$27,655
Site	\$2,688
Conveying	\$0
Equipment	\$0
Total	\$276,187

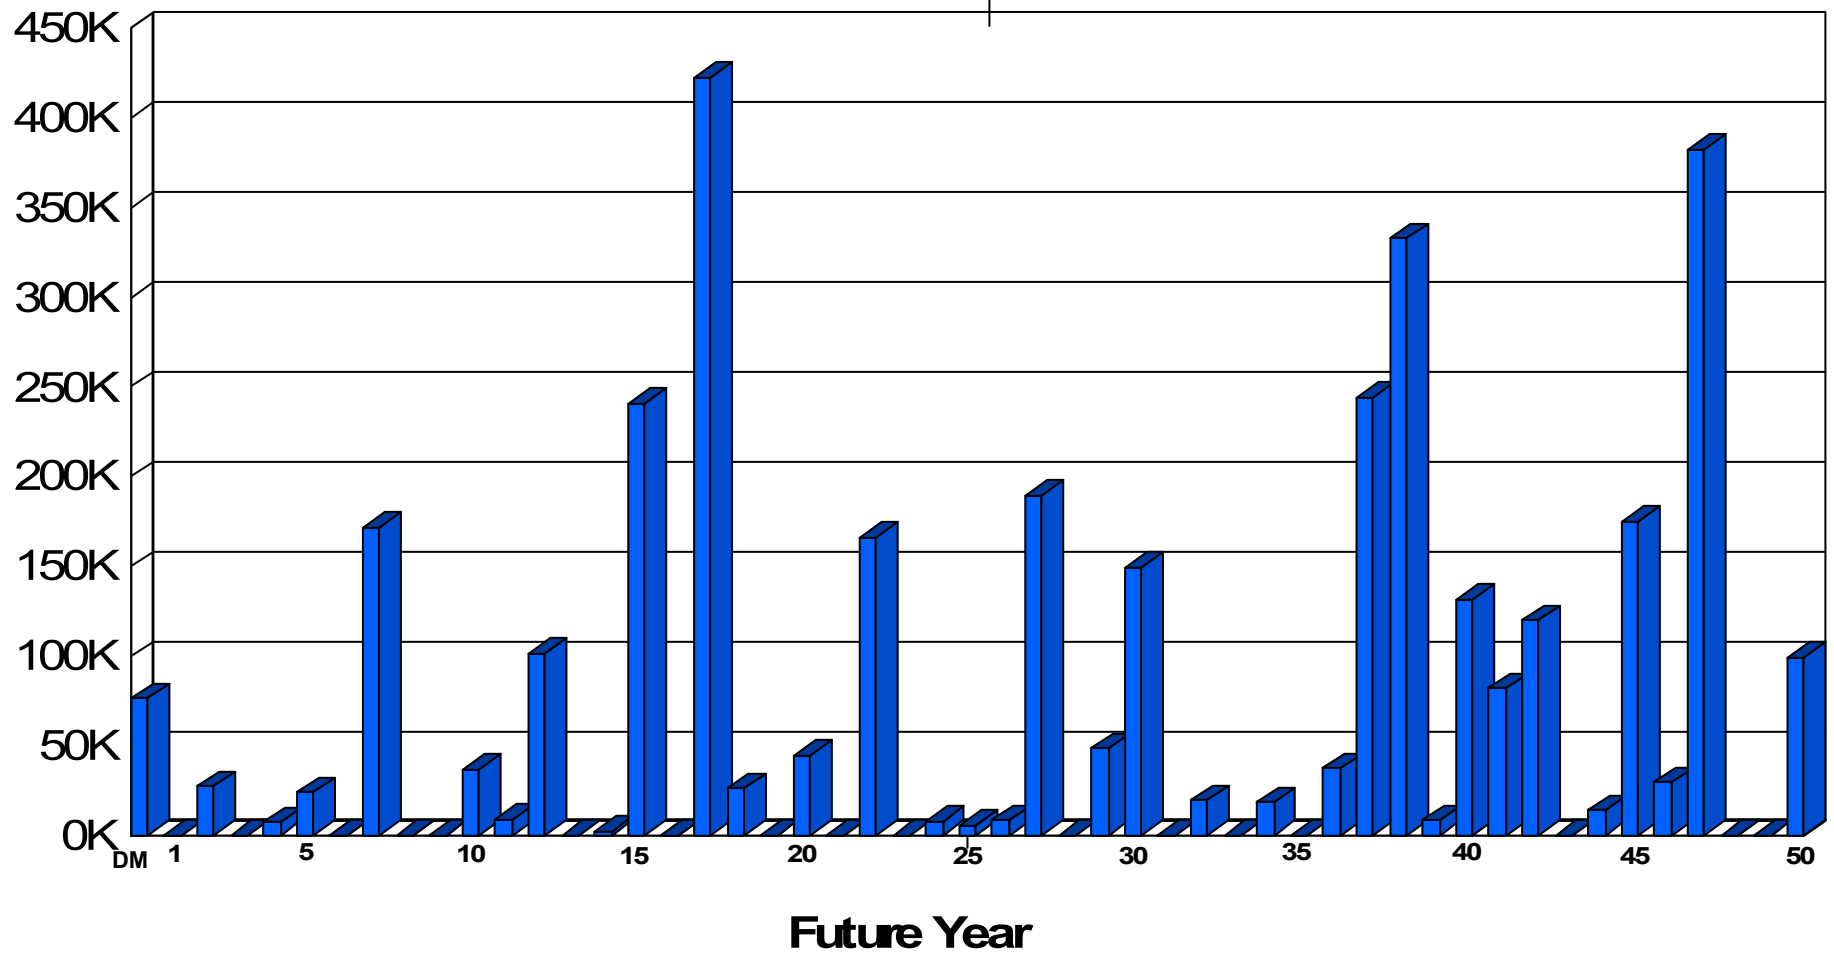
Recurring Component Expenditure Projections

MRI : MRI OF EASTERN CAROLINA

Average Annual Renewal Cost per SqFt \$8.67
