EAST CAROLINA UNIVERSITY

RAGSDALE HALL

FACILITY CONDITION ANALYSIS

AUGUST 25, 2010

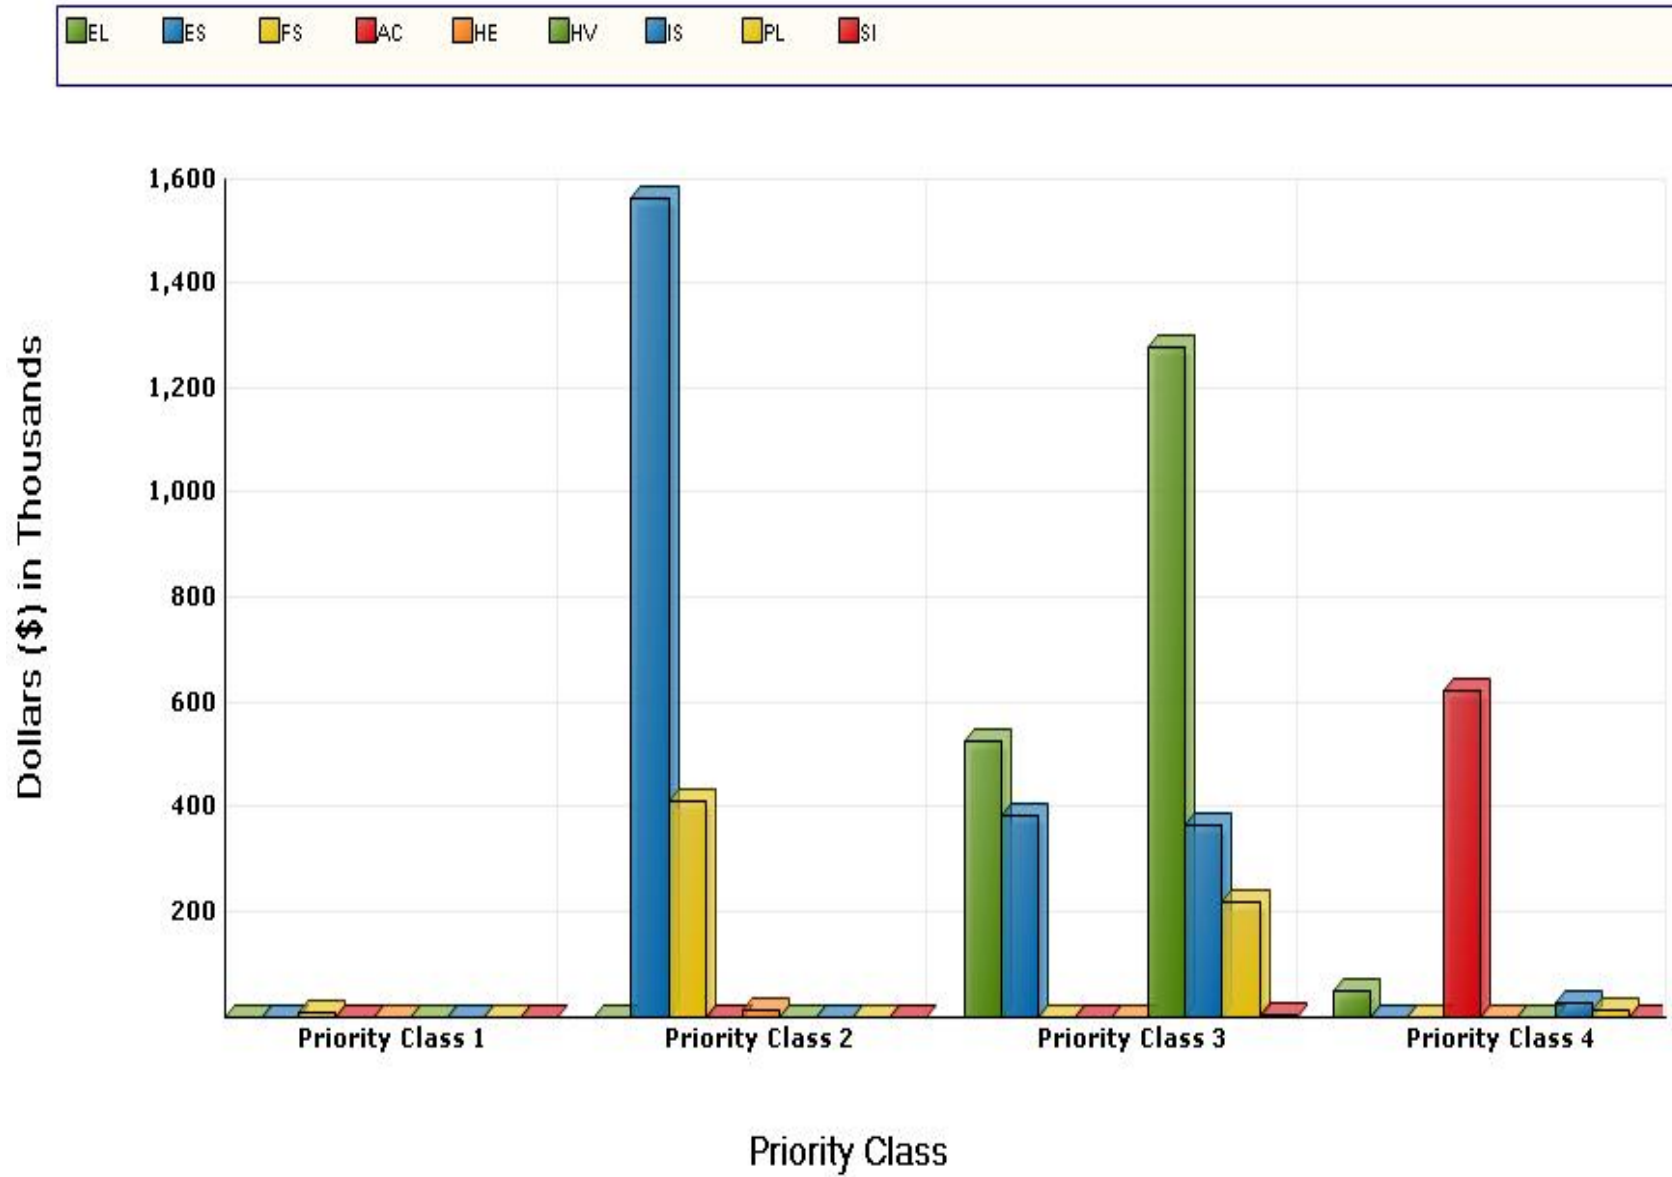
System Code by Priority Class

System Code	System Description	Project Classes			Subtotal
		Capital Renewal	Deferred Maintenance	Plant Adaption	
AC	ACCESSIBILITY	0	0	625,617	625,617
EL	ELECTRICAL	378,677	200,016	0	578,693
ES	EXTERIOR	384,843	1,564,712	0	1,949,555
FS	FIRE/LIFE SAFETY	0	0	419,340	419,340
HE	HEALTH	0	15,599	0	15,599
HV	HVAC	0	0	1,278,092	1,278,092
IS	INTERIOR/FINISH SYS.	396,693	0	0	396,693
PL	PLUMBING	12,172	221,125	0	233,298
SI	SITE	3,978	0	0	3,978
	TOTALS	1,176,363	2,001,453	2,323,049	5,500,865

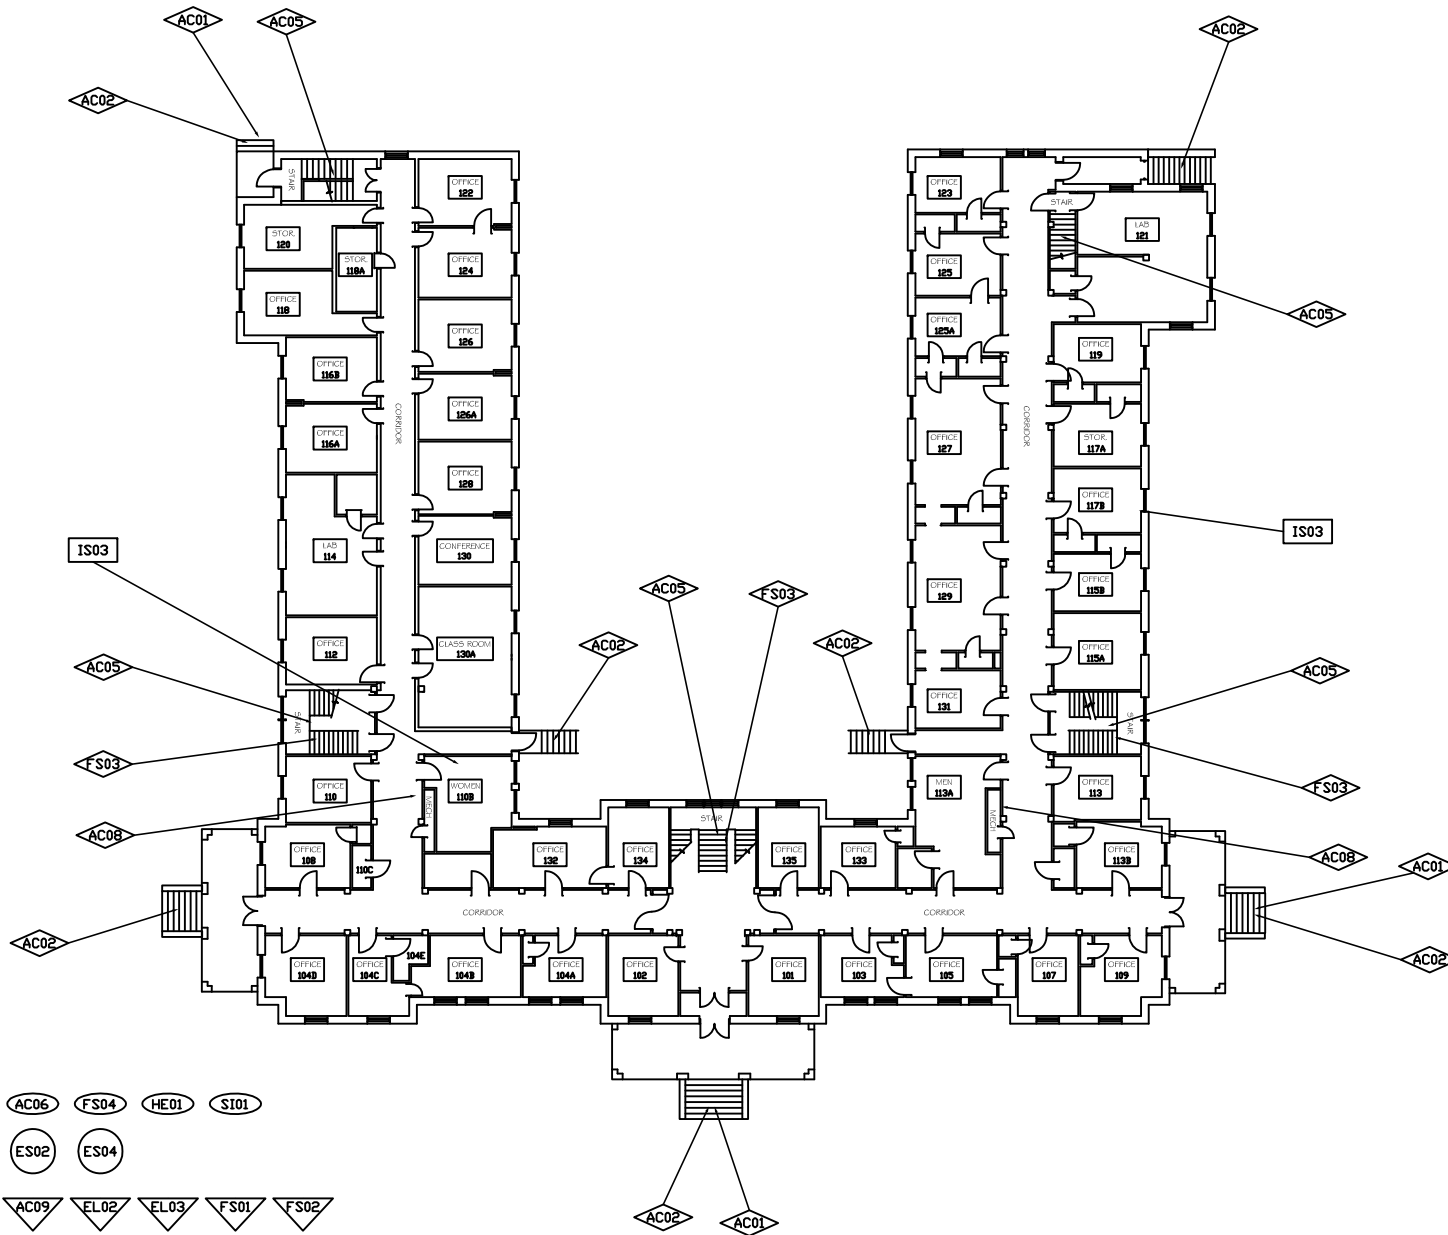
RAGSDALE HALL

- AC03 AC06 FS04 HE01 SI01
- EL04 ES02 ES04
- AC04 AC09 EL02 EL03 FS01 FS02
- HV01 IS01 IS02 IS04 PL02 PL03
