EAST CAROLINA UNIVERSITY

RIVERS ADDITION

FACILITY CONDITION ANALYSIS

DECEMBER 28, 2009

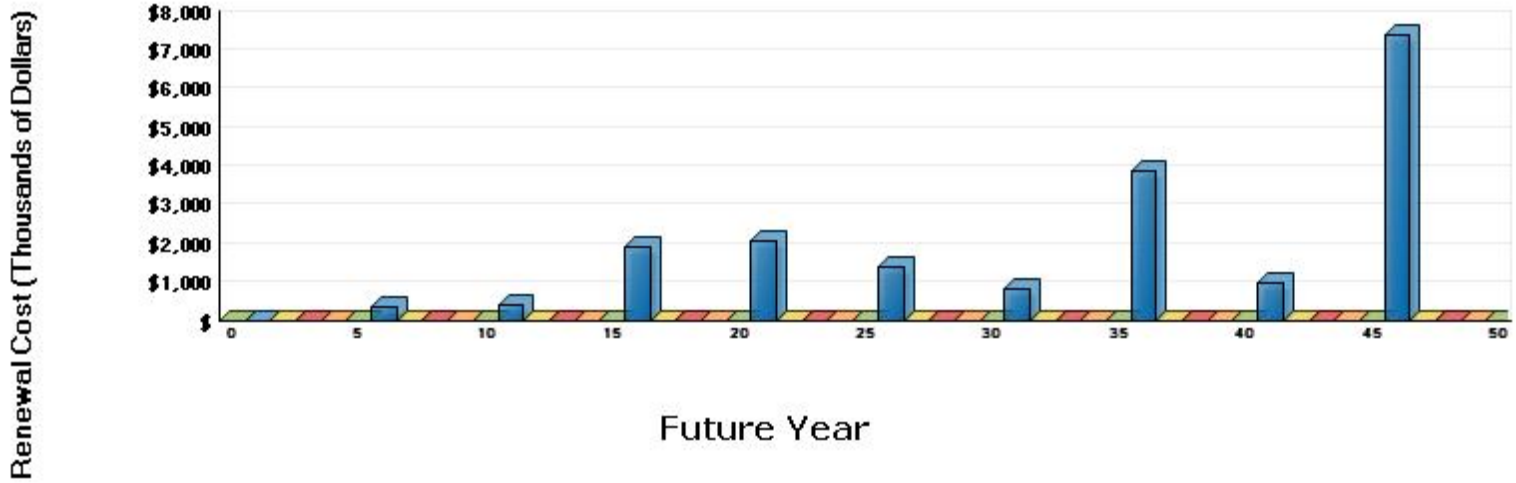
LIFE CYCLE MODEL EXPENDITURE PROJECTIONS

Average Annual Renewal Cost Per SqFt \$3.87

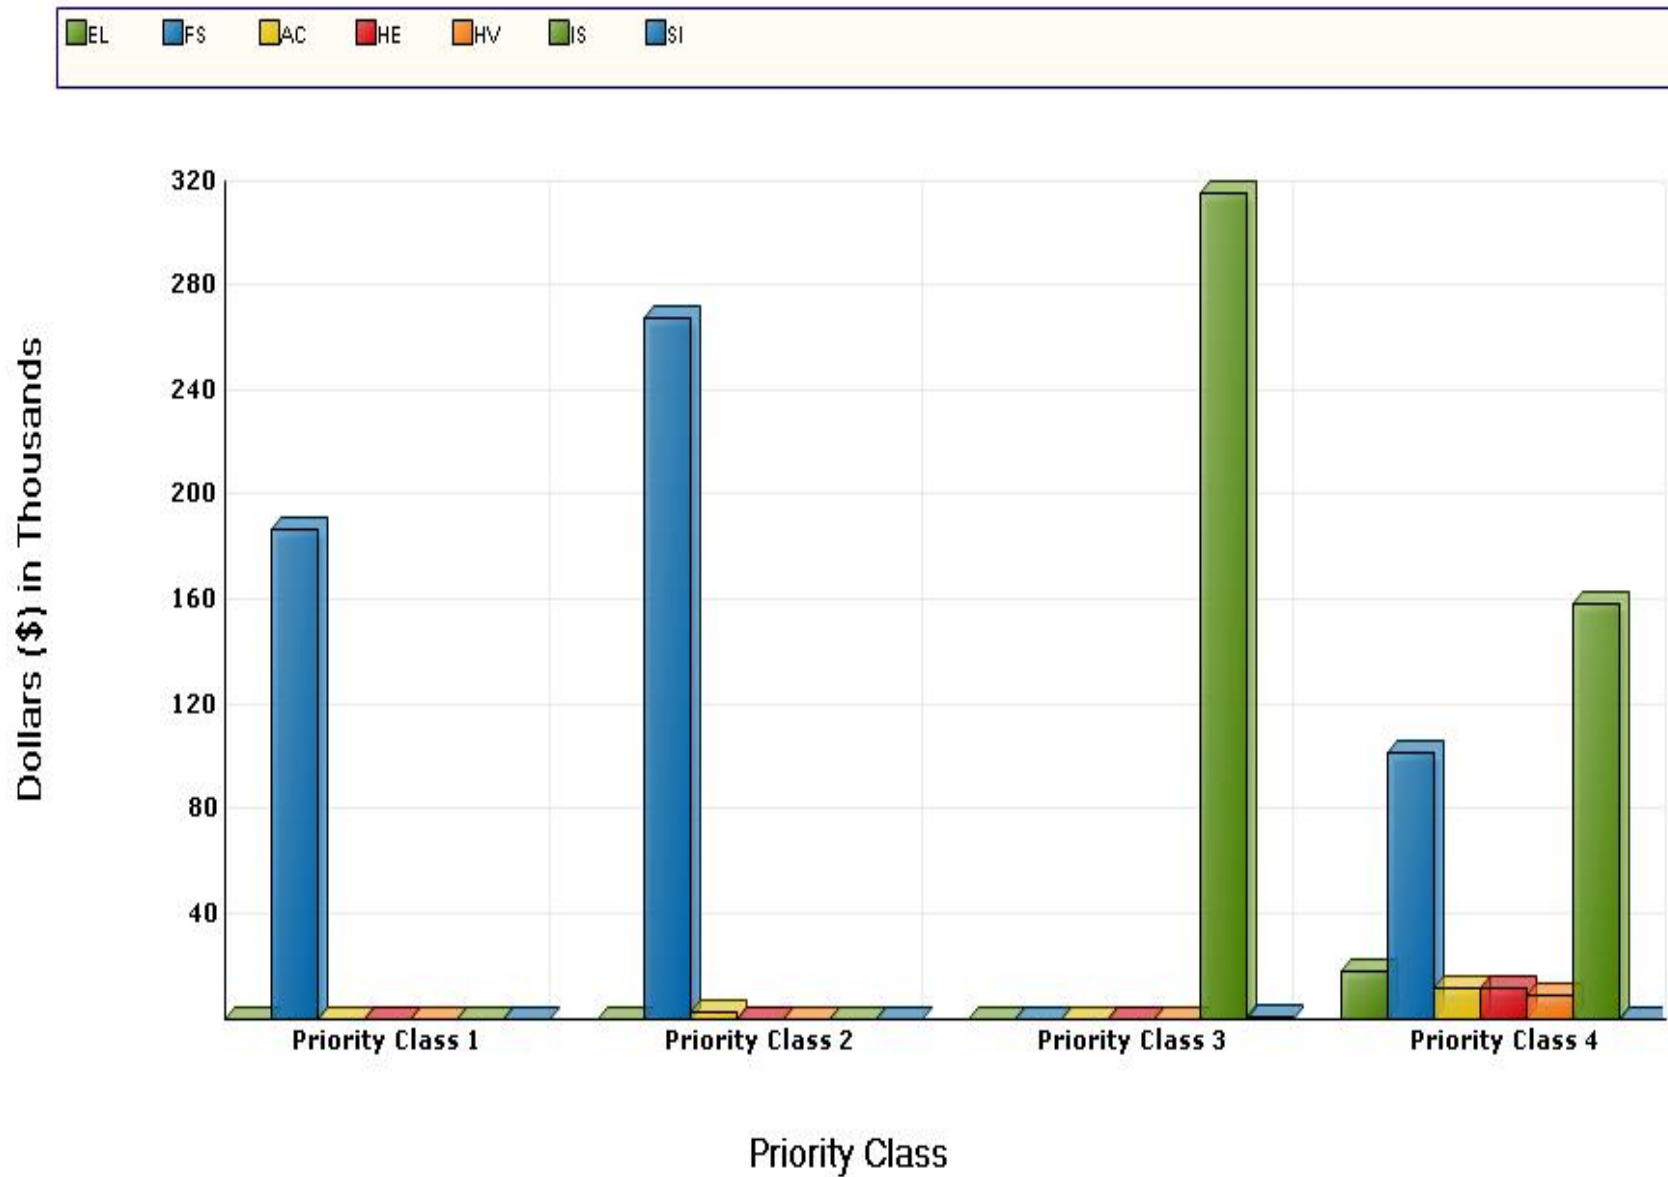
System Code by Priority Class

**Detailed Project Totals
 Facility Condition Analysis
 System Code by Project Class
 RIVE2 : RIVERS ADDITION**

System Code	System Description	Project Classes			Subtotal
		Capital Renewal	Deferred Maintenance	Plant Adaption	
AC	ACCESSIBILITY	0	0	15,580	15,580
EL	ELECTRICAL	18,917	0	0	18,917
FS	FIRE/LIFE SAFETY	102,587	0	455,290	557,878
HE	HEALTH	12,934	0	0	12,934
HV	HVAC	9,705	0	0	9,705
IS	INTERIOR/FINISH SYS.	475,197	0	0	475,197
SI	SITE	1,286	0	0	1,286
	TOTALS	620,625	0	470,871	1,091,496

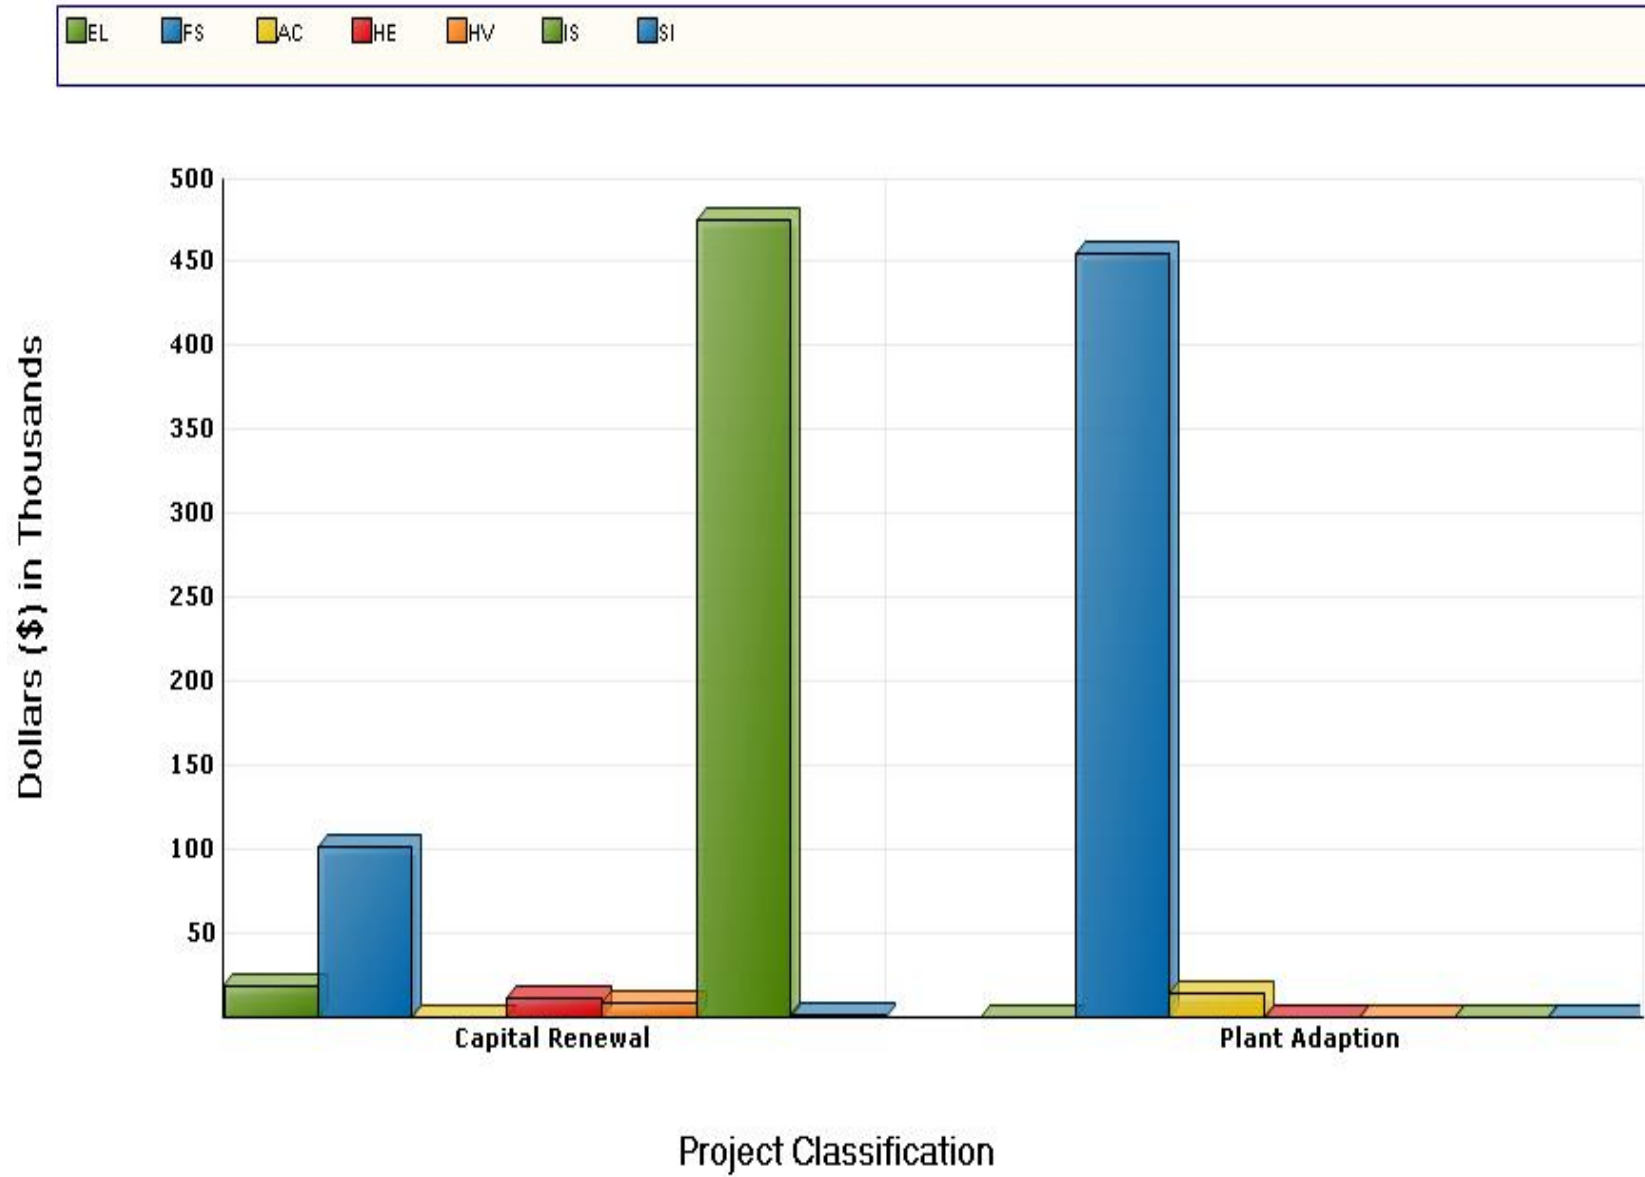
System Code by Project Class

Detailed Project Summary
Facility Condition Analysis
Project Class by Priority Class
RIVE2 : RIVERS ADDITION

Project Class	Priority Classes				Subtotal
	1	2	3	4	
Capital Renewal	0	0	316,803	303,822	620,625
Plant Adaption	187,184	271,189	0	12,498	470,871
TOTALS	187,184	271,189	316,803	316,320	1,091,496

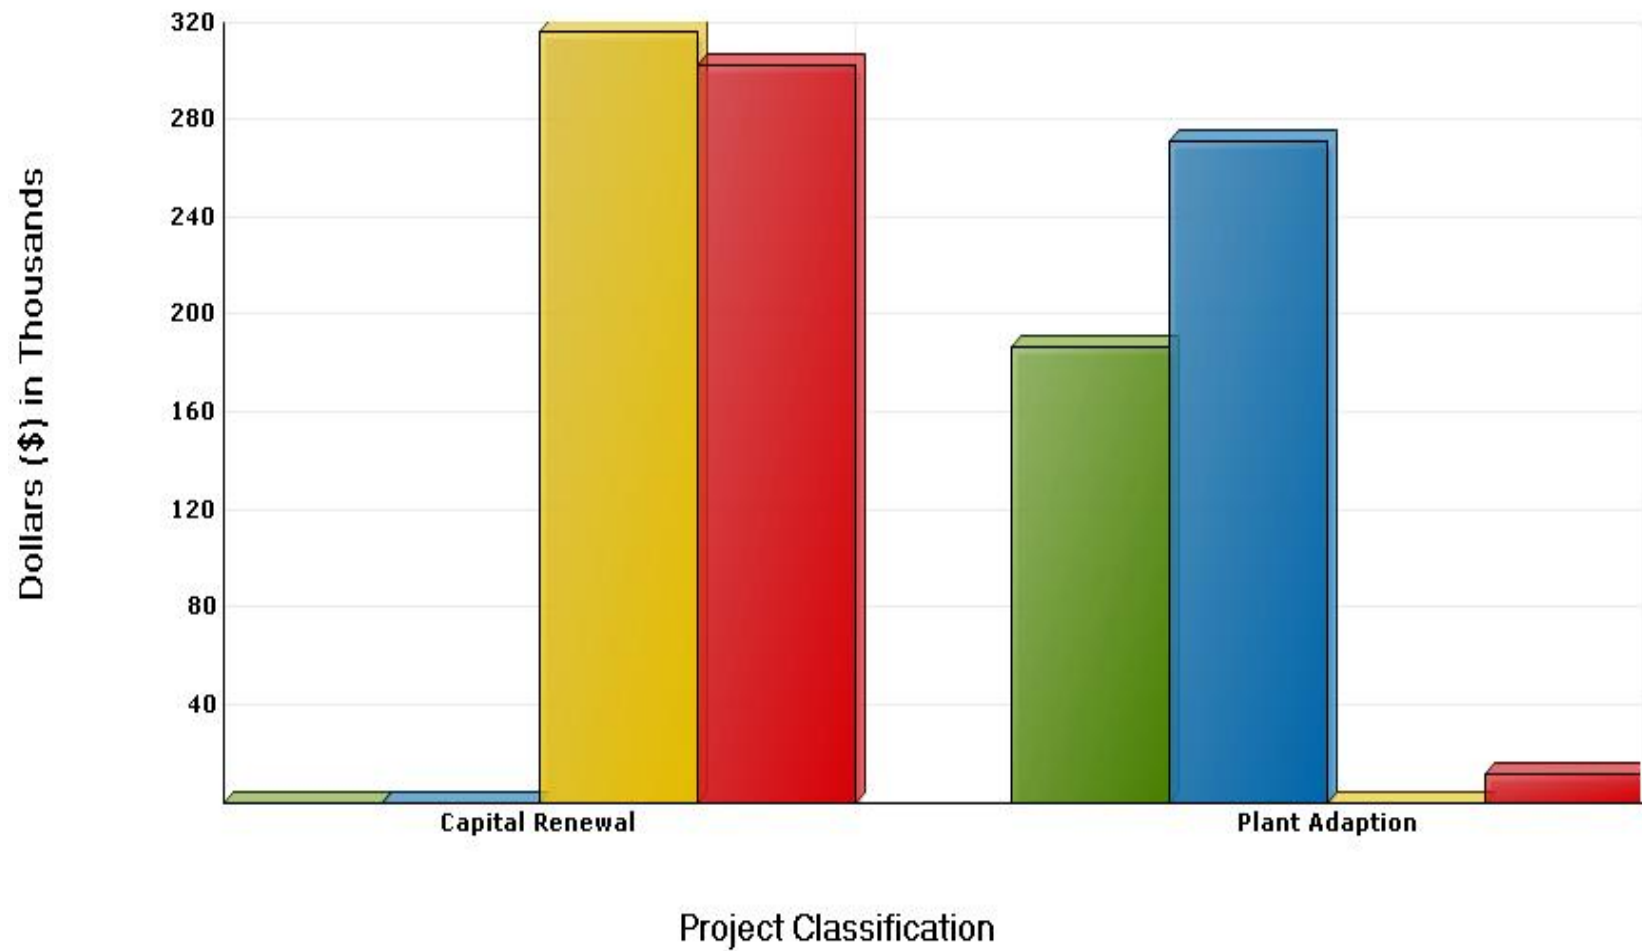
Project Class by Priority Class

Detailed Project Summary
Facility Condition Analysis
Priority Class - Priority Sequence
RIVE2 : RIVERS ADDITION

Cat. Code	Project Number	Pri Cls	Pri Seq	Project Title	Construction Cost	Professional Fee	Total Cost
FS5F	RIVE2FS01	1	1	INTERIOR DOOR UPGRADES	161,365	25,818	187,184
Totals for Priority Class 1					161,365	25,818	187,184
FS3A	RIVE2FS03	2	2	FIRE SPRINKLER SYSTEM INSTALLATION	231,127	36,980	268,107
AC4B	RIVE2AC01	2	3	AUDITORIUM ACCESSIBILITY UPGRADES	2,657	425	3,083
Totals for Priority Class 2					233,784	37,405	271,189
IS2B	RIVE2IS01	3	4	REFINISH WALLS	57,093	9,135	66,227
IS1A	RIVE2IS02	3	5	REFINISH FLOORING	214,905	34,385	249,290
SI2A	RIVE2SI01	3	6	LANDSCAPING UPGRADE	1,109	177	1,286
Totals for Priority Class 3					273,106	43,697	316,803
FS2A	RIVE2FS02	4	7	FIRE ALARM SYSTEM REPLACEMENT	88,437	14,150	102,587
HE1A	RIVE2HE01	4	8	FOOD SERVICE COLD BOX REFRIGERATION SYSTEM REPLACEMENT	11,150	1,784	12,934
AC3D	RIVE2AC02	4	9	UPGRADE BUILDING SIGNAGE PACKAGE	10,774	1,724	12,498
HV5B	RIVE2HV01	4	10	CONDENSATE RECEIVER REPLACEMENT	8,366	1,339	9,705

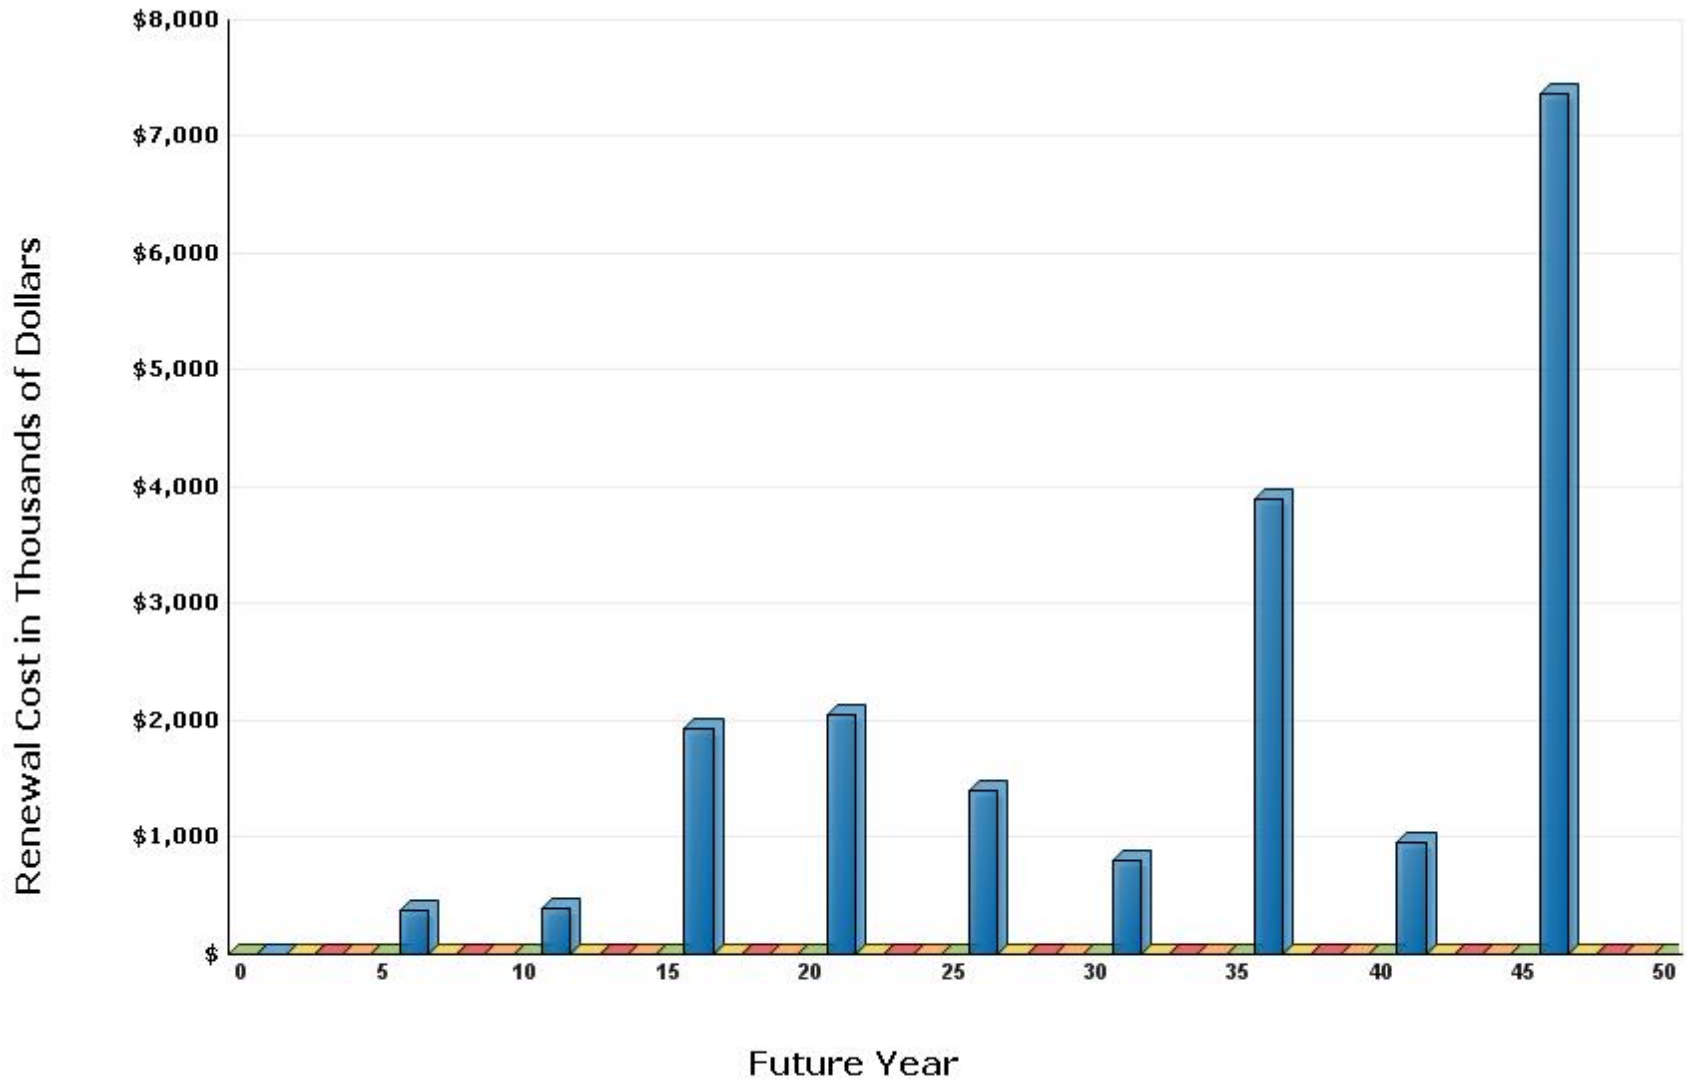
Life Cycle Model Expenditure Projections

Average Annual Renewal Cost Per SqFt \$3.87
