# EAST CAROLINA UNIVERSITY

## SLAY HALL

FACILITY CONDITION ANALYSIS

DECEMBER 12, 2009

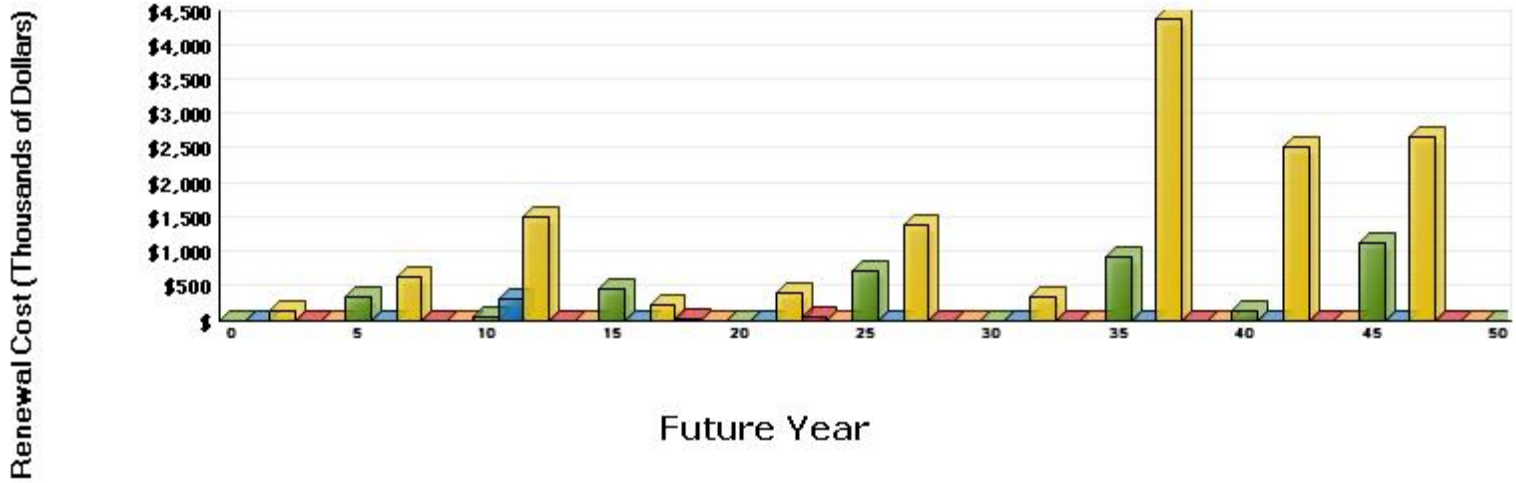
#### LIFE CYCLE MODEL EXPENDITURE PROJECTIONS

**Average Annual Renewal Cost Per SqFt \$4.45**

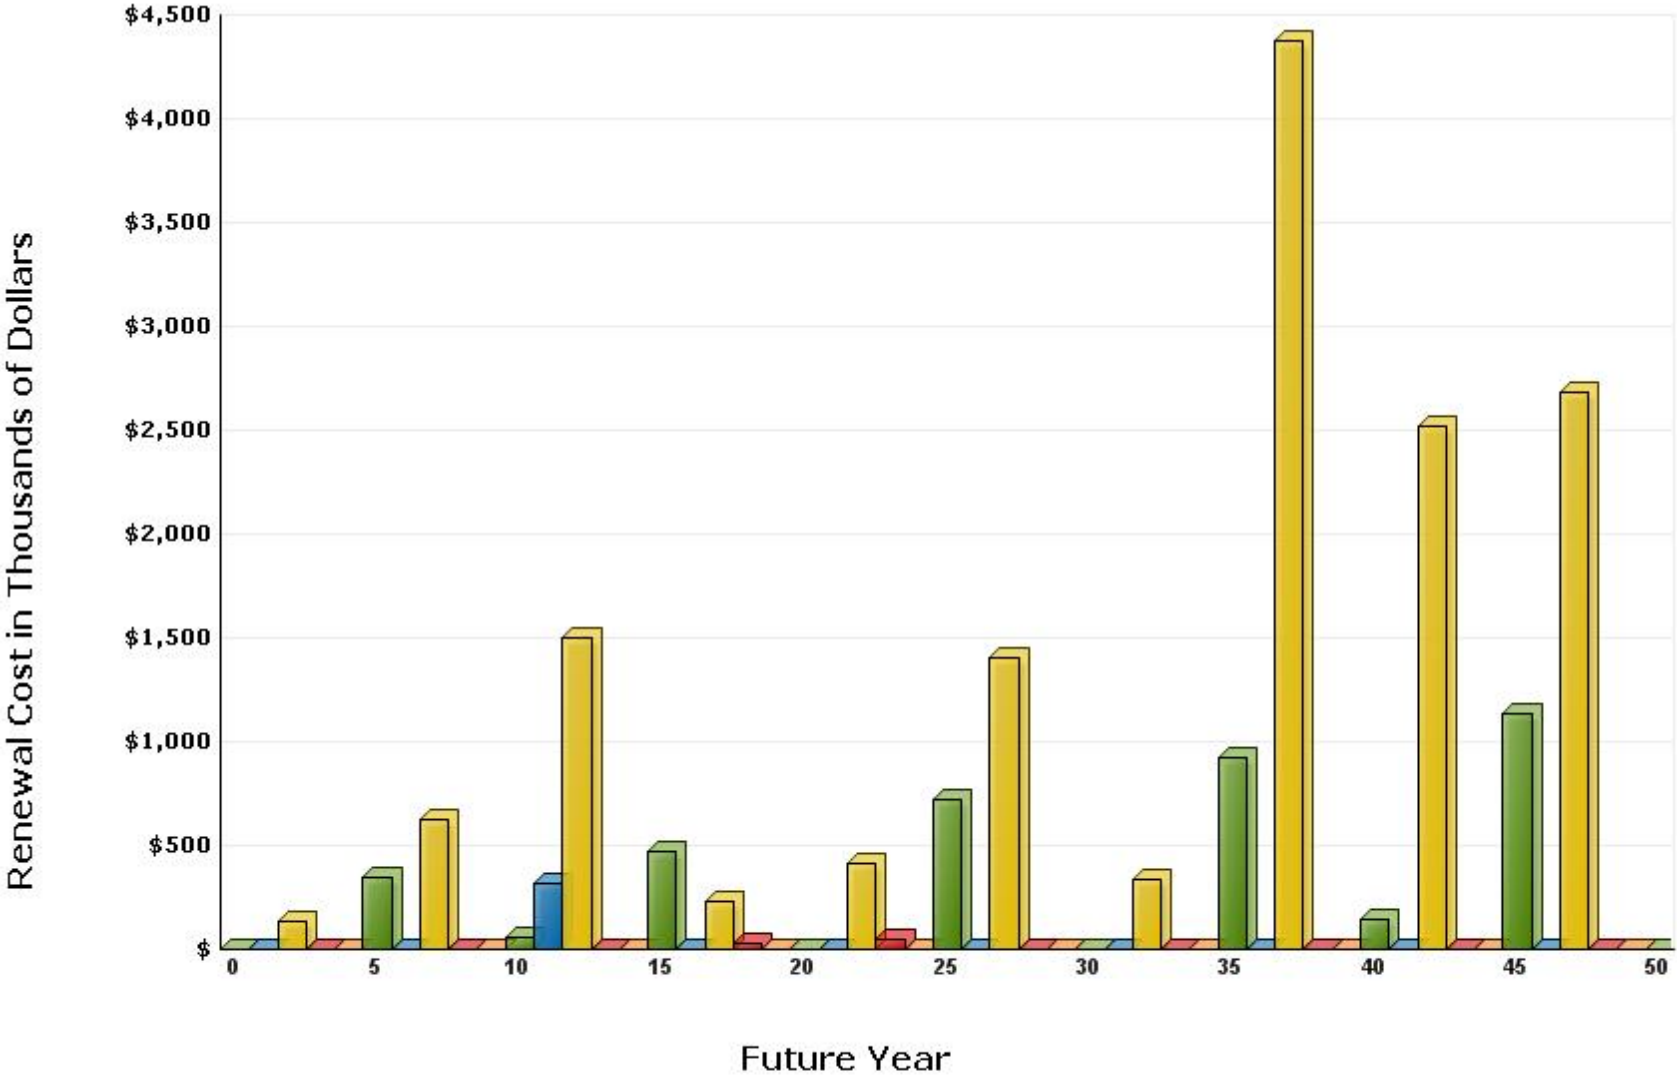
# Life Cycle Model Expenditure Projections

Average Annual Renewal Cost Per SqFt \$4.45
