EAST CAROLINA UNIVERSITY

SPEIGHT BUILDING

FACILITY CONDITION ANALYSIS

DECEMBER 23, 2009

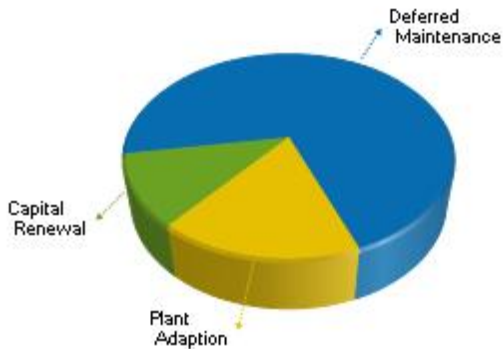
PROJECT COSTS BY CLASSIFICATION

Priority 1: \$307,730
Priority 2: \$359,978
Priority 3: \$4,143,262
Priority 4: \$415,059
Total Project Costs: \$5,226,030

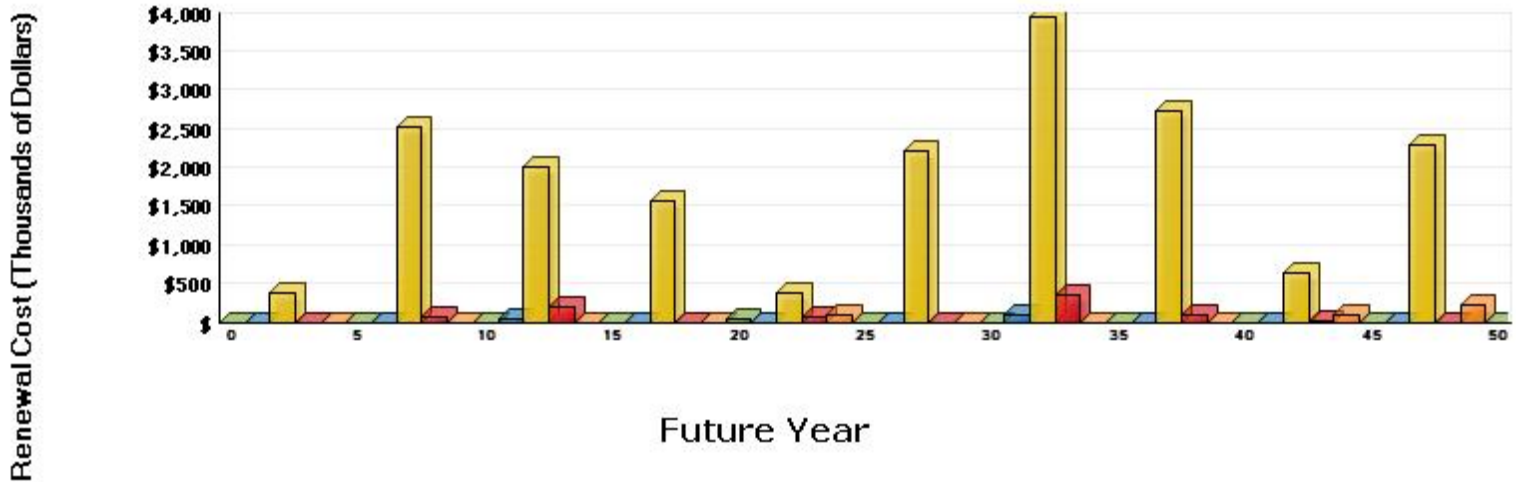
LIFE CYCLE MODEL EXPENDITURE PROJECTIONS

Average Annual Renewal Cost Per SqFt \$3.90

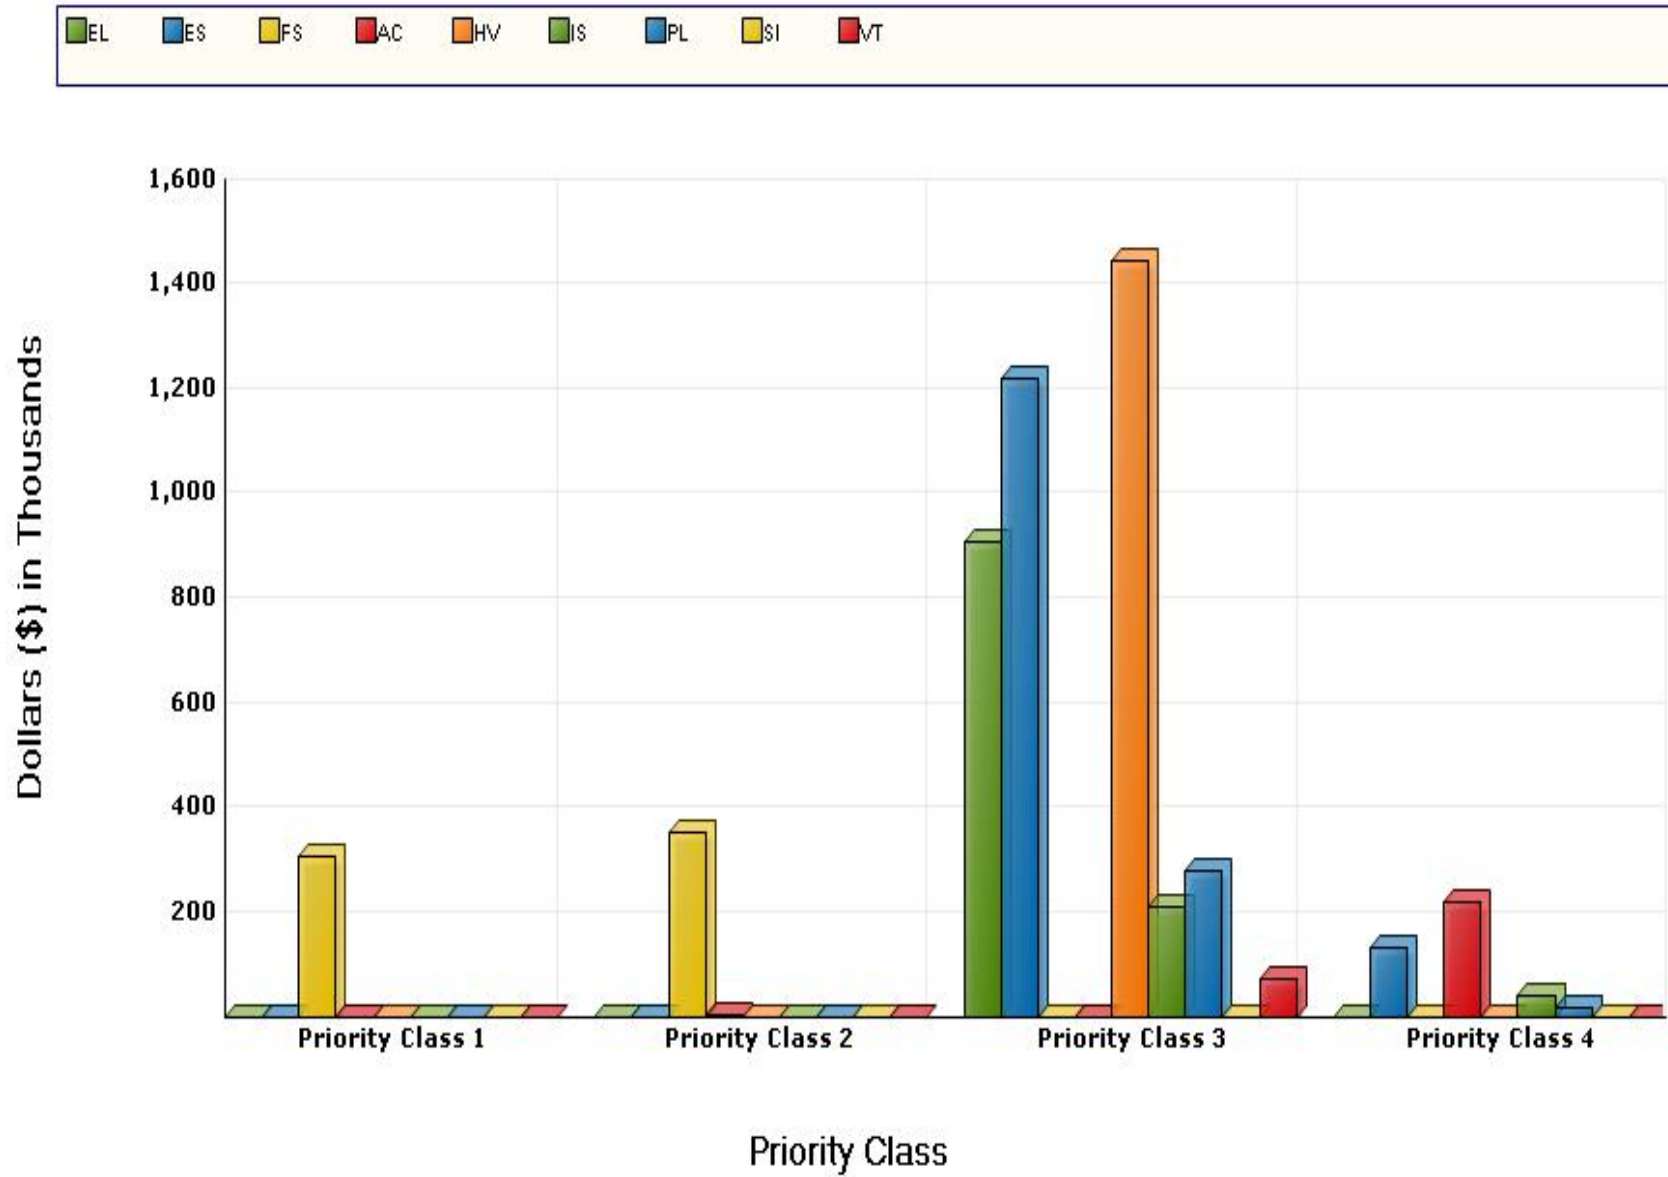
System Code by Priority Class

**Detailed Project Totals
 Facility Condition Analysis
 System Code by Project Class
 SPEI : SPEIGHT BUILDING**

System Code	System Description	Project Classes			Subtotal
		Capital Renewal	Deferred Maintenance	Plant Adaption	
AC	ACCESSIBILITY	0	0	228,434	228,434
EL	ELECTRICAL	0	909,945	0	909,945
ES	EXTERIOR	157,629	1,194,887	0	1,352,516
FS	FIRE/LIFE SAFETY	0	0	662,145	662,145
HV	HVAC	161,303	1,281,313	0	1,442,616
IS	INTERIOR/FINISH SYS.	254,700	0	0	254,700
PL	PLUMBING	17,704	280,398	0	298,102
SI	SITE	2,572	0	0	2,572
VT	VERT. TRANSPORTATION	0	75,000	0	75,000
	TOTALS	593,908	3,741,543	890,579	5,226,030

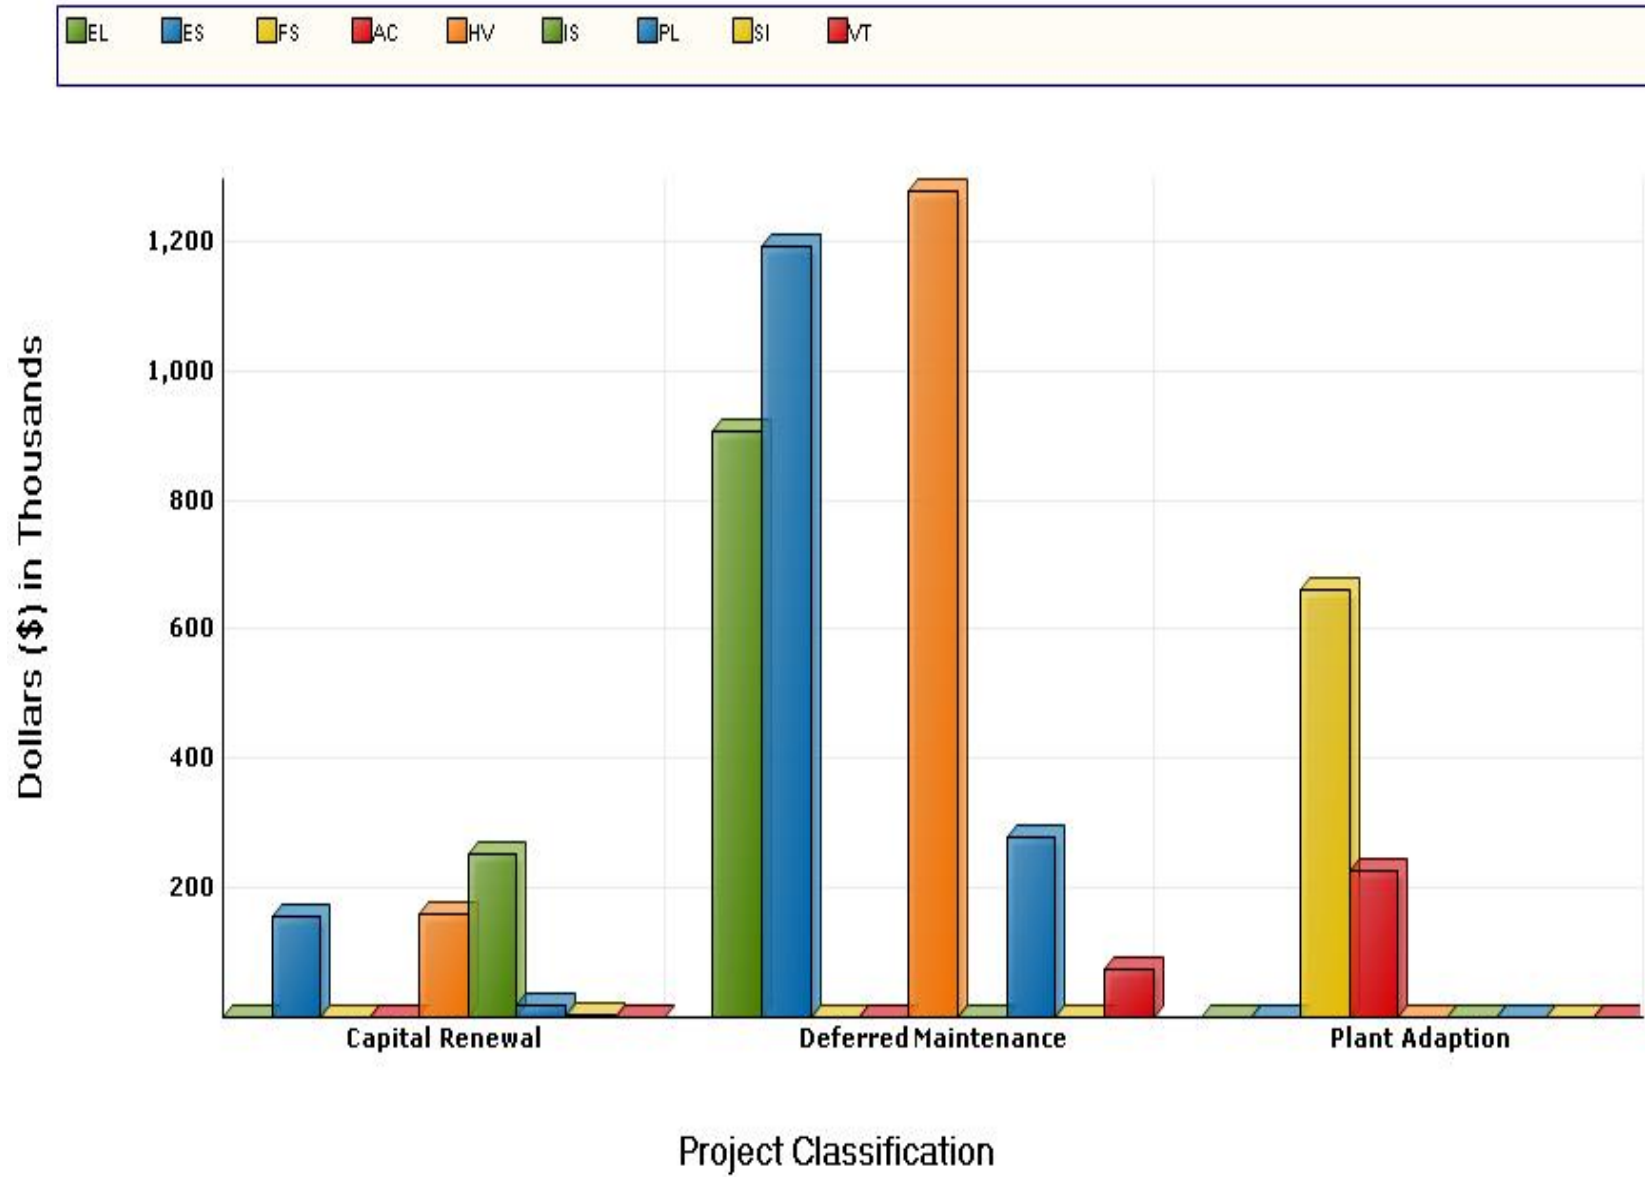
System Code by Project Class

Detailed Project Summary
Facility Condition Analysis
Project Class by Priority Class
SPEI : SPEIGHT BUILDING

Project Class	Priority Classes				Subtotal
	1	2	3	4	
Capital Renewal	0	0	401,719	192,188	593,908
Deferred Maintenance	0	0	3,741,543	0	3,741,543
Plant Adaption	307,730	359,978	0	222,871	890,579
TOTALS	307,730	359,978	4,143,262	415,059	5,226,030

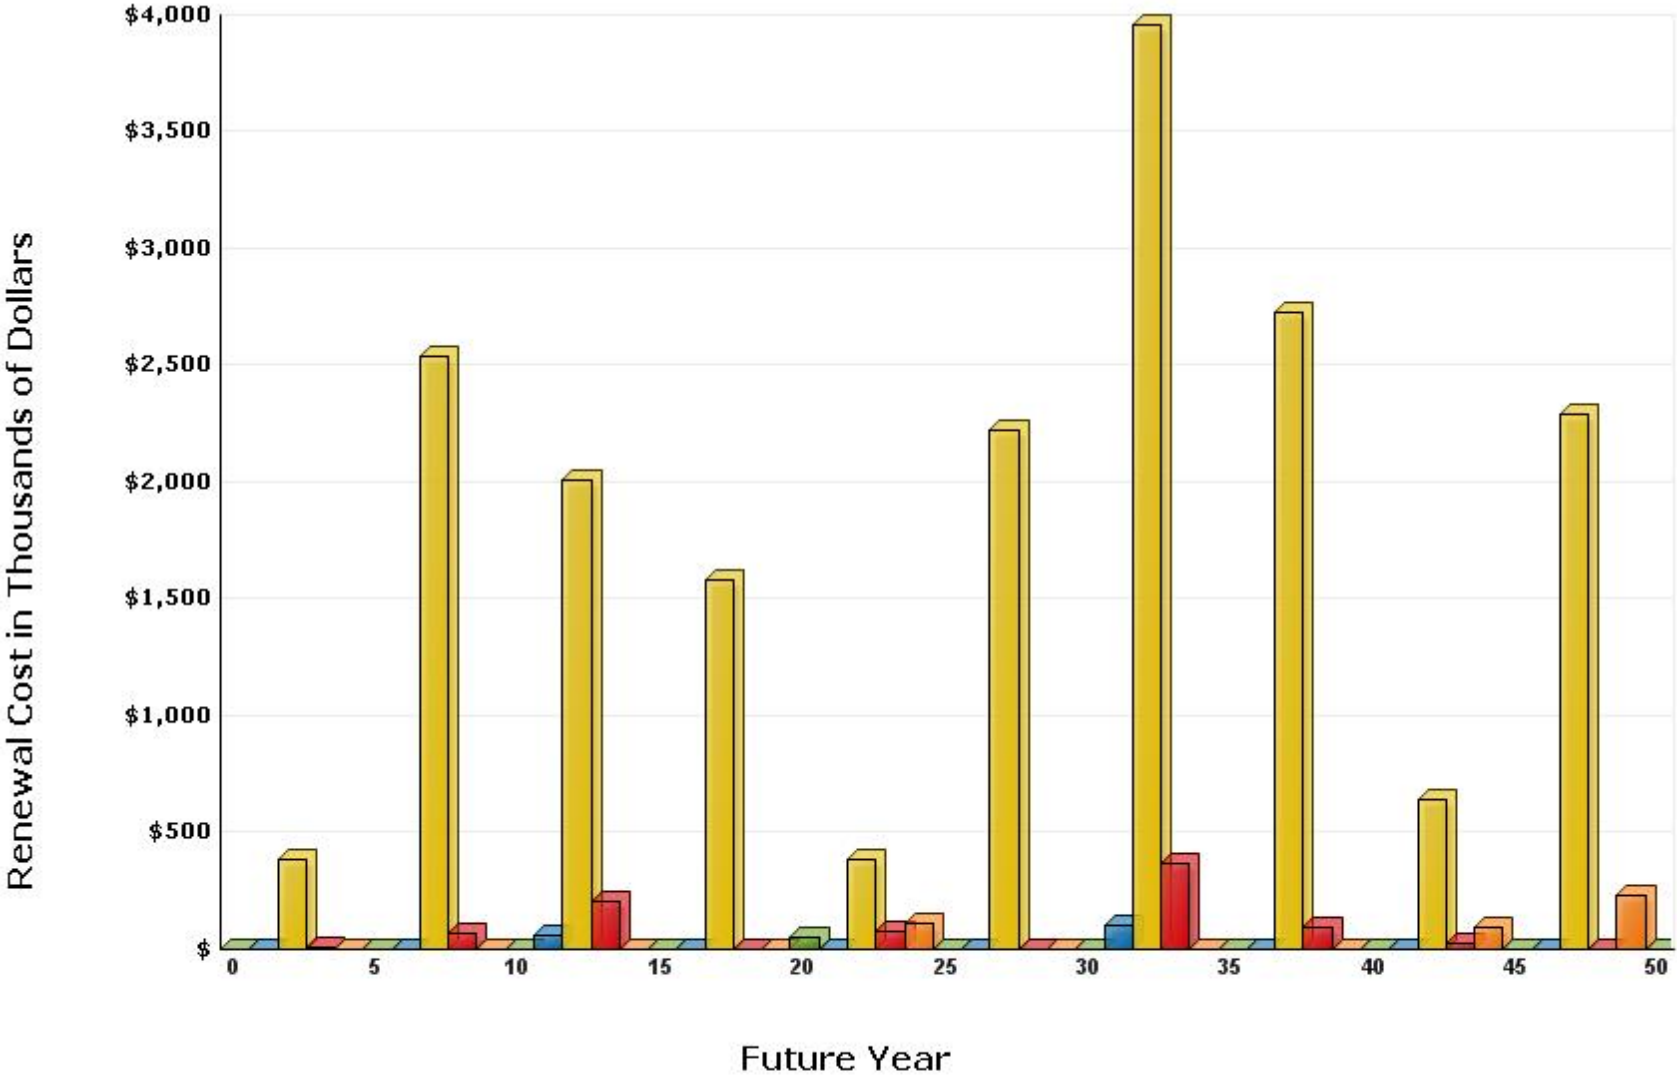
Life Cycle Model Expenditure Projections

Average Annual Renewal Cost Per SqFt \$3.90
