# EAST CAROLINA UNIVERSITY

## TYLER RESIDENCE HALL

FACILITY CONDITION ANALYSIS

DECEMBER 18, 2009

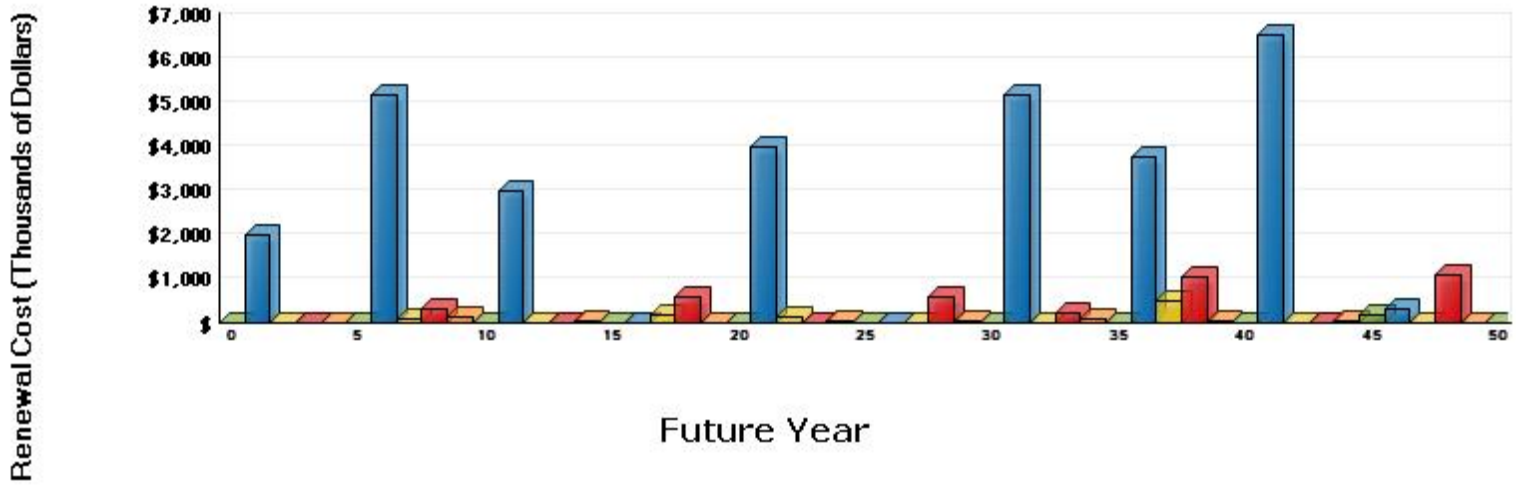
### LIFE CYCLE MODEL EXPENDITURE PROJECTIONS

**Average Annual Renewal Cost Per SqFt \$3.78**

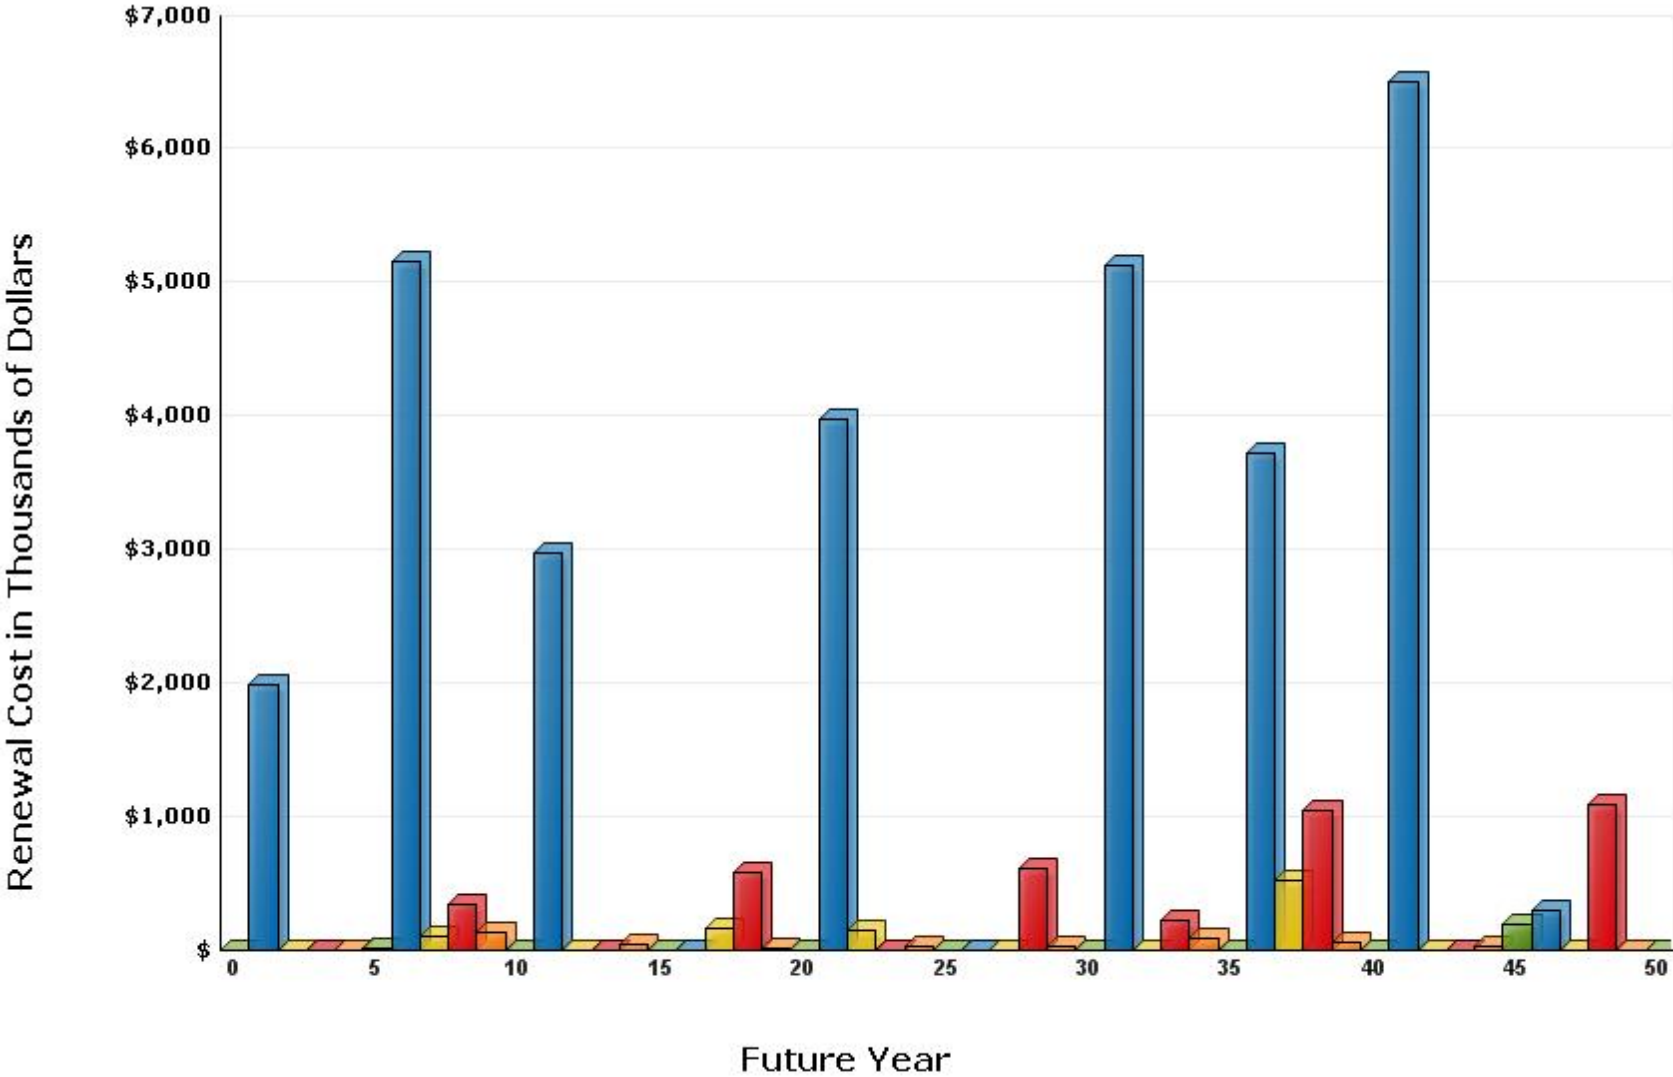
# Life Cycle Model Expenditure Projections

Average Annual Renewal Cost Per SqFt \$3.78
