EAST CAROLINA UNIVERSITY

WHITE RESIDENCE HALL

FACILITY CONDITION ANALYSIS

DECEMBER 18, 2009

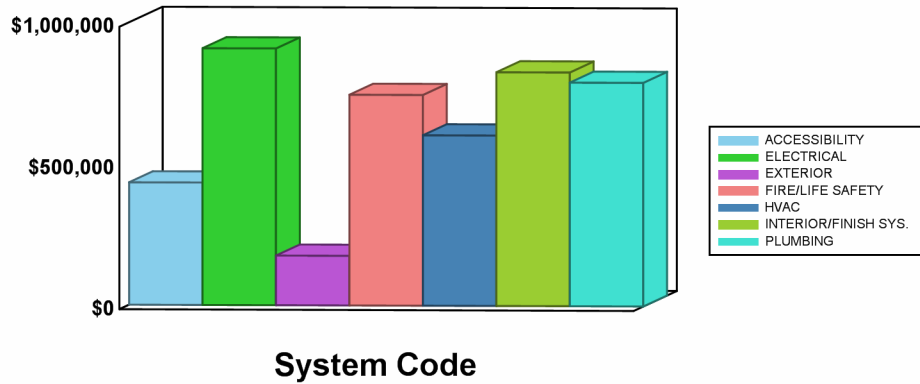
PROJECT COSTS BY SYSTEM CODE

System Code	System Description	Project Classes			Subtotal
		Capitla Renewal	Deferred Maintenance	Plant Adaption	
AC	ACCESSIBILITY	0	0	433,518	433,518
EL	ELECTRICAL	0	909,069	0	909,069
ES	EXTERIOR	175,893	0	0	175,893
FS	FIRE/LIFE SAFETY	0	0	746,250	746,250
HV	HVAC	218,520	385,071	0	603,591
IS	INTERIOR/FINISH SYS.	827,642	0	0	827,642
PL	PLUMBING	0	791,795	0	791,795
	TOTALS	1,222,054	2,085,935	1,179,768	4,487,758

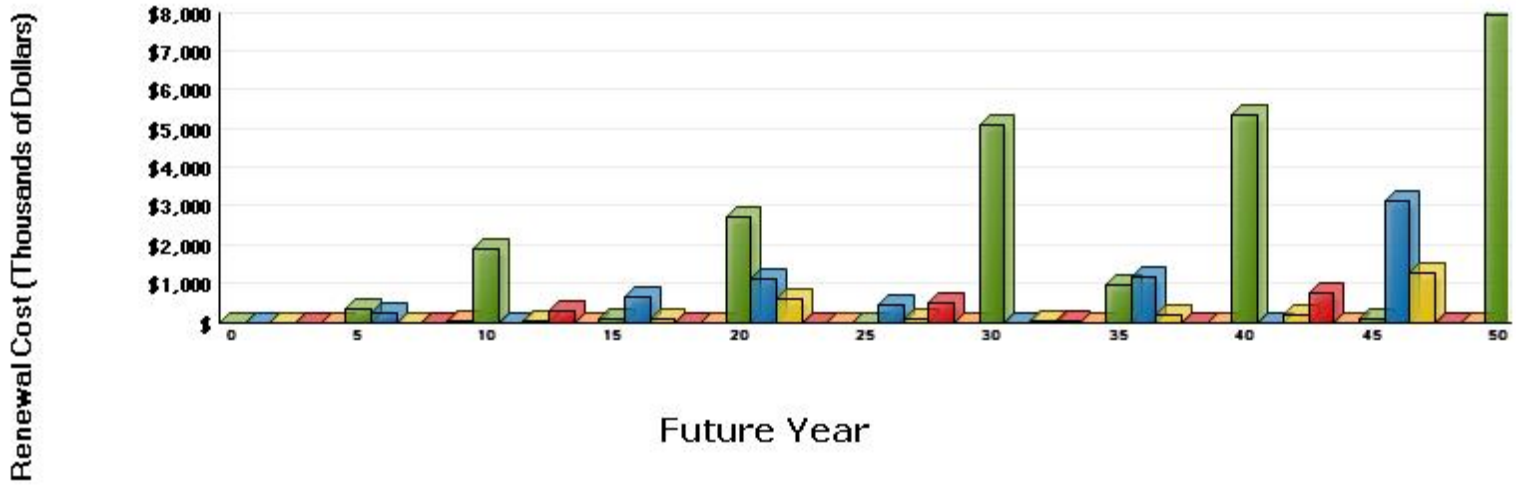
LIFE CYCLE MODEL EXPENDITURE PROJECTIONS

Average Annual Renewal Cost Per SqFt \$3.28

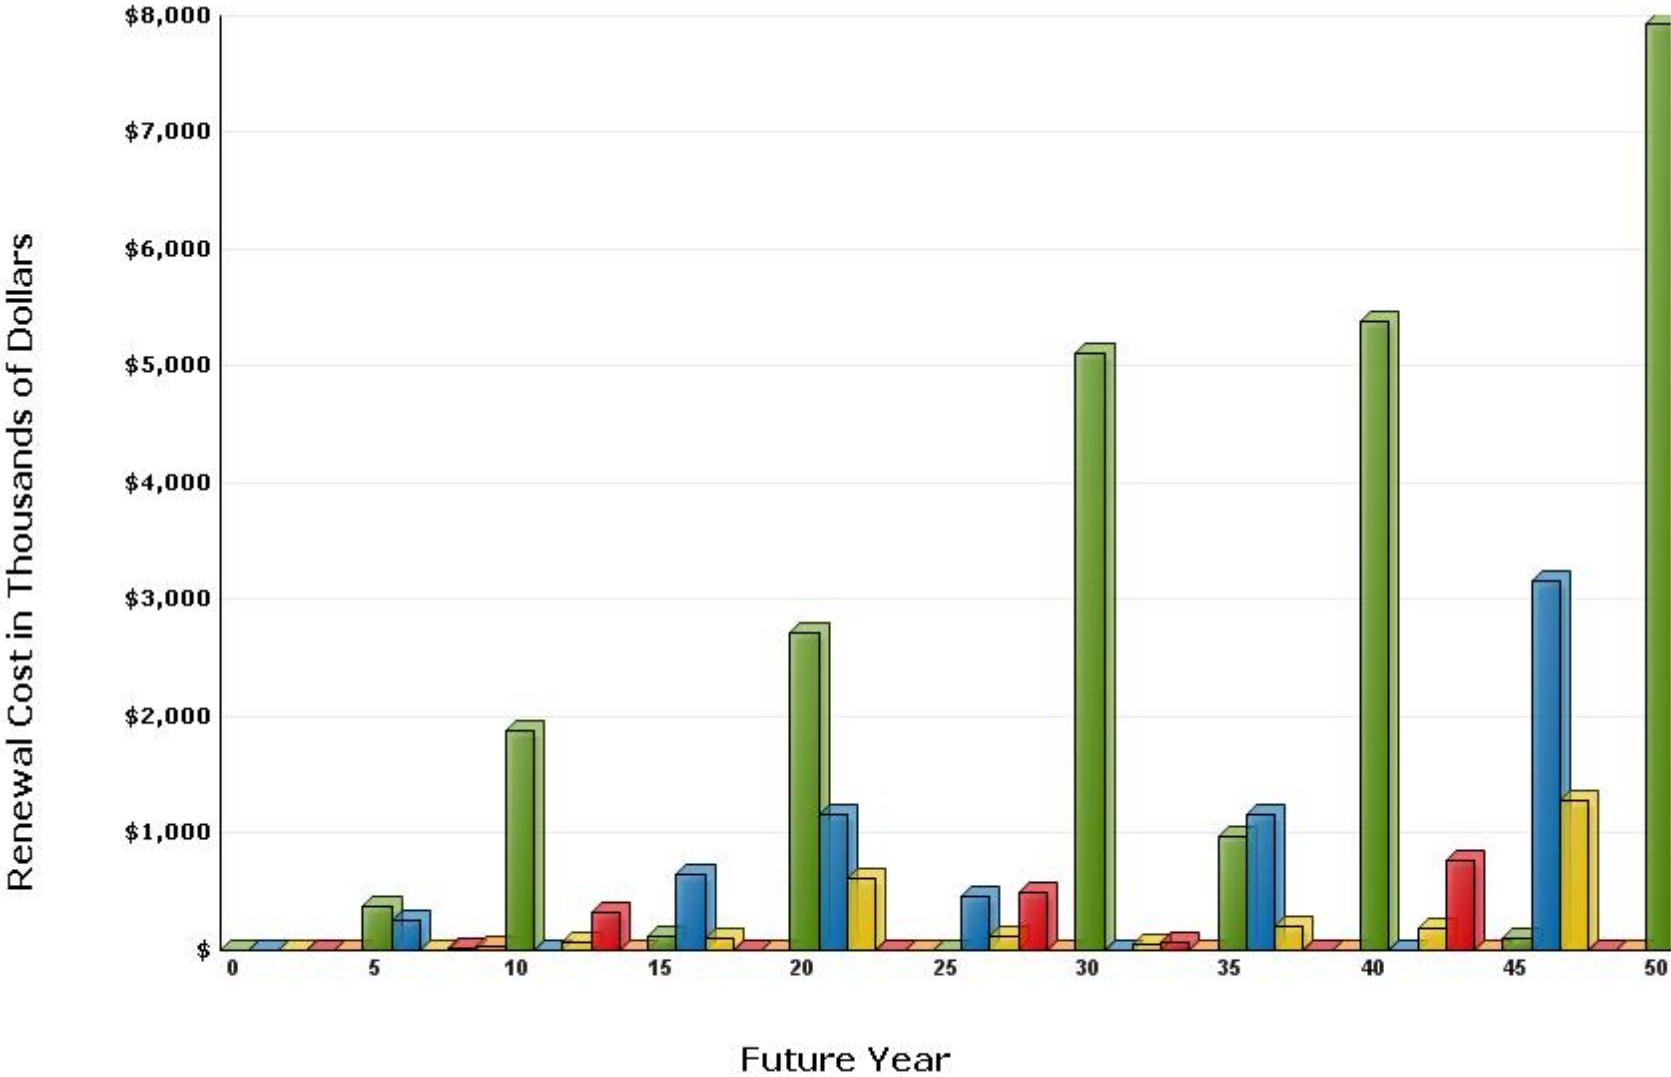
Life Cycle Model Expenditure Projections

Average Annual Renewal Cost Per SqFt \$3.28
