EAST CAROLINA UNIVERSITY

WILLIS BUILDING

FACILITY CONDITION ANALYSIS

DECEMBER 18, 2009

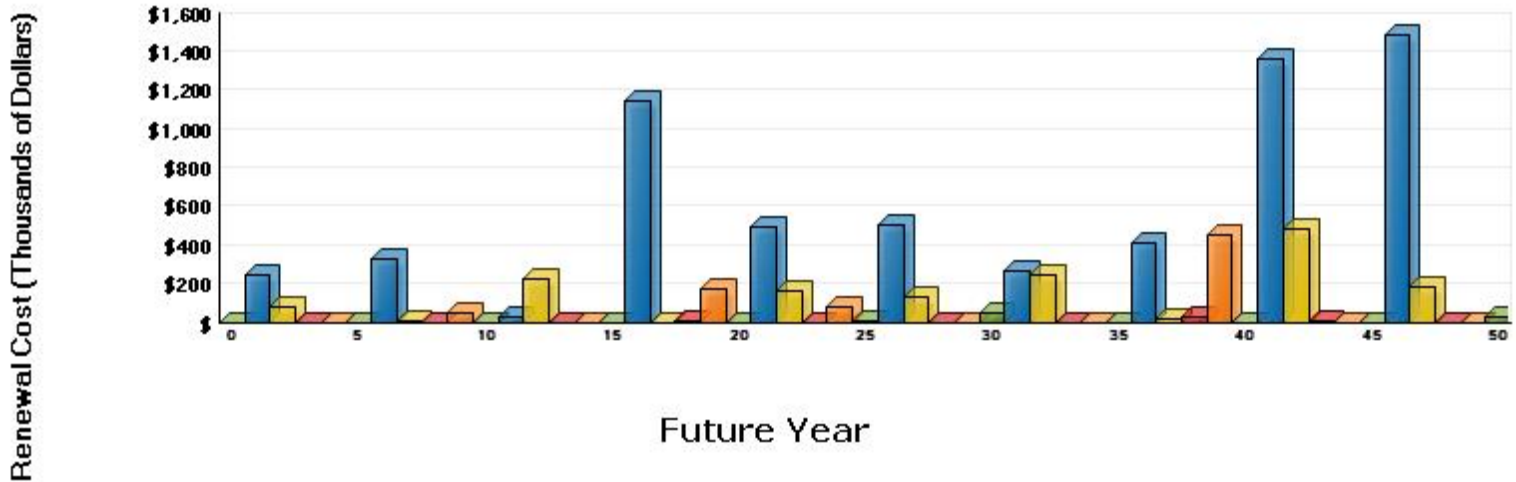
LIFE CYCLE MODEL EXPENDITURE PROJECTIONS

Average Annual Renewal Cost Per SqFt \$5.02

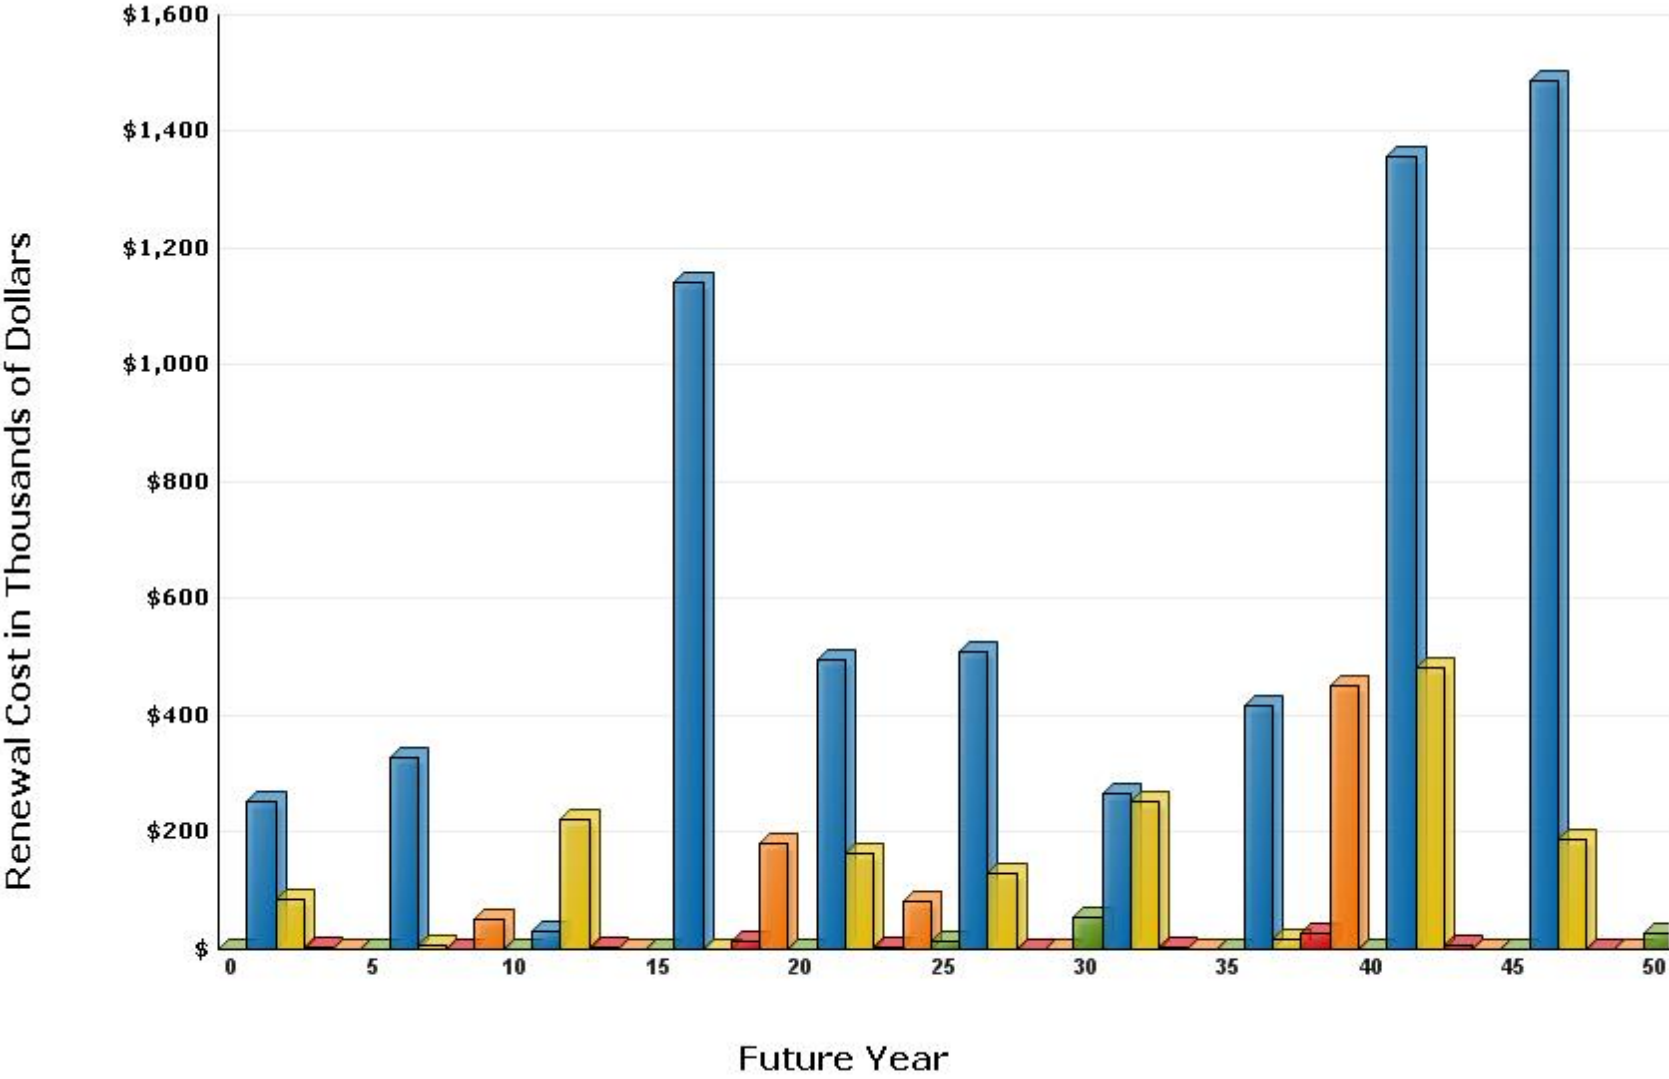
Life Cycle Model Expenditure Projections

Average Annual Renewal Cost Per SqFt \$5.02
