EAST CAROLINA UNIVERSITY

Facility Condition Assessment

Neurosurgical and Spine Center

Inspected March 3, 2014

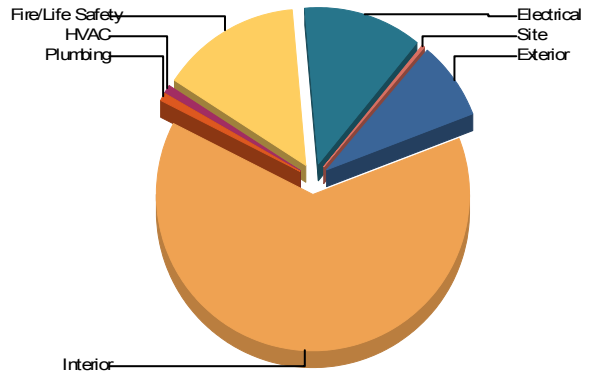
Recurring Facilities Renewal Cost By System

Exterior	\$53,982
Interior	\$420,303
Plumbing	\$5,009
HVAC	\$5,598
Fire/Life Safety	\$96,571
Electrical	\$79,381
Site	\$2,688
Conveying	\$0
Equipment	\$0
Total	\$663,533

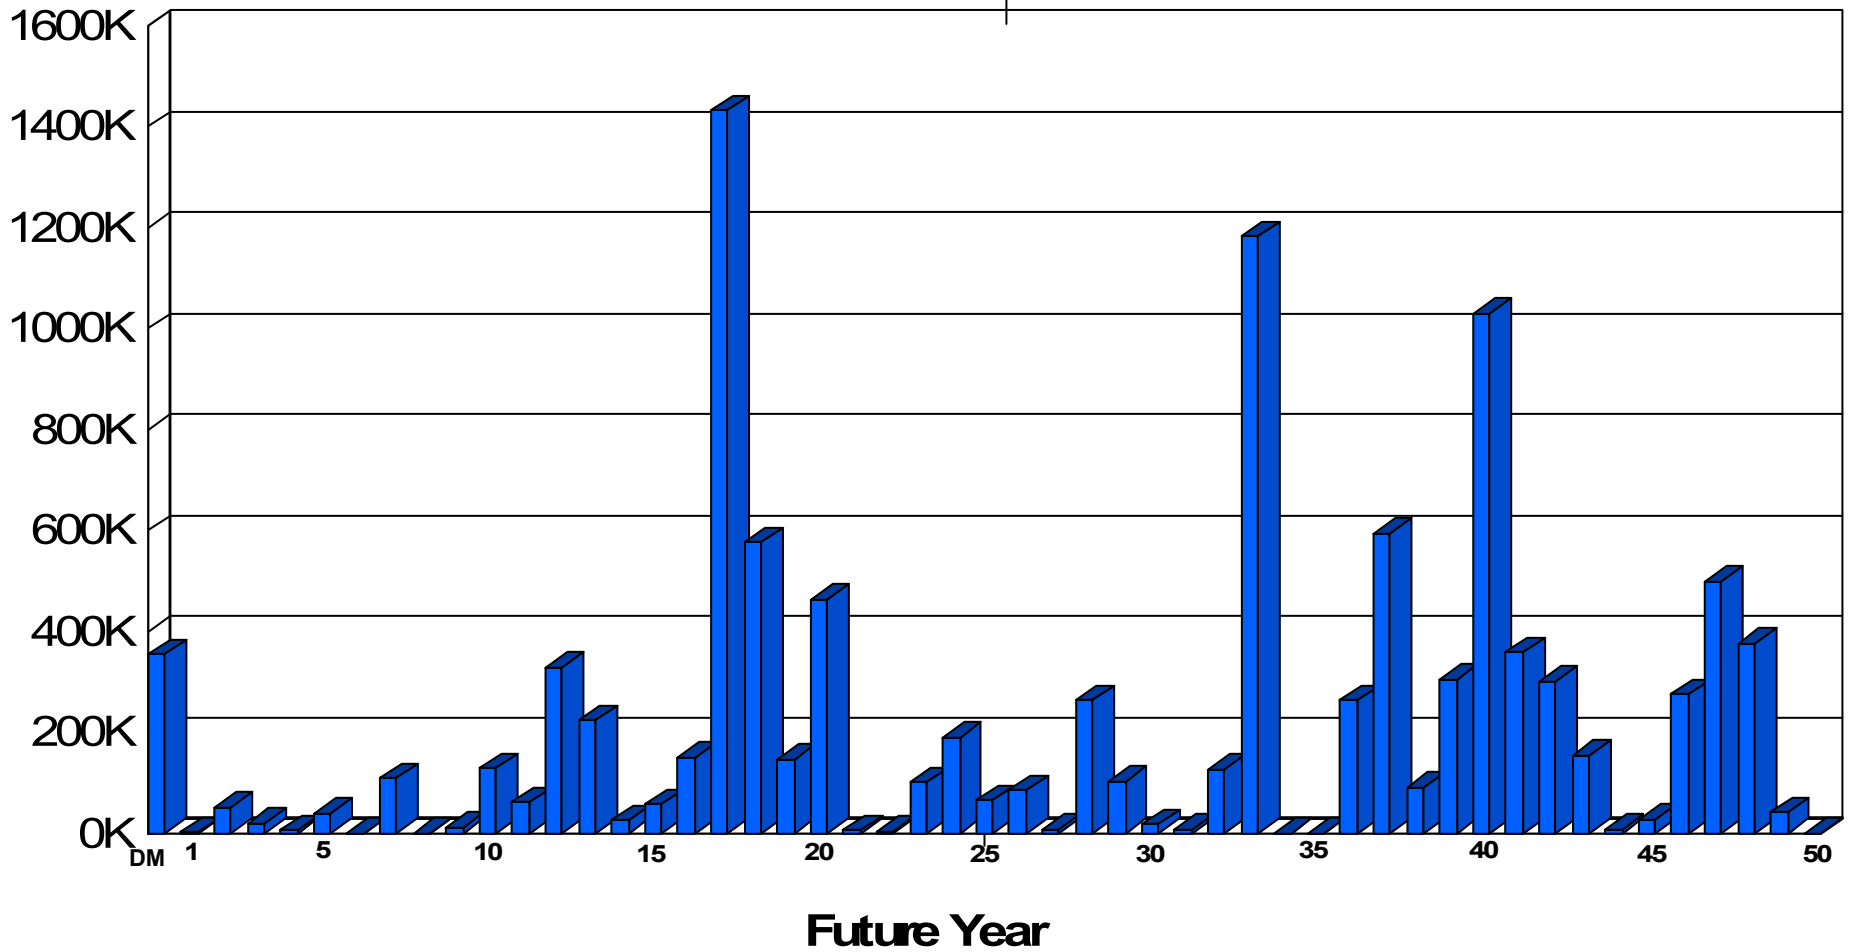
Recurring Component Expenditure Projections

NSC : NEUROSURGICAL AND SPINE CENTER

Average Annual Renewal Cost per SqFt \$4.82
