**EAST CAROLINA UNIVERSITY**

Facility Condition Assessment

Warren Life Sciences Building

Asset LIFE

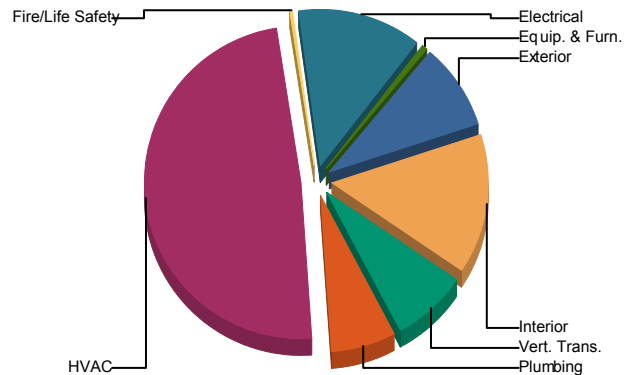
**Recurring Facilities Renewal Cost By System**

Exterior	\$911,317
Interior	\$1,464,665
Plumbing	\$688,429
HVAC	\$4,958,140
Fire/Life Safety	\$18,050
Electrical	\$1,290,655
Site	\$0
Conveying	\$801,767
Equipment	\$68,063
<b>Total</b>	<b>\$10,201,085</b>

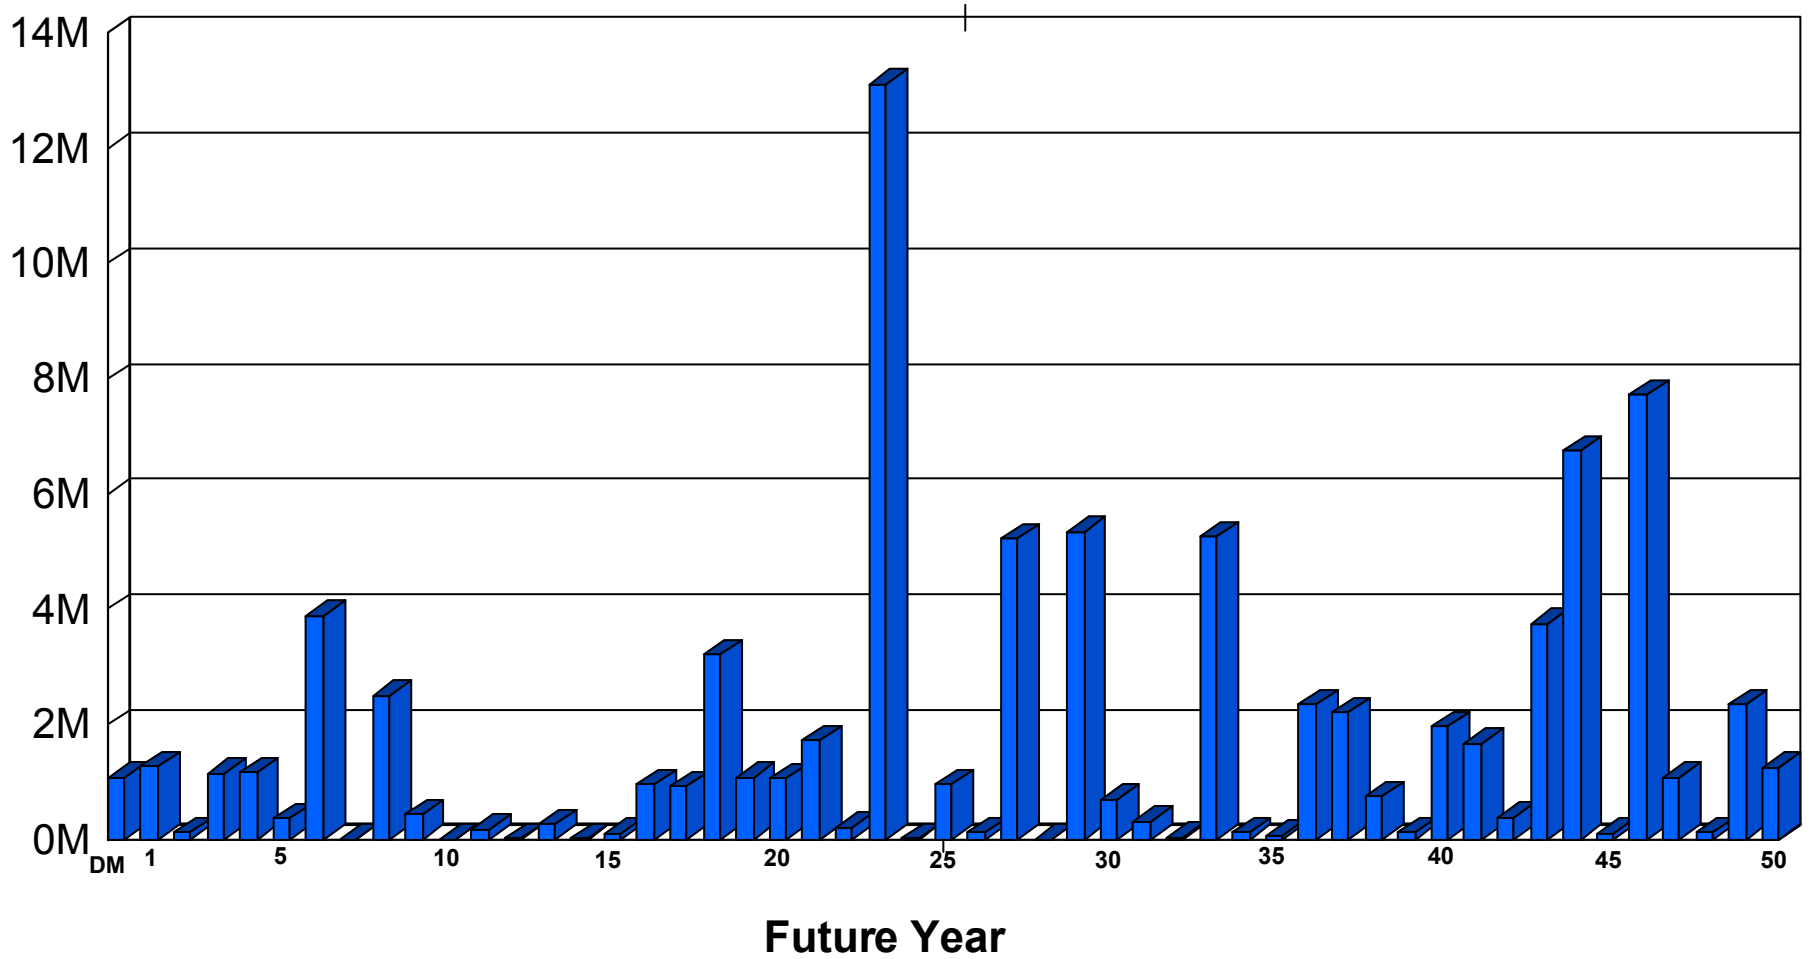
# Recurring Component Expenditure Projections

LIFE : WARREN LIFE SCIENCES BUILDING

Average Annual Renewal Cost per SqFt \$10.17
