EAST CAROLINA UNIVERSITY

WEST ACADEMIC BUILDING

FACILITY CONDITION ANALYSIS

DECEMBER 21, 2009

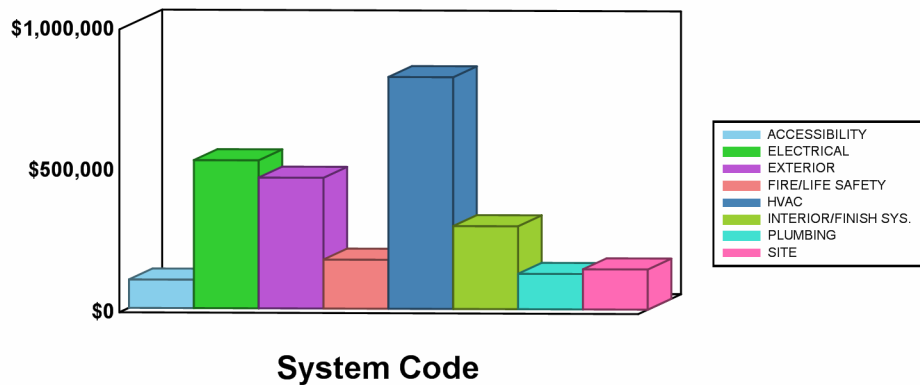
PROJECT COSTS BY SYSTEM CODE

System Code	System Description	Project Classes			Subtotal
		Capital Renewal	Deferred Maintenance	Plant Adaption	
AC	ACCESSIBILITY	0	0	100,657	100,657
EL	ELECTRICAL	0	523,225	0	523,225
ES	EXTERIOR	411,075	51,252	0	462,327
FS	FIRE/LIFE SAFETY	4,706	0	168,558	173,264
HV	HVAC	167,848	651,498	0	819,347
IS	INTERIOR/FINISH SYS.	293,299	0	0	293,299
PL	PLUMBING	0	125,316	0	125,316
SI	SITE	0	142,078	0	142,078
	TOTALS	876,928	1,493,371	269,215	2,639,513

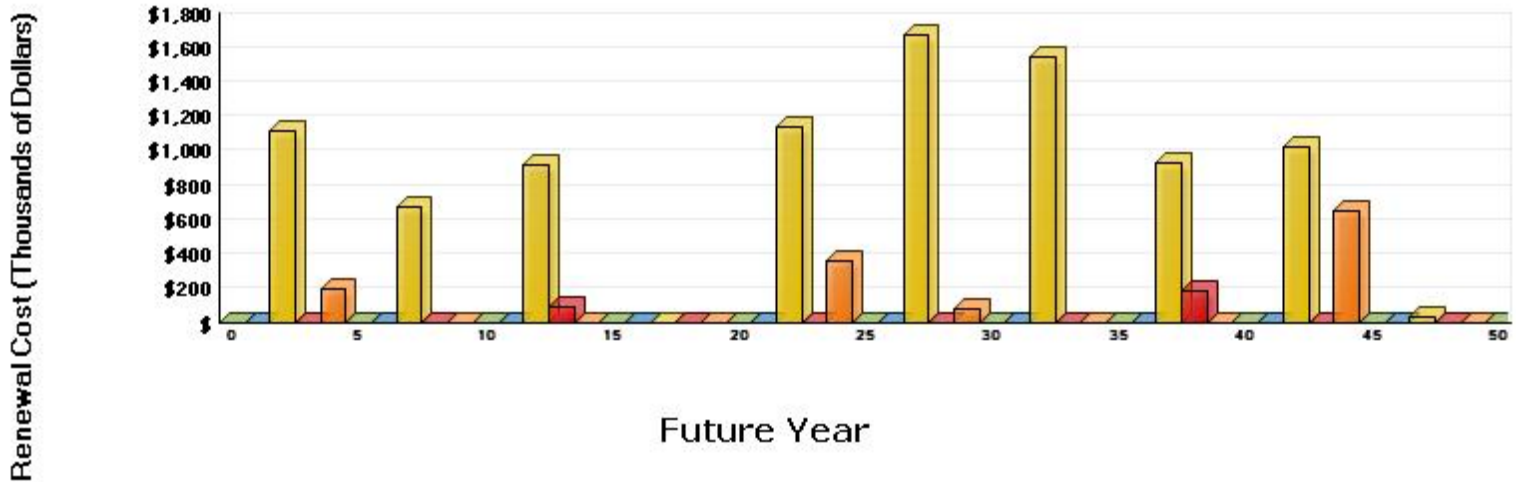
LIFE CYCLE MODEL EXPENDITURE PROJECTIONS

Average Annual Renewal Cost Per SqFt \$4.56

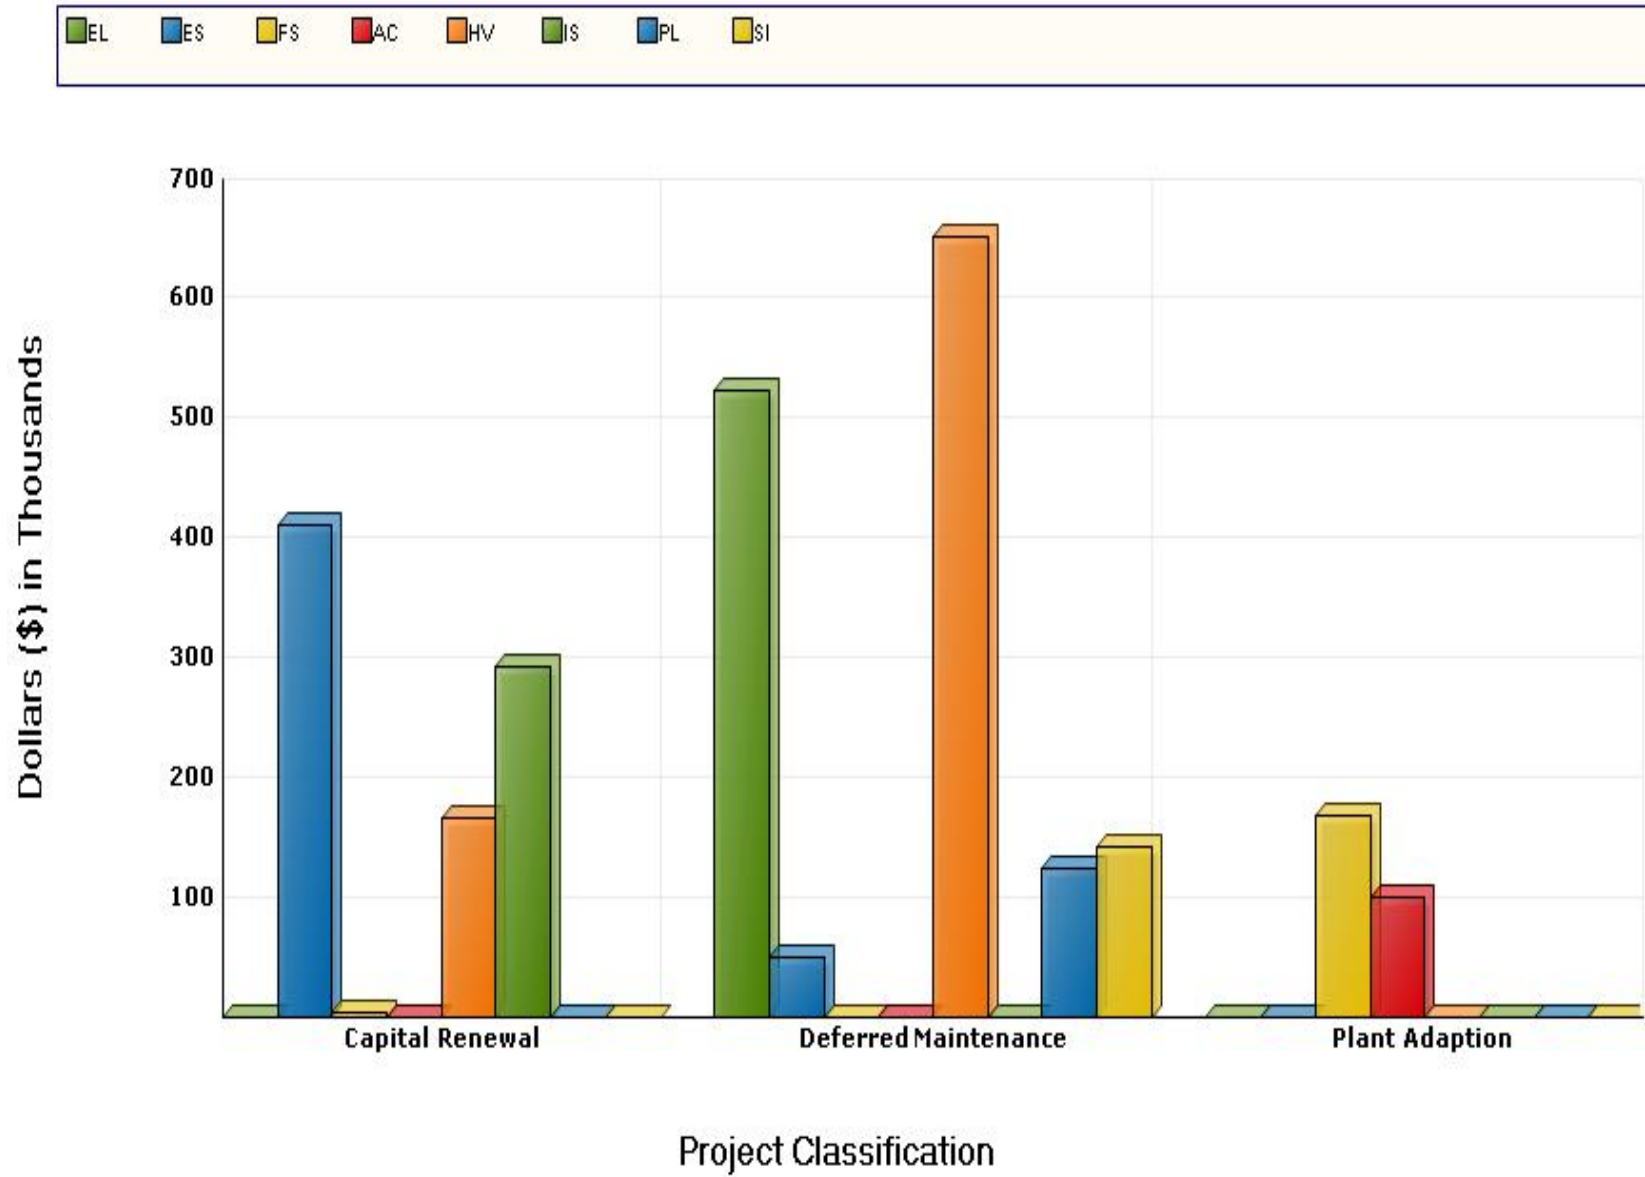
System Code by Project Class

Project Class	Priority Classes				Subtotal
	1	2	3	4	
Capital Renewal	0	0	384,803	492,124	876,928
Deferred Maintenance	0	0	1,493,371	0	1,493,371
Plant Adaption	0	168,558	0	100,657	269,215
TOTALS	0	168,558	1,878,174	592,782	2,639,513

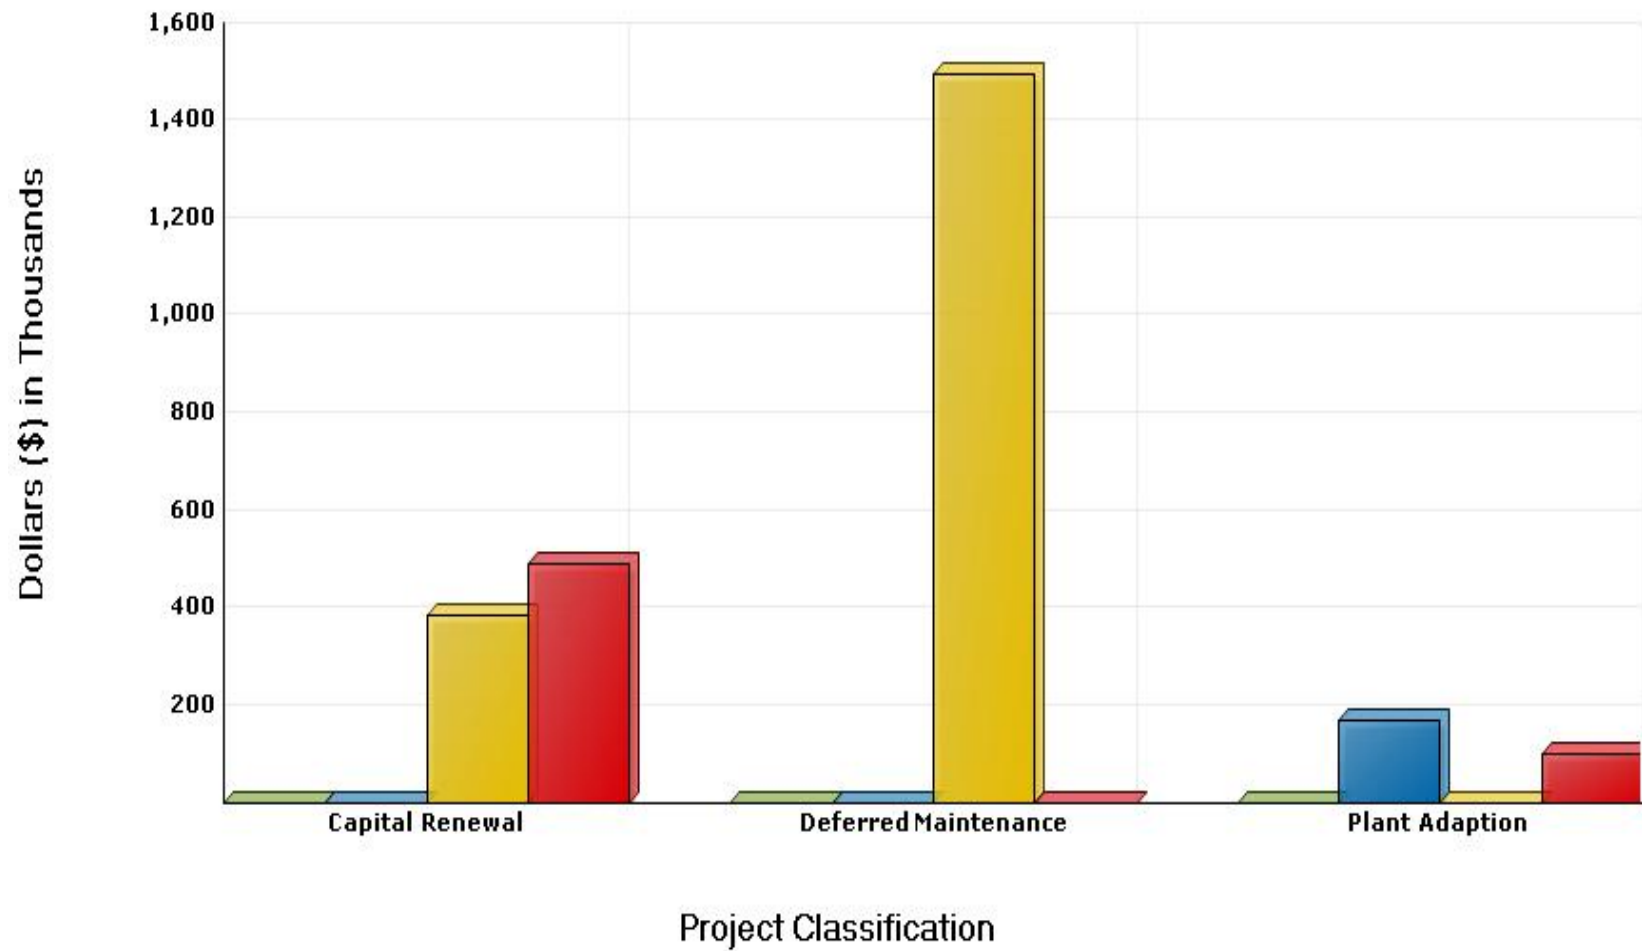
Project Class by Priority Class

Cat. Code	Project Number	Pri Cls	Pri Seq	Project Title	Construction Cost	Professional Fee	Total Cost
FS3A	WRABFS01	2	1	FIRE SPRINKLER SYSTEM INSTALLATION	145,308	23,249	168,558
Totals for Priority Class 2					145,308	23,249	168,558
ES5A	WRABES03	3	2	EXTERIOR DOOR REPLACEMENT	44,183	7,069	51,252
ES2B	WRABES01	3	3	RESTORE BRICK VENEER	11,775	1,884	13,659
ES2B	WRABES02	3	4	RESTORE STONE FINISH	1,560	250	1,810
HV3A	WRABHV01	3	5	HVAC SYSTEM REPLACEMENT	525,332	84,053	609,385
HV4B	WRABHV03	3	6	FUME HOOD REPLACEMENT	36,305	5,809	42,113
HV2A	WRABHV02	3	7	REPLACE AIR-COOLED CHILLER	144,697	23,151	167,848
EL2A	WRABEL01	3	8	REPLACE 120/208 VOLT SWITCHGEAR	42,821	6,851	49,673
EL3B	WRABEL03	3	9	UPGRADE ELECTRICAL DISTRIBUTION NETWORK	250,165	40,026	290,192
EL4B	WRABEL02	3	10	INTERIOR LIGHTING UPGRADE	153,209	24,513	177,722
EL4A	WRABEL04	3	11	EXTERIOR LIGHTING REPLACEMENT	4,861	778	5,638
IS1A	WRABIS01	3	12	REFINISH FLOORING	137,802	22,048	159,850

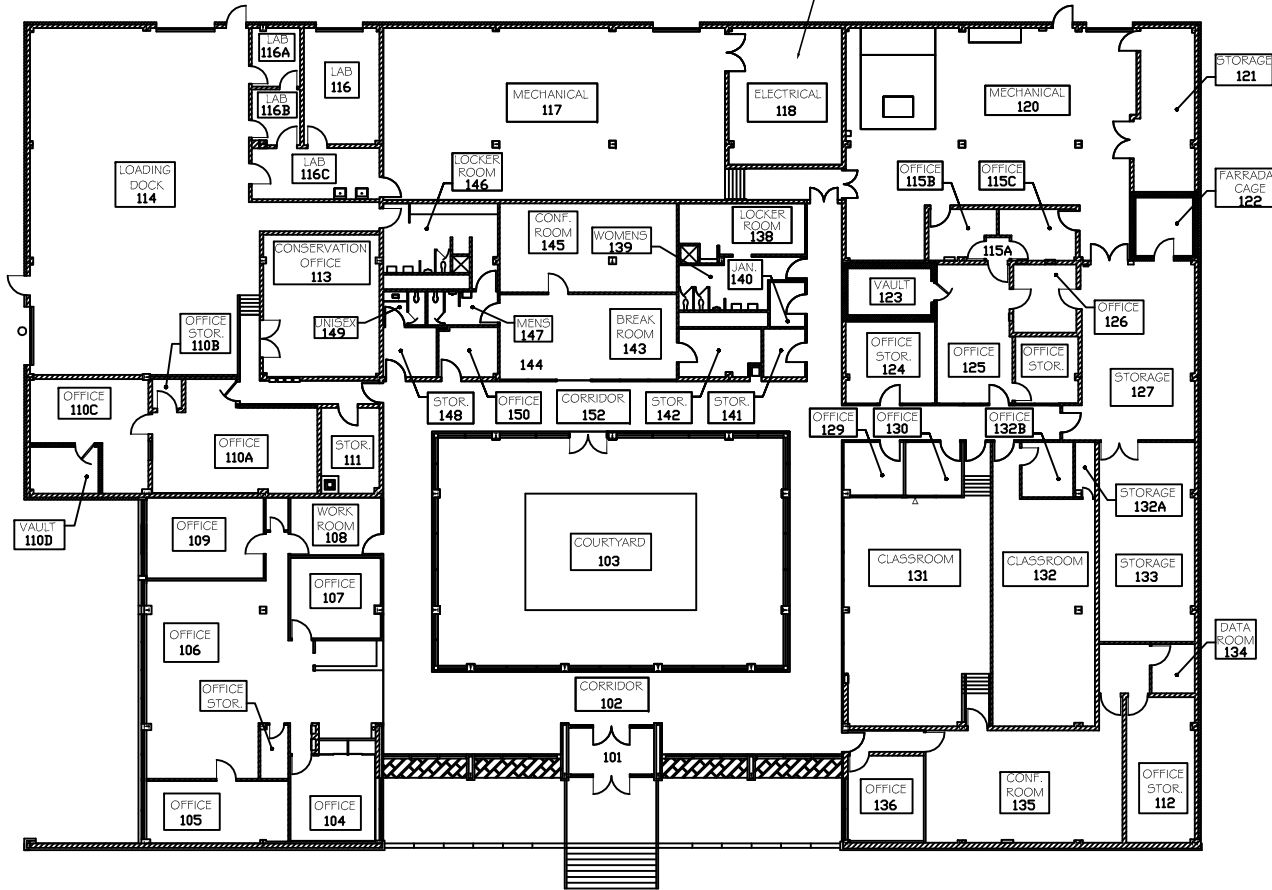
**DRAWINGS
AND PROJECT LOCATIONS**

WEST ACADEMIC BUILDING

BLDG NO. WRAB

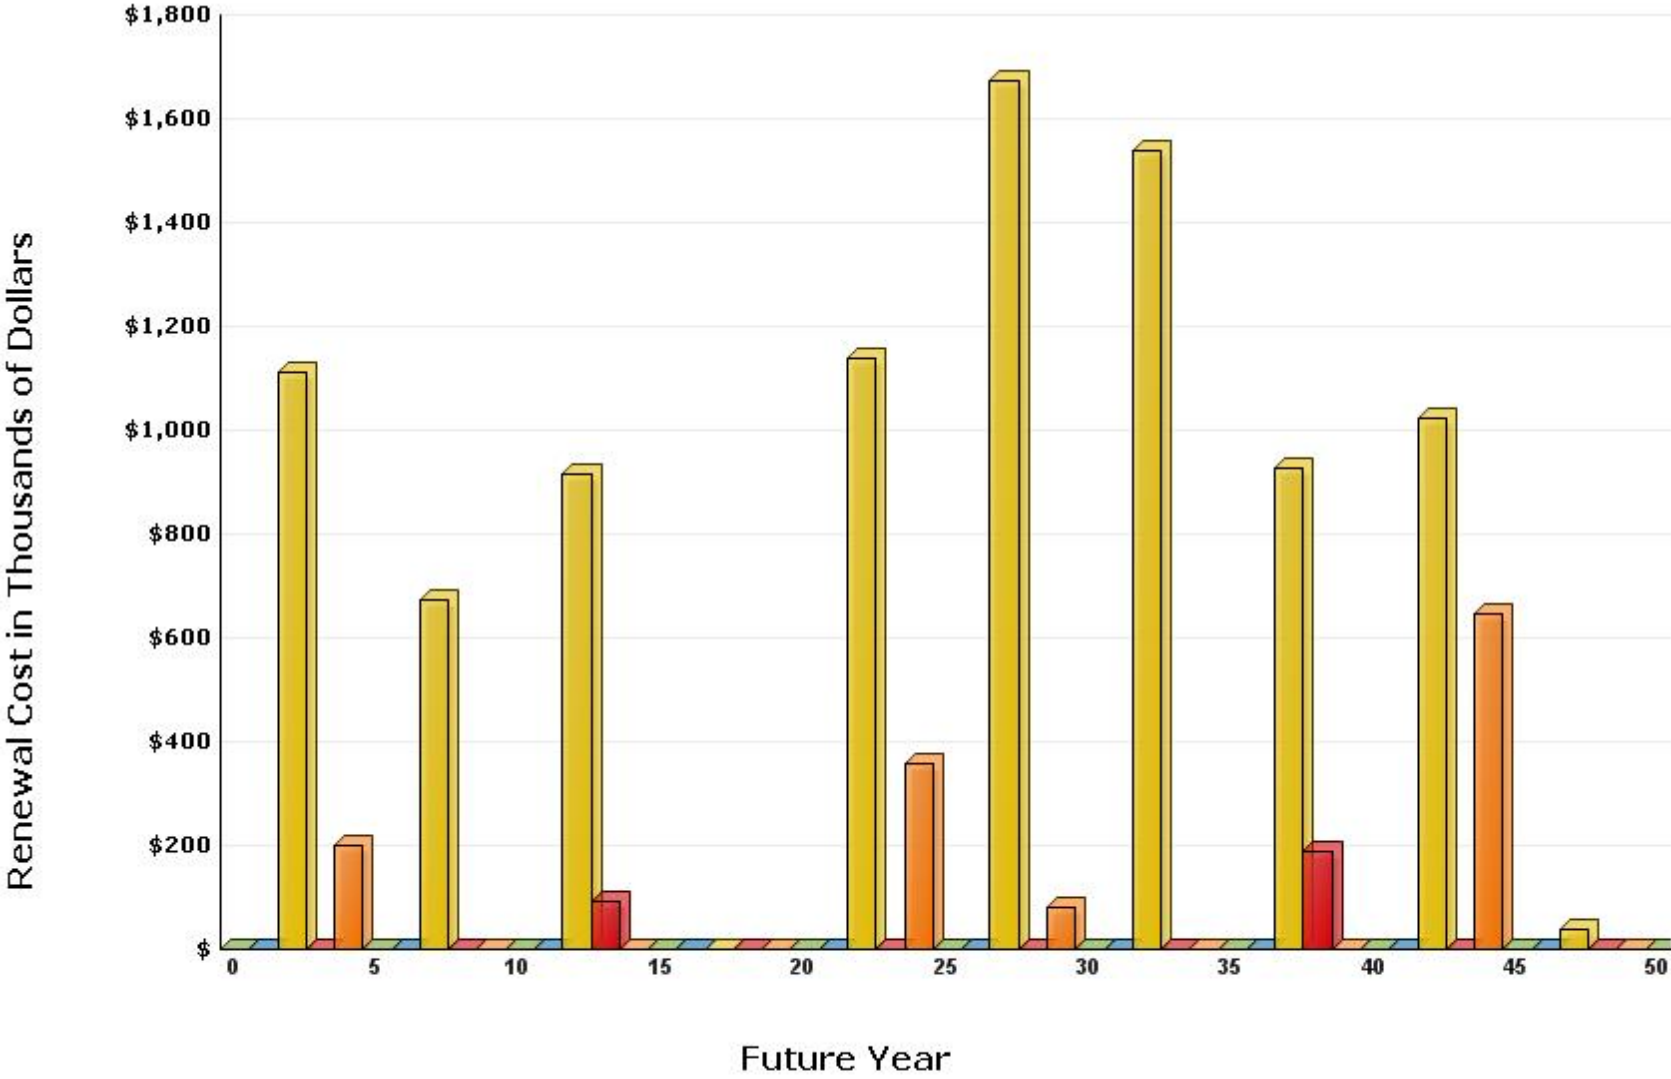
Life Cycle Model Expenditure Projections

Average Annual Renewal Cost Per SqFt \$4.56
