EAST CAROLINA UNIVERSITY

COTTEN RESIDENCE HALL

FACILITY CONDITION ANALYSIS

DECEMBER 7, 2009

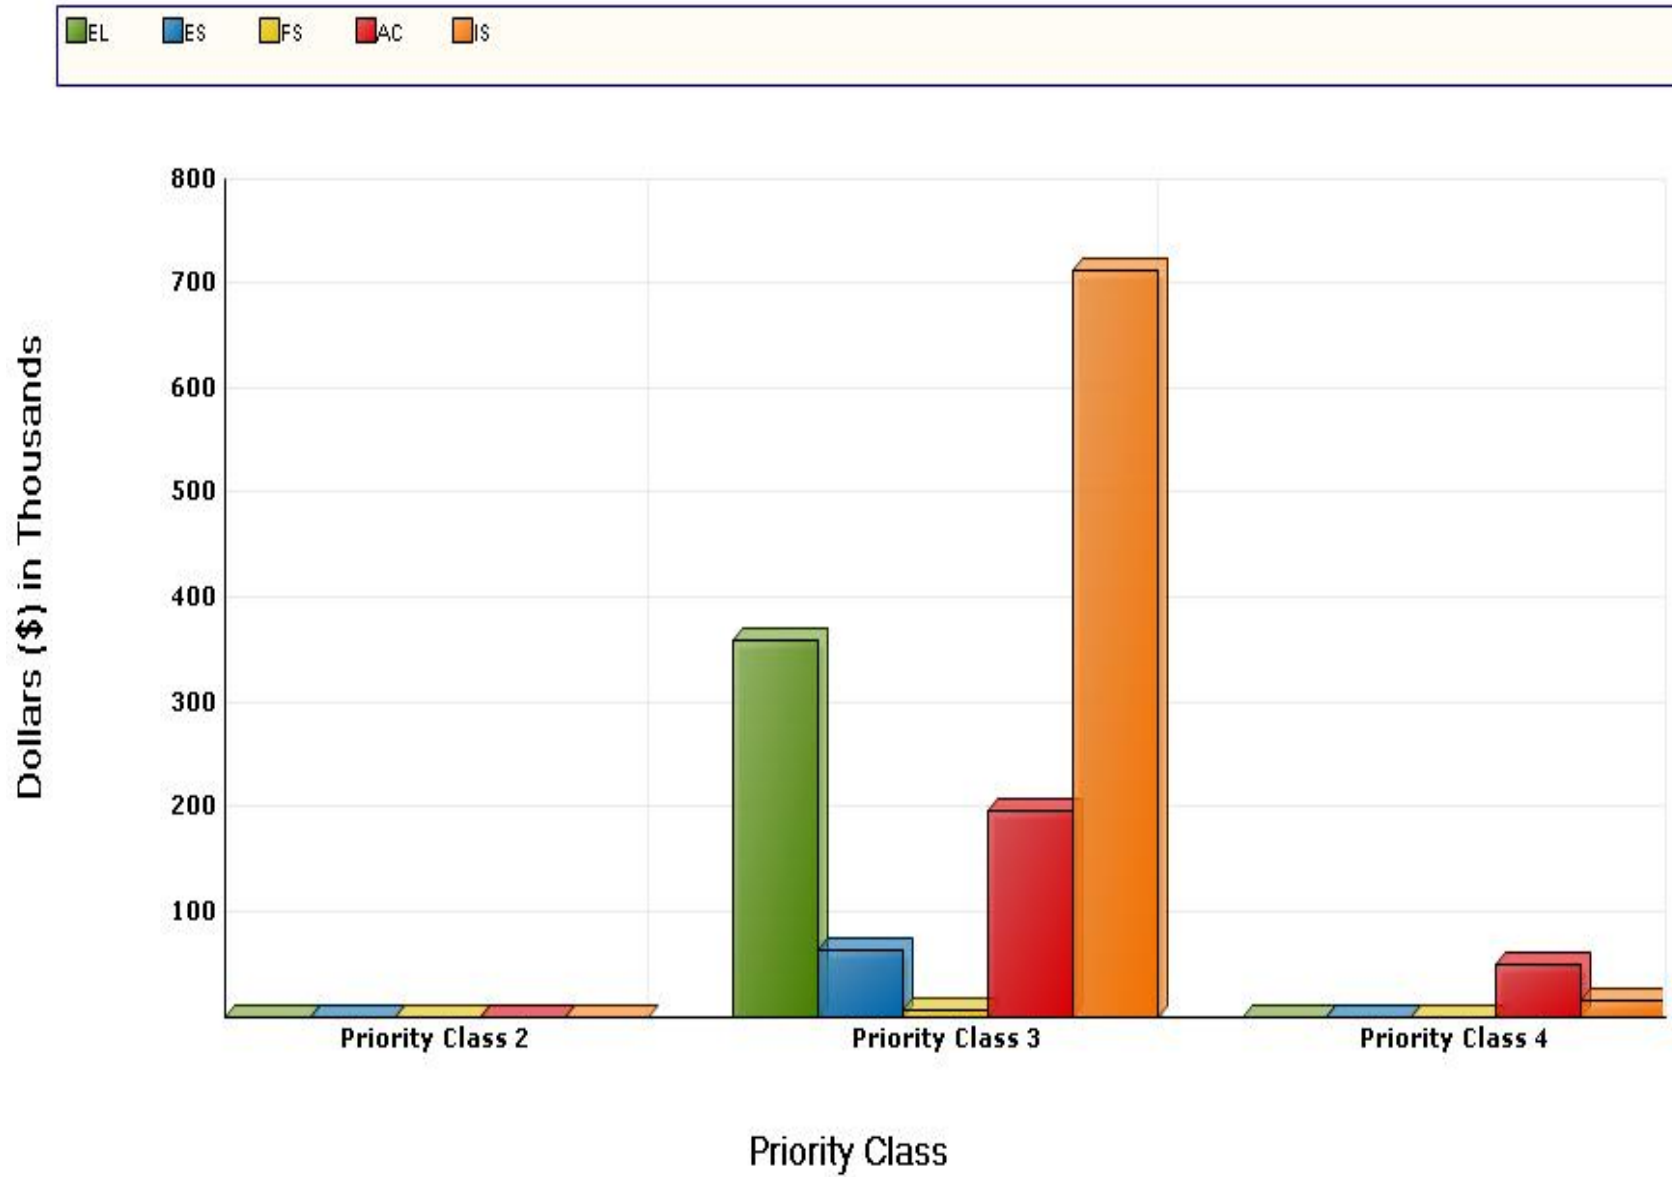
System Code by Priority Class

**Detailed Project Totals
 Facility Condition Analysis
 System Code by Project Class
 COTT : COTTEN RESIDENCE HALL**

System Code	System Description	Project Classes			Subtotal
		Capital Renewal	Deferred Maintenance	Plant Adaption	
AC	ACCESSIBILITY	0	0	247,314	247,314
EL	ELECTRICAL	0	359,083	0	359,083
ES	EXTERIOR	0	64,342	0	64,342
FS	FIRE/LIFE SAFETY	0	9,189	0	9,189
IS	INTERIOR/FINISH SYS.	15,318	712,460	0	727,778
	TOTALS	15,318	1,145,074	247,314	1,407,707
