EAST CAROLINA UNIVERSITY

CHANCELLOR'S RESIDENCE

FACILITY CONDITION ANALYSIS

OCTOBER 29, 2009

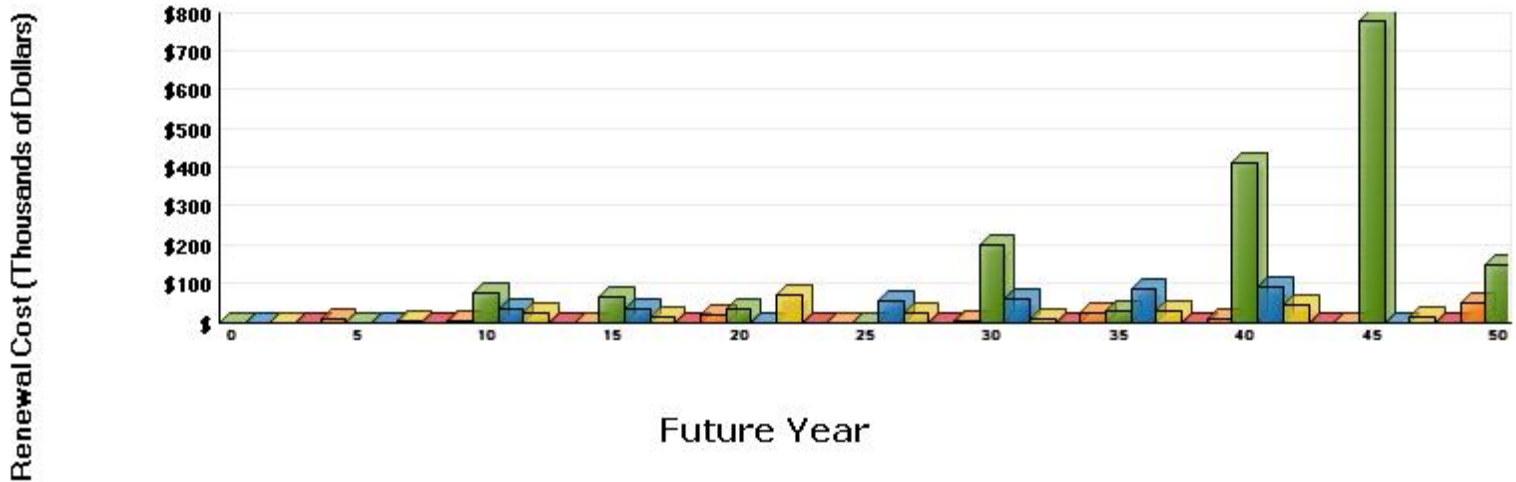
LIFE CYCLE MODEL EXPENDITURE PROJECTIONS

Average Annual Renewal Cost Per SqFt \$2.57

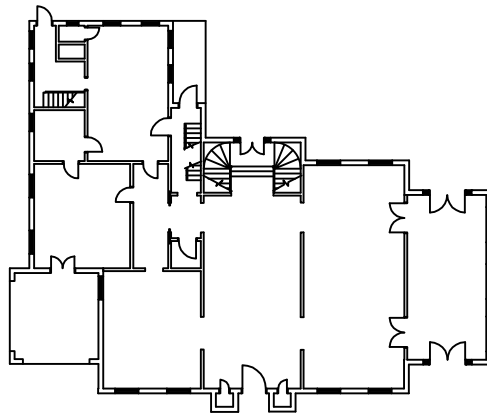
AC01

AC02

It is recommended that ADA compliant, painted metal handrails be installed at all exterior entranceways with steps as required. Also, the wheelchair ramp from the curbs lacks compliant handrails on both sides. Install accessible handrails along both sides of this wheelchair ramp.

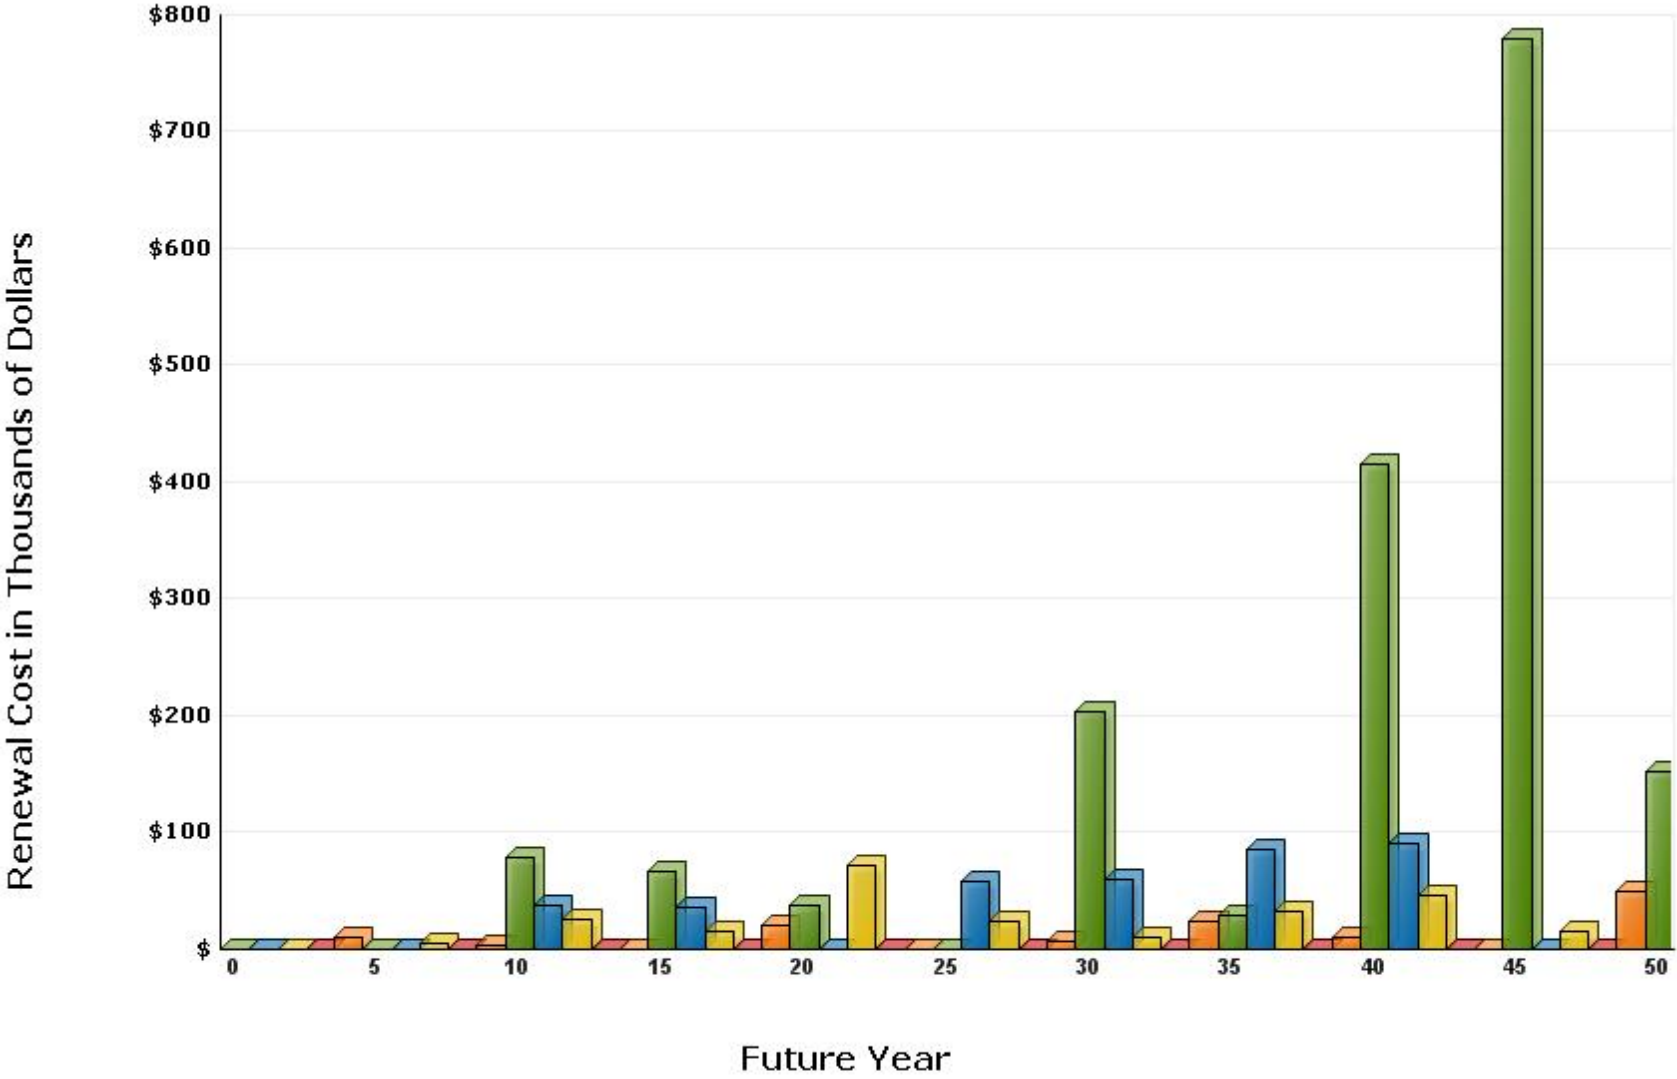
Life Cycle Model Expenditure Projections

Average Annual Renewal Cost Per SqFt \$2.57
