EAST CAROLINA UNIVERSITY

FLEMING RESIDENCE HALL

FACILITY CONDITION ANALYSIS

NOVEMBER 4, 2009

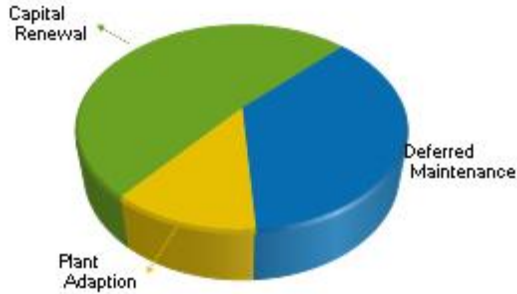
PROJECT COSTS BY CLASSIFICATION

Building Code: FLEM
Building Name: FLEMING RESIDENCE HALL
Year Built: 1923
Building Use: Dormitory / Apartments
Square Feet: 32,428

Project Costs by Priority

Priority 1:	\$999
Priority 2:	\$28,370
Priority 3:	\$1,591,147
Priority 4:	\$401,241
Total Project Costs:	\$2,021,756

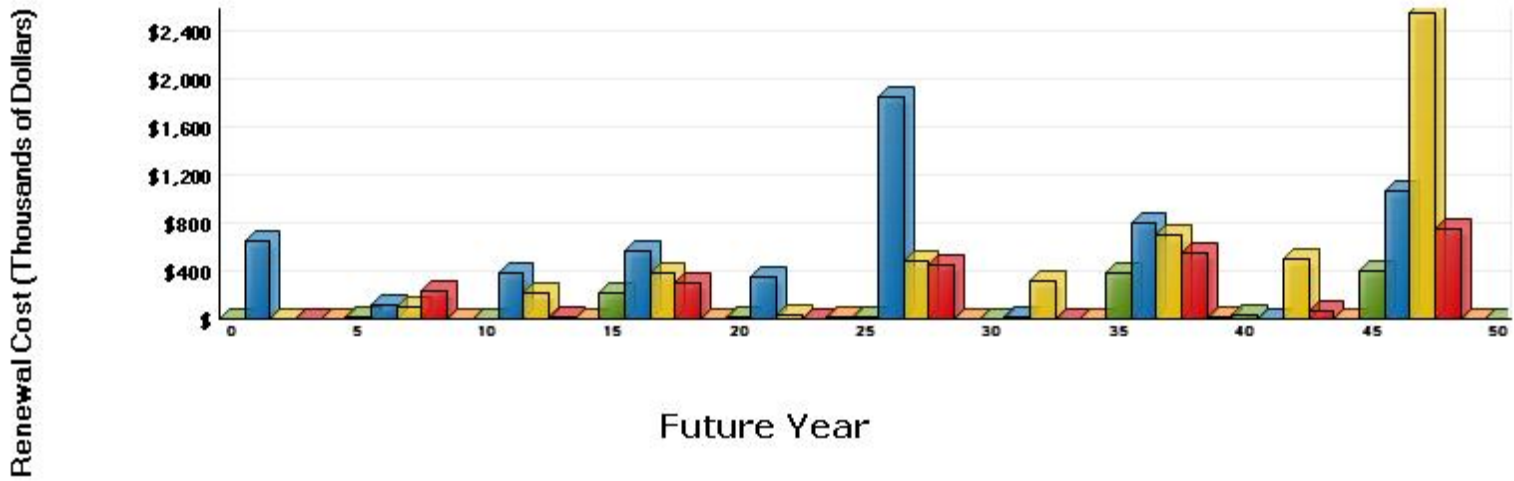
LIFE CYCLE MODEL EXPENDITURE PROJECTIONS

Average Annual Renewal Cost Per SqFt \$3.84

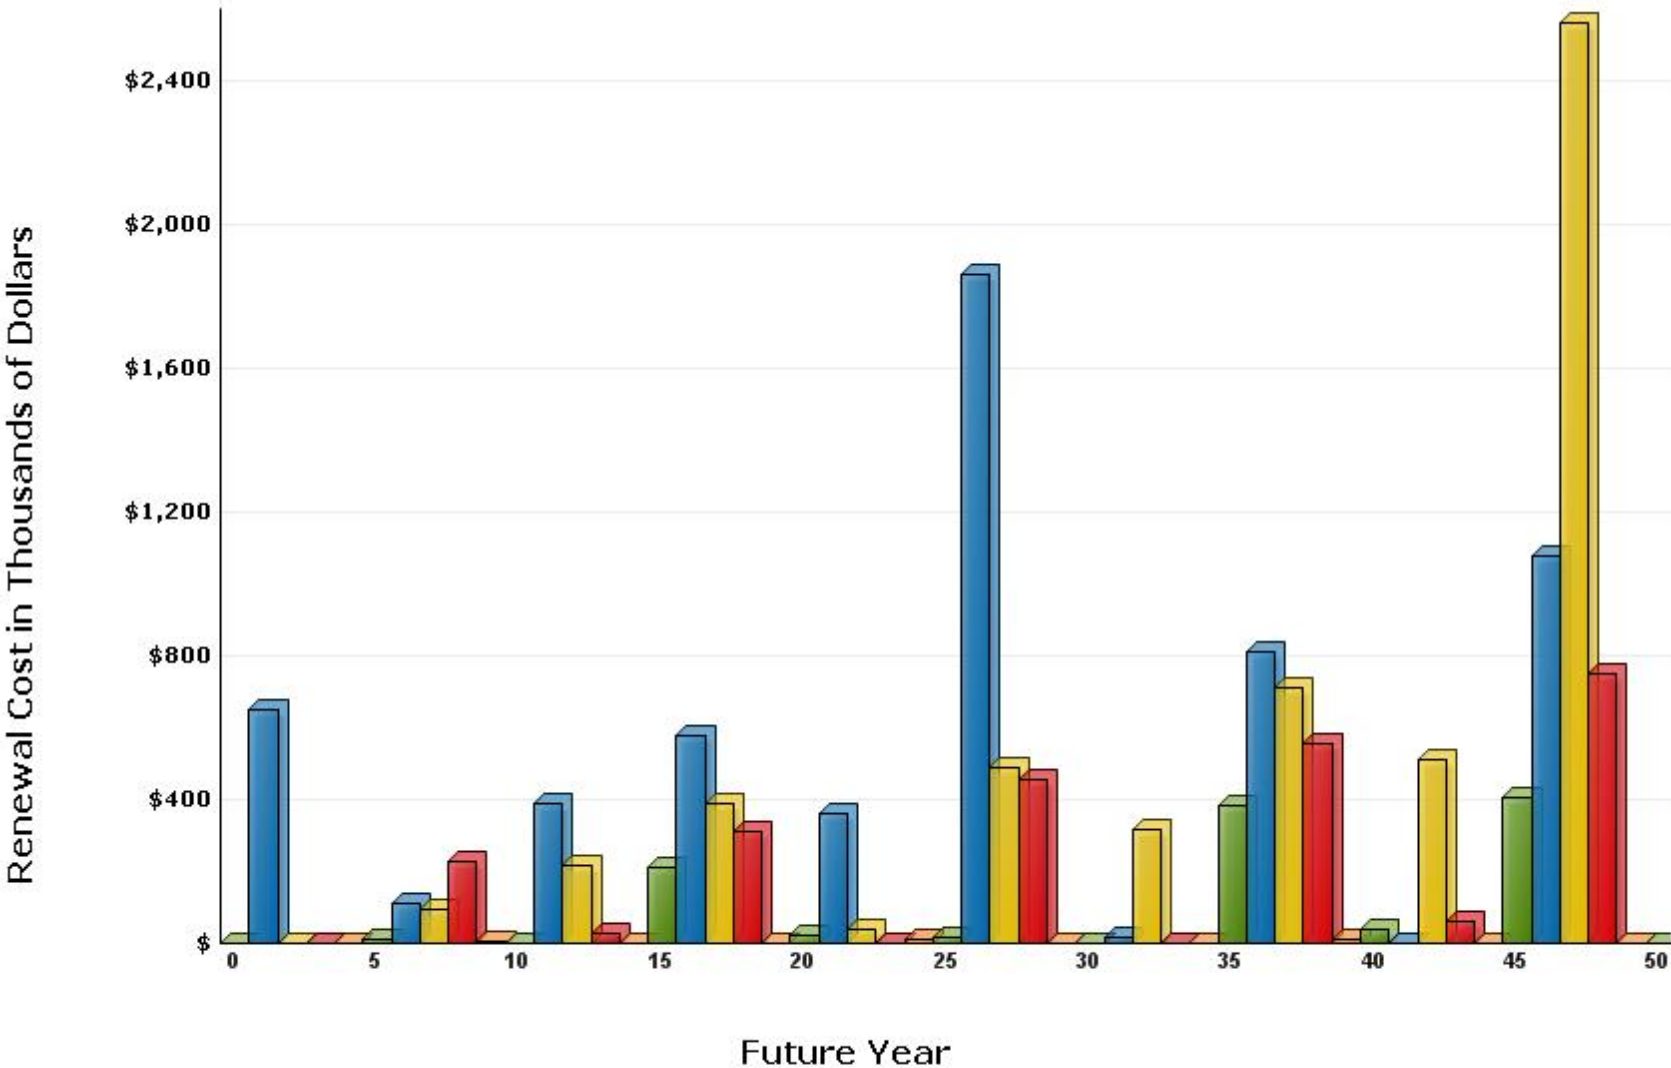
Life Cycle Model Expenditure Projections

Average Annual Renewal Cost Per SqFt \$3.84
