# EAST CAROLINA UNIVERSITY

## FLETCHER RESIDENCE HALL

FACILITY CONDITION ANALYSIS

DECEMBER 4, 2009

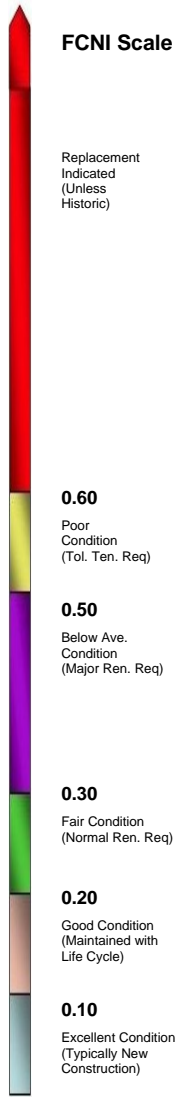
Priority 1:	\$0
Priority 2:	\$1,957,518
Priority 3:	\$2,787,397
Priority 4:	\$607,563
<b>Total Project Costs:</b>	<b>\$5,352,478</b>

**Facility Replacement Cost: \$25,050,000**

**Facility Condition Needs Index (FCNI): 0.21**  
 (Project Costs / Replacement Cost)
