EAST CAROLINA UNIVERSITY

MAIL SERVICES / WAREHOUSE / TECH LAB A

ASSET CODE: B043

FACILITY CONDITION ANALYSIS

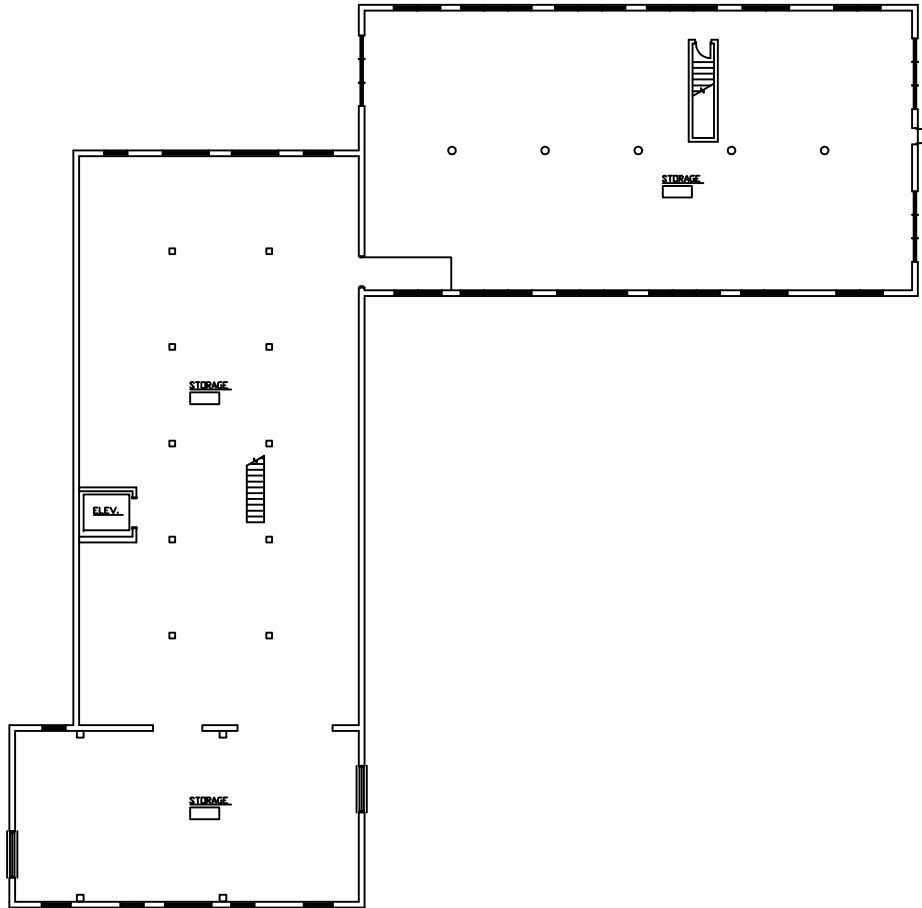
FIRST
FLOOR
PLAN

Sheet No.
1 of 2

MAIL SERVICES/
 WAREHOUSE/
 TECH LAB A

BLDG NO. B043
