EAST CAROLINA UNIVERSITY

Facility Condition Assessment

Cardiovascular Building
Asset CARD

Inspected November 6, 2018

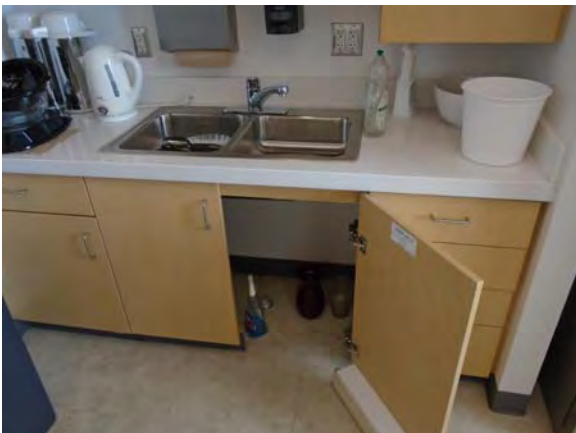
CARD012a 11/6/2018
Wheelchair accessible sink
Fourth floor

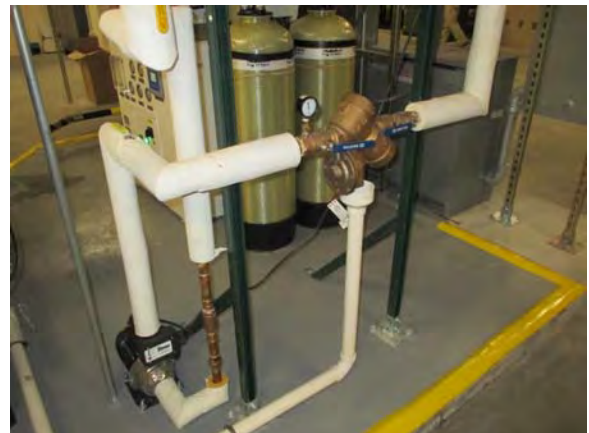
CARD036e 11/6/2018
Backflow preventer for the RO/DI water system
East mezzanine

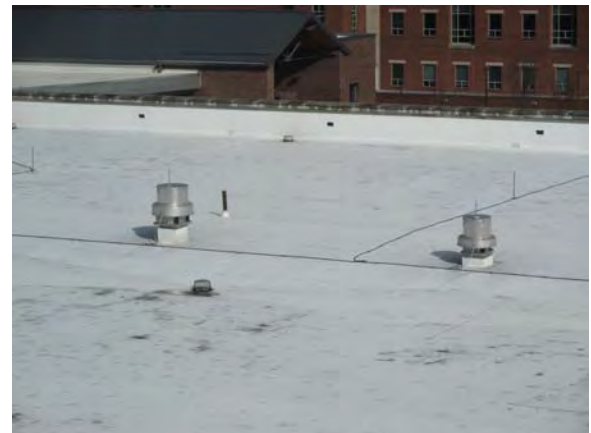
CARD039e 11/6/2018
Two centrifugal roof exhausters
North roof

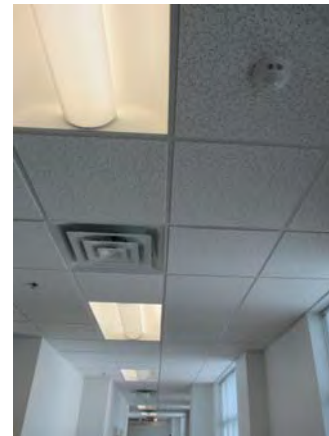
CARD042e 11/6/2018
Modern lay-in fluorescent light fixtures
Fourth floor corridor

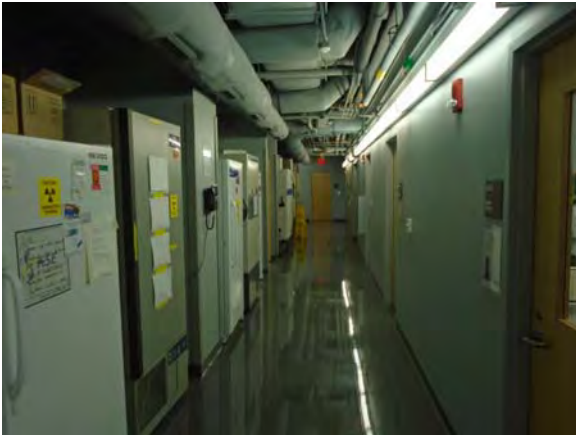
CARD047a 11/6/2018
Vinyl tile floor and painted walls
Fourth floor corridor

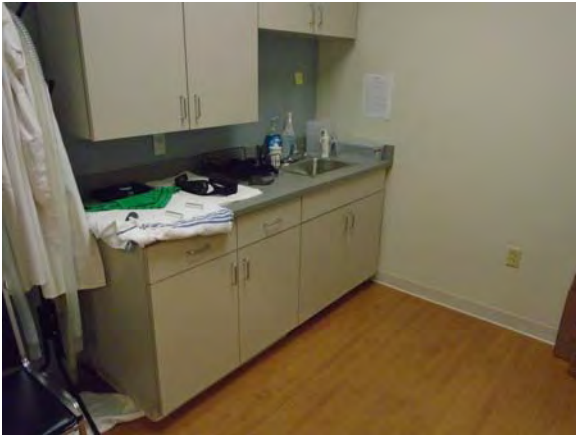
CARD079a 11/6/2018
Wood laminate flooring, sink, and cabinetry
Third floor

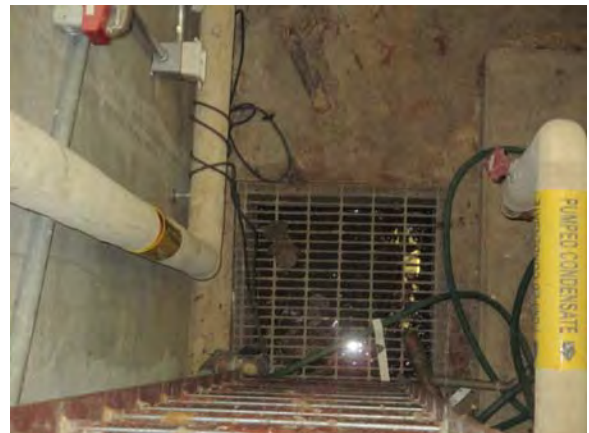
CARD081e 11/6/2018
Sump pump at bottom of pit
Room 1418

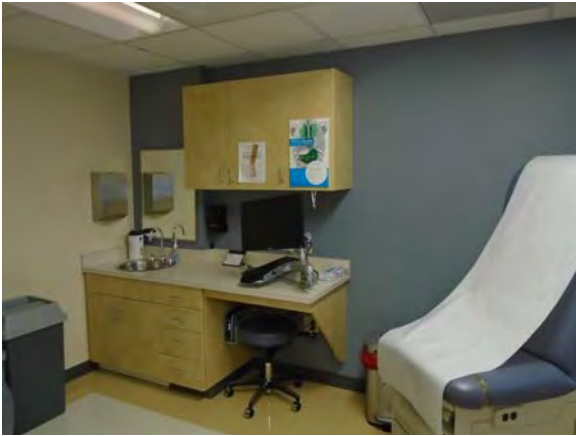
CARD082a 11/6/2018

Vinyl tile floor, painted walls, suspended ceiling, and base and overhead cabinetry with sink
Third floor exam room

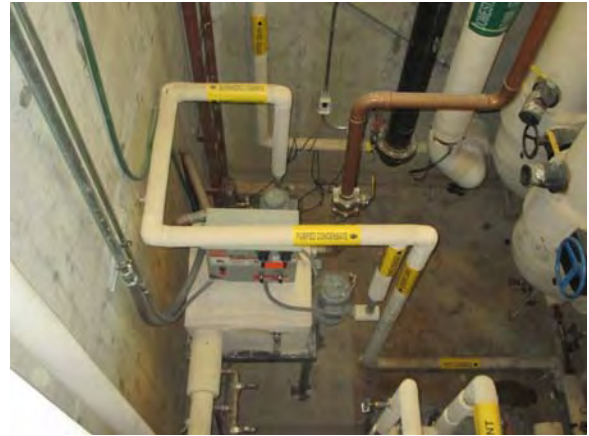
CARD082e 11/6/2018

Condensate pump CP-2 in pit
Room 1418

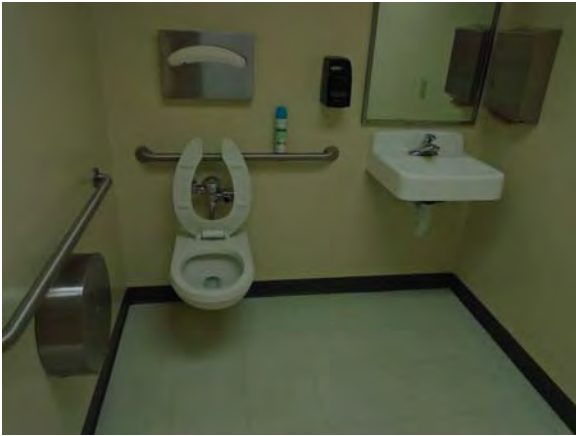
CARD083a 11/6/2018

Vinyl flooring, painted walls, and accessible fixtures
Third floor accessible unisex restroom

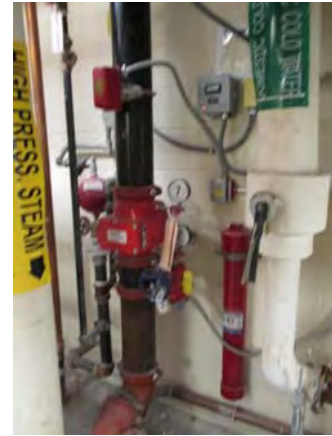
CARD083e 11/6/2018

Fire standpipe with tamper switch
Room 1418

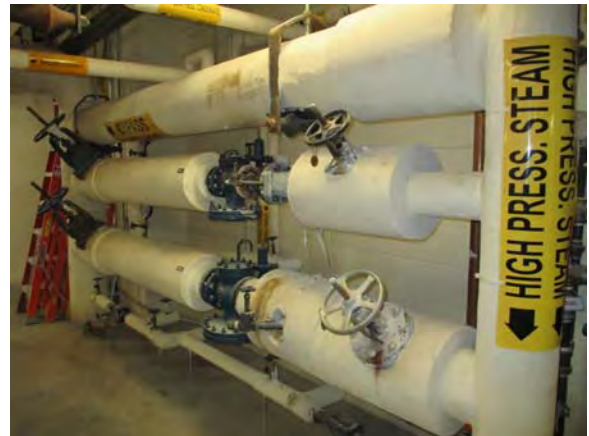
CARD084e 11/6/2018

Pressure reducing valves for the steam piping
Room 1418

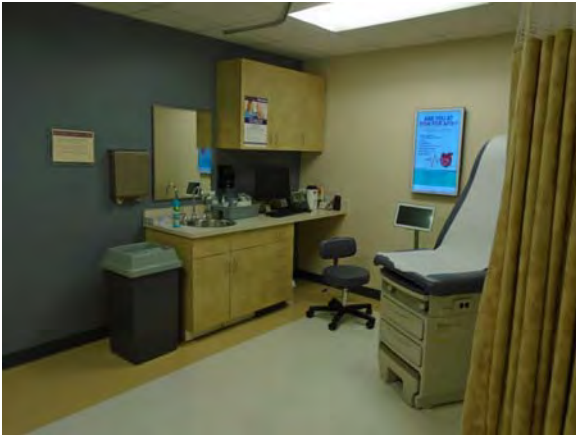
CARD094a 11/6/2018

Vinyl tile floor, painted walls, suspended ceiling, and base and overhead cabinetry with sink
Second floor exam room

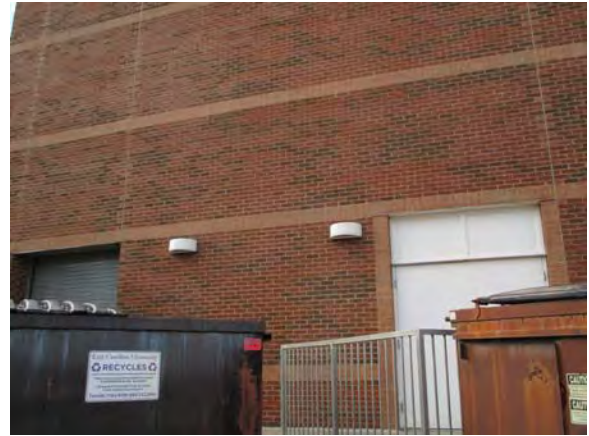
CARD094e 11/6/2018

Wall-mounted CFL half cylinder exterior lights
East exterior

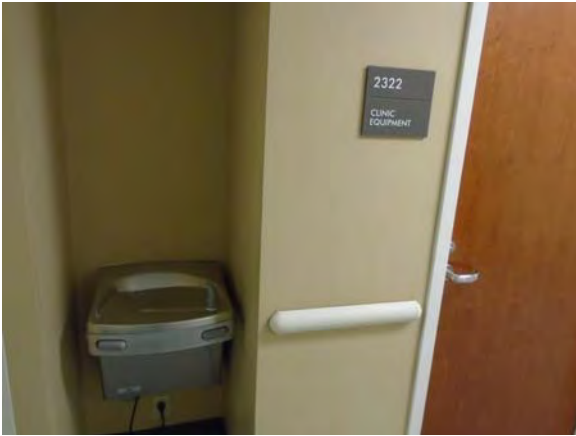
CARD095a 11/6/2018

Single-level water fountain
Second floor

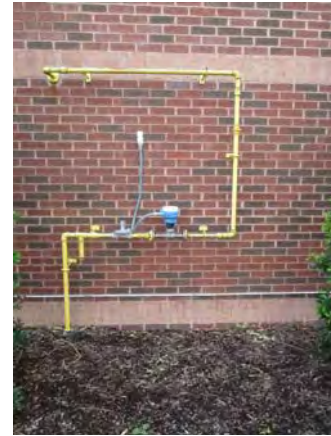
CARD095e 11/6/2018

Natural gas piping entering the building
North exterior

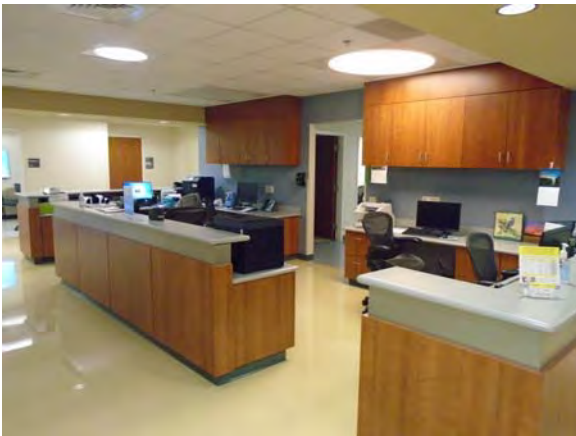
CARD096a 11/6/2018

Vinyl tile floor, painted walls, suspended ceiling, and base and overhead cabinetry
Second floor nurses station

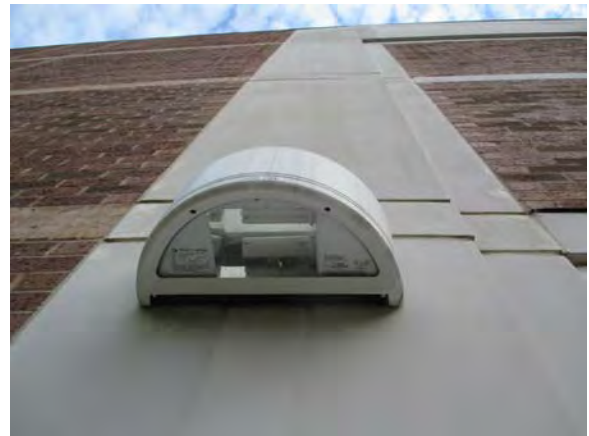
CARD096e 11/6/2018

Close-up of wall-mounted exterior light fixture
West exterior

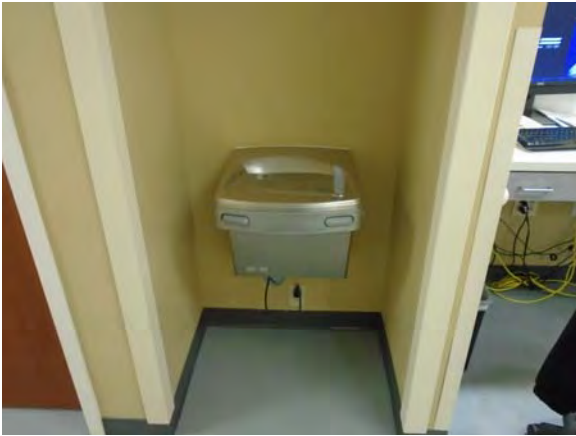
CARD097a 11/6/2018
Single-level water fountain
Second floor

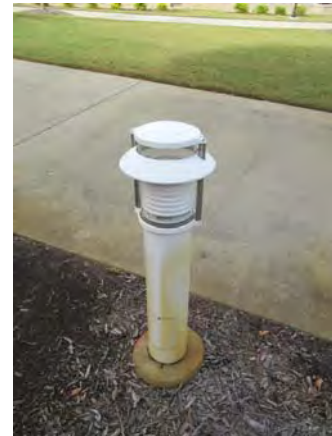
CARD098e 11/6/2018
Post-mounted exterior light
West exterior

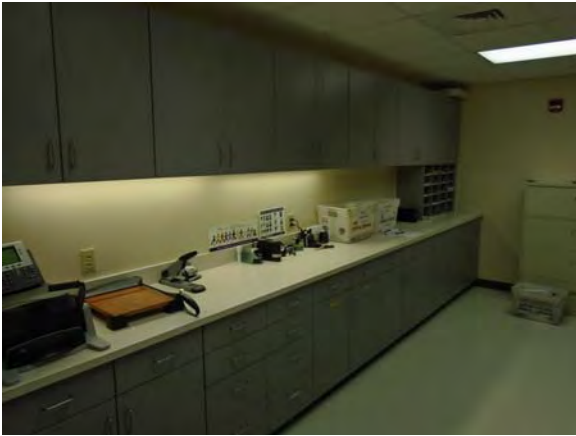
CARD112a 11/6/2018
Base and overhead cabinetry
First floor

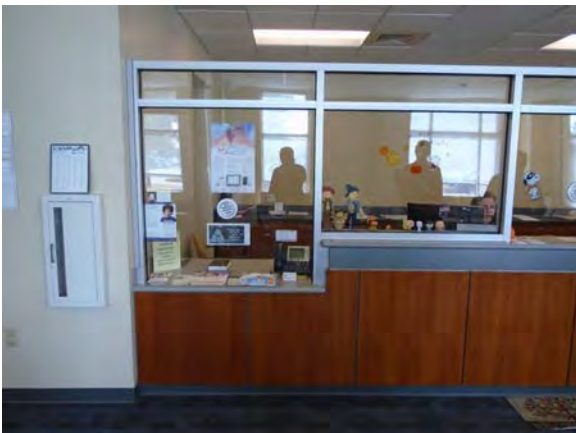
CARD116a 11/6/2018
Wheelchair accessible service counter
First floor

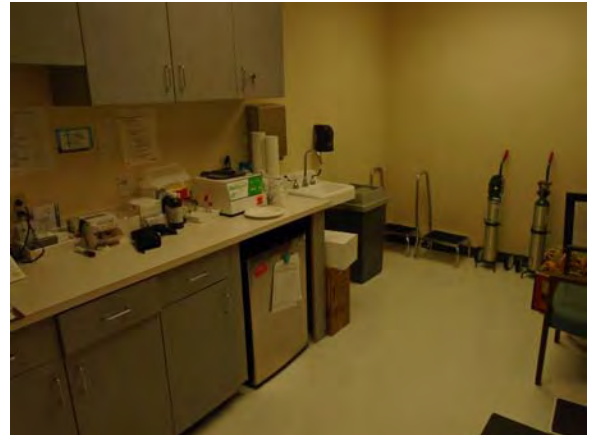
CARD119a 11/6/2018

Vinyl tile floor, painted walls, suspended ceiling, base and overhead cabinetry, and wall-mounted sink
First floor exam room

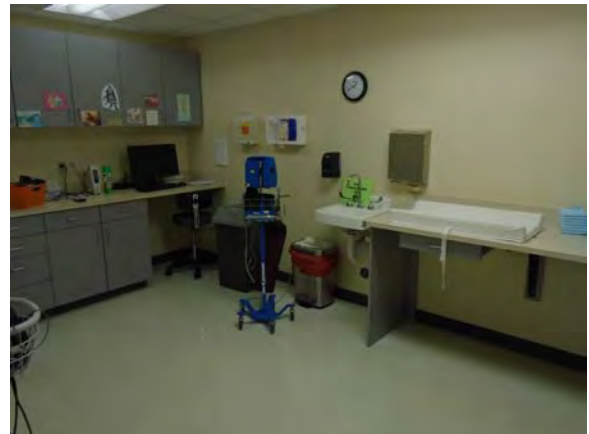
CARD121a 11/6/2018

Vinyl tile floor, painted walls, suspended ceiling, base and overhead cabinetry, and wall-mounted sink
First floor exam room

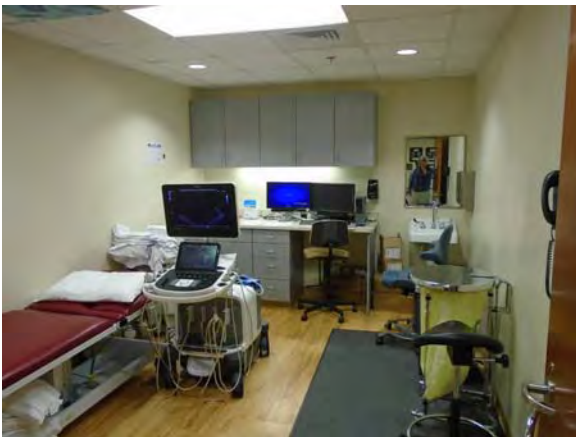
CARD122a 11/6/2018

Vinyl tile floor, painted walls, suspended ceiling, base and overhead cabinetry, and wall-mounted sink
First floor exam room

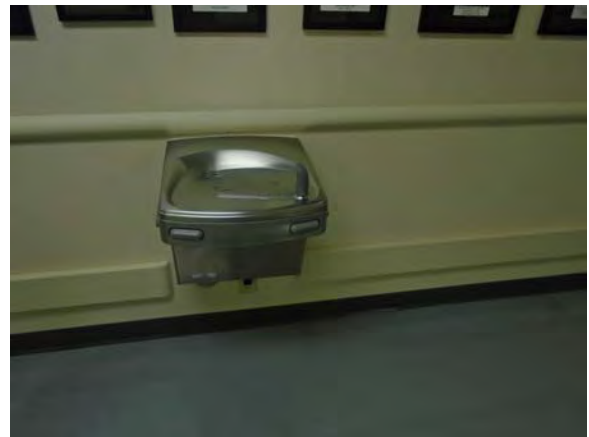
CARD123a 11/6/2018

Single-level water fountain
First floor

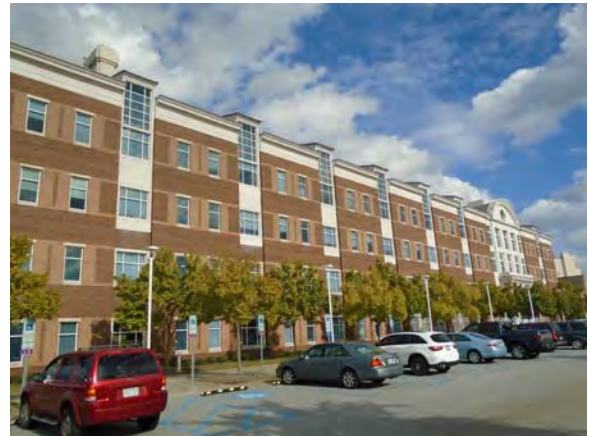
CARD174a 11/6/2018
Brick masonry exterior, dual-pane windows, and glass
doors
West corner
