EAST CAROLINA UNIVERSITY

Facility Condition Assessment

Allied Health Sciences Building
Asset AHSB

Inspected April 20, 2016

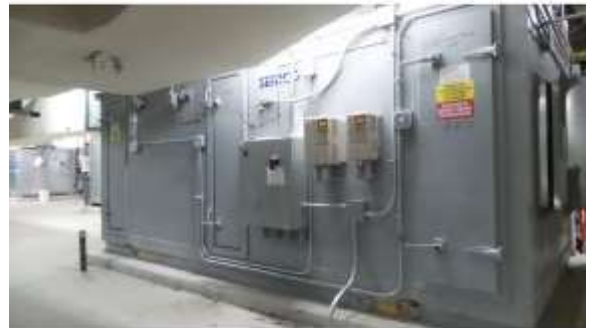
AHSB011e 4/20/2016
Energy recovery unit ERU-4
East Penthouse

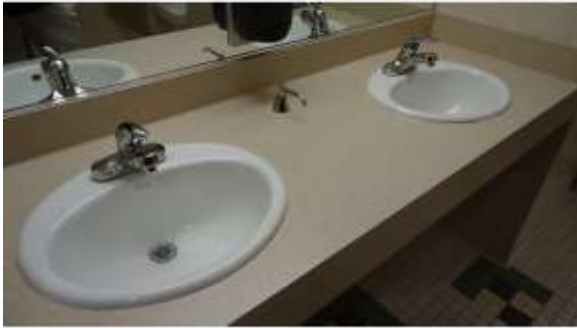
AHSB013a 4/20/2016
Lavatories
Typical restrooms
