EAST CAROLINA UNIVERSITY

Facility Condition Assessment

Ross Hall
Asset 256

Inspected May 11, 2021

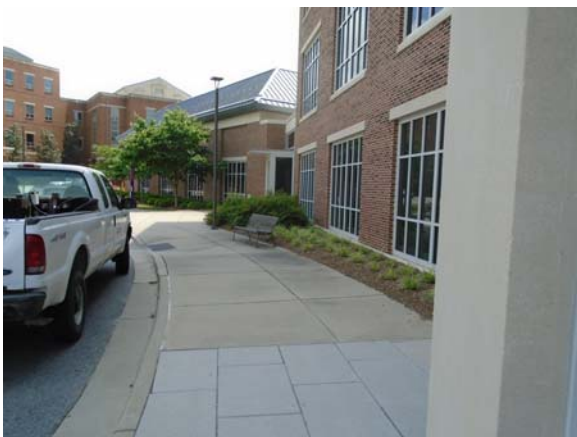
256003a 5/12/2021
Concrete sidewalk leading to stone entry
East sidewalk

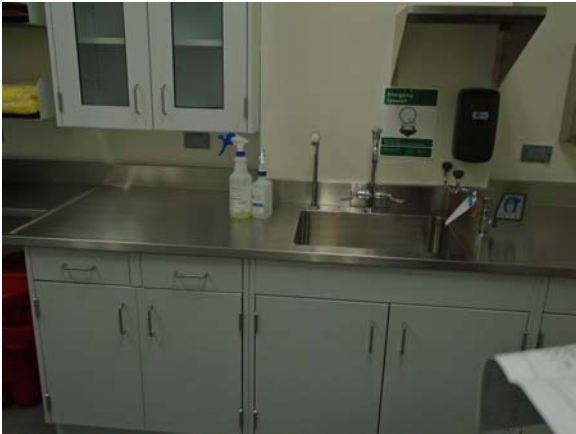
256052a 5/12/2021
Metal sink and countertop
Suite 4210

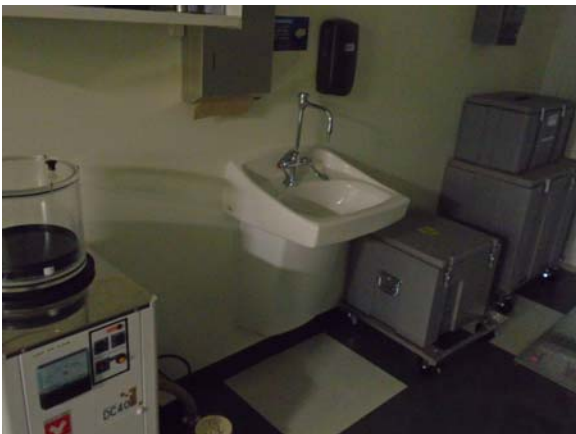
256054a 5/12/2021
Small wall-hung lab sink
Fourth floor lab area

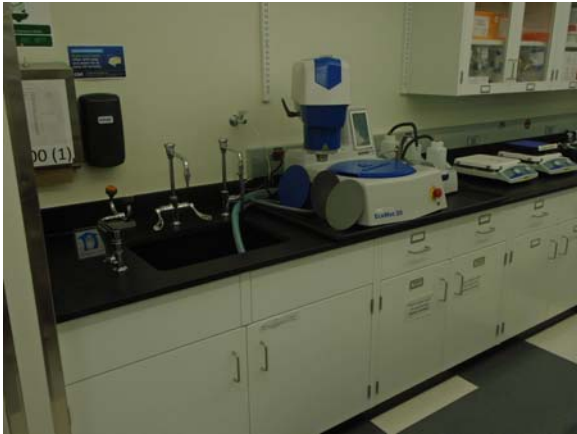
256055a 5/12/2021
Metal sink and countertop
Fourth floor lab area

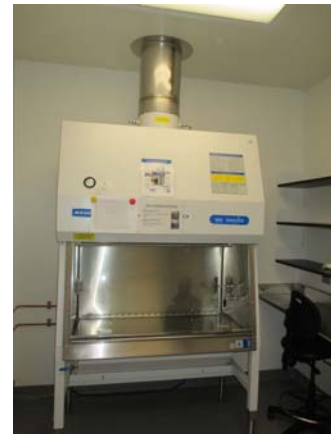
256060e 5/11/2021
Vented bio-safety cabinet
Room 4210C

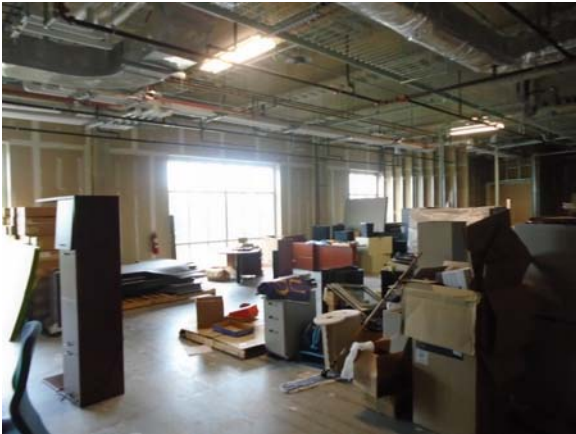
256062a 5/12/2021
Unfinished area
Fourth floor

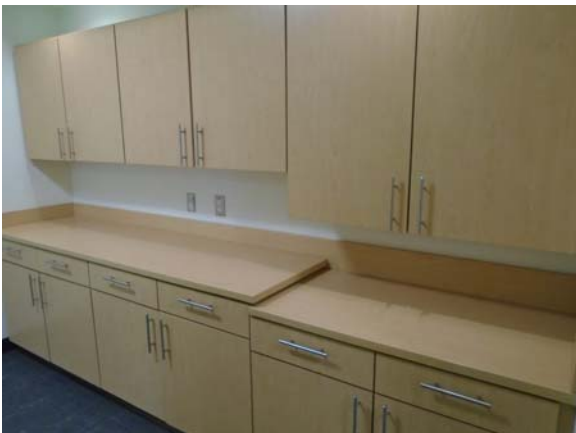
256063a 5/12/2021
Newer wood cabinetry
Fourth floor

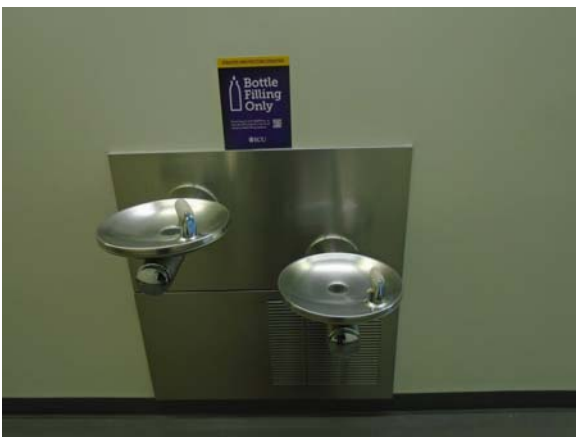
256078a 5/12/2021
Dual-level water fountain
Third floor lab corridor

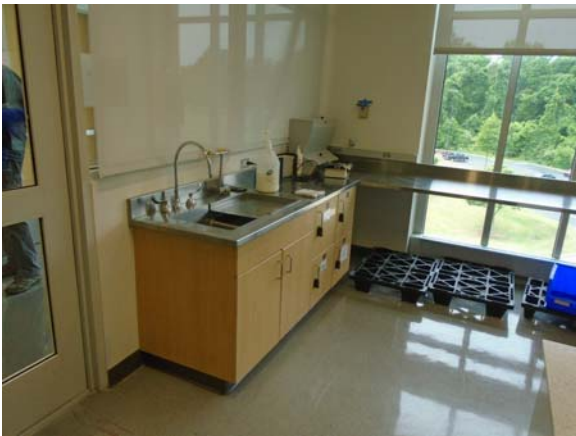
256080a 5/12/2021
Wood cabinetry with steel sink and countertop
Third floor labs

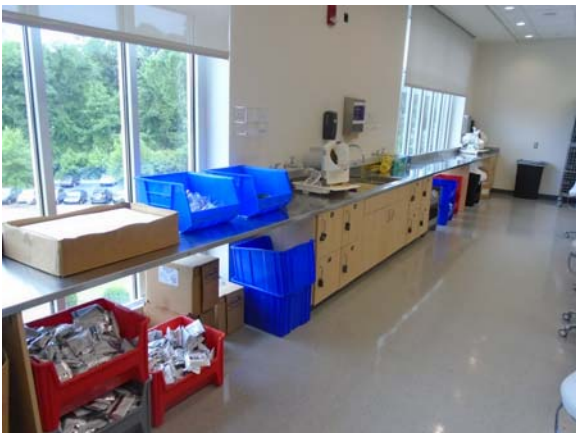
256081a 5/12/2021
Wood cabinetry with steel sink and countertop
Third floor labs

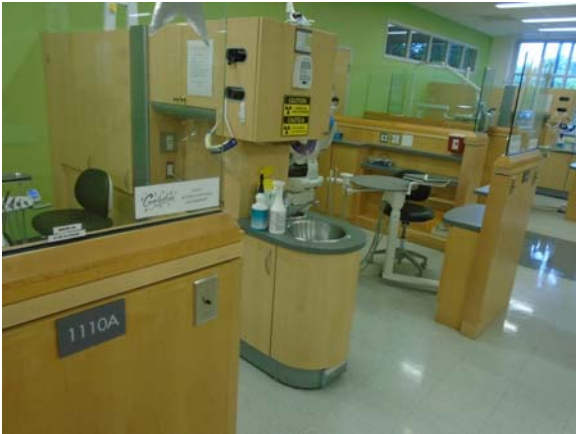
256112a 5/12/2021
Small round shared lab/exam sinks
First floor dental training area

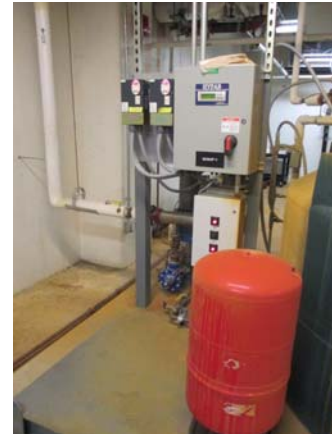
256115e 5/11/2021
Hyfab modular variable speed pressure booster
Room B0100

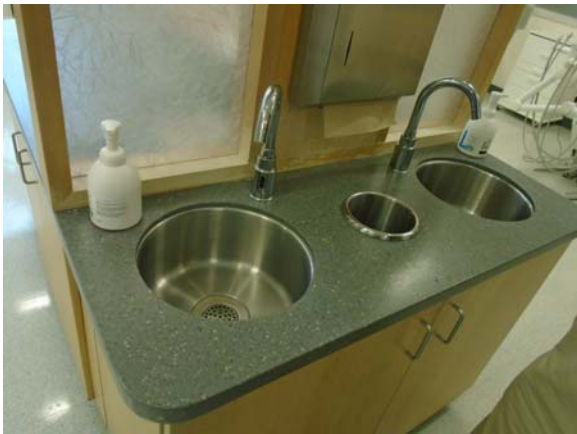
256116a 5/12/2021
Small round shared lab/exam sinks
First floor dental training area

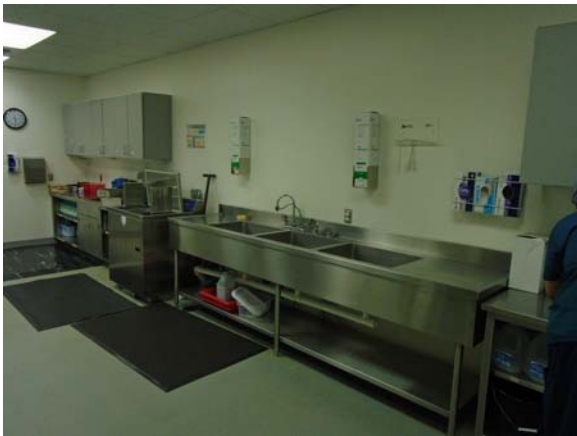
256119a 5/12/2021
Stainless steel sinks for cleaning
1268
