# EAST CAROLINA UNIVERSITY

Facility Condition Assessment

Austin Building (006)

Inspected May 11, 2021

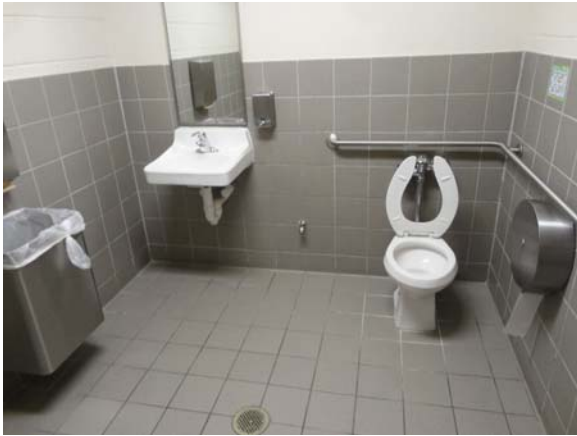
AUST019a 5/11/2021  
Accessible two-fixture restroom  
Third floor, men's restroom

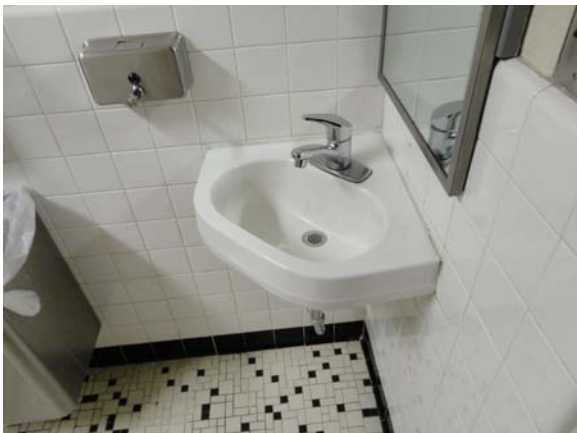
AUST021a 5/11/2021  
Standard corner wall-hung lavatory  
Third floor, men's restroom

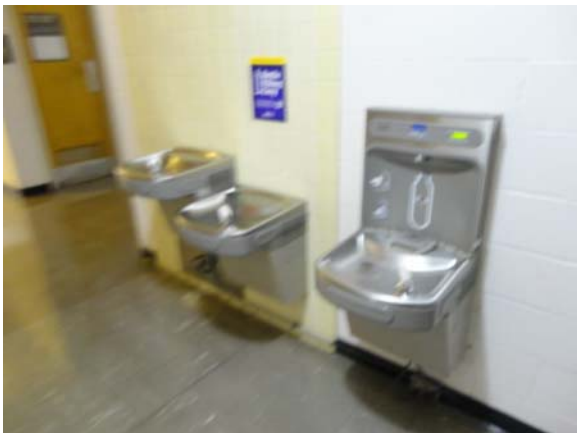
AUST036a 5/11/2021  
Accessible water fountains  
First floor corridor
