EAST CAROLINA UNIVERSITY

Facility Condition Assessment

Harold H. Bate Building (095)

Inspected May 11, 2021

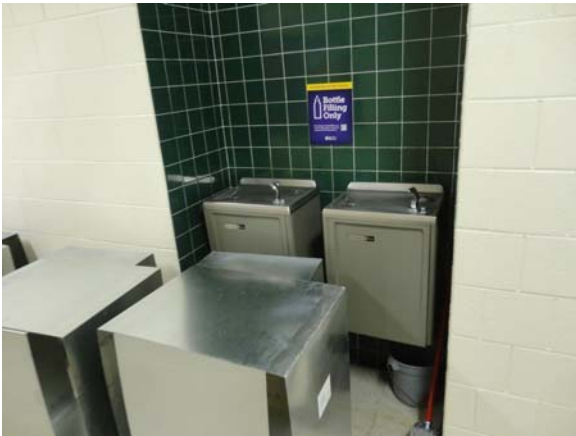
BATE045a 5/11/2021
Older water fountains
Second floor, corridor
