EAST CAROLINA UNIVERSITY

Facility Condition Assessment

Rawl Building (004)

Inspected May 10, 2021

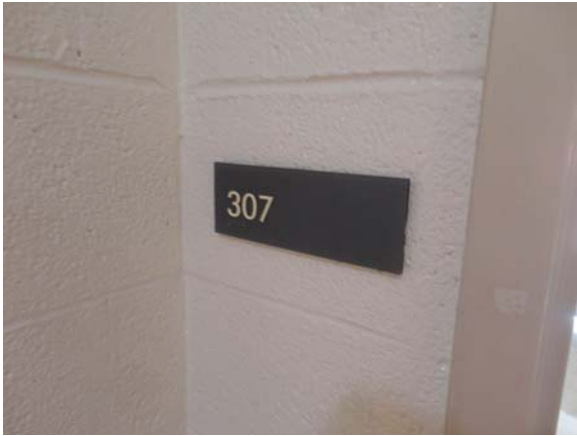
RAWL007a 5/10/2021
Newer accessible wall-mounted signage with Braille
Third floor corridor

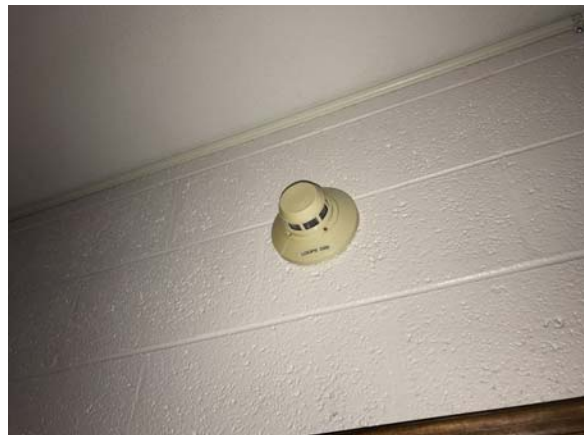
RAWL015e 5/10/2021
Smoke detector
Third floor corridor

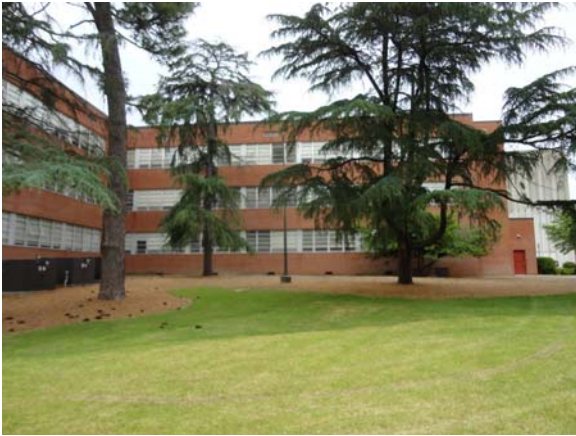
RAWL055a 5/10/2021
Exterior finishes
South elevation of east wing

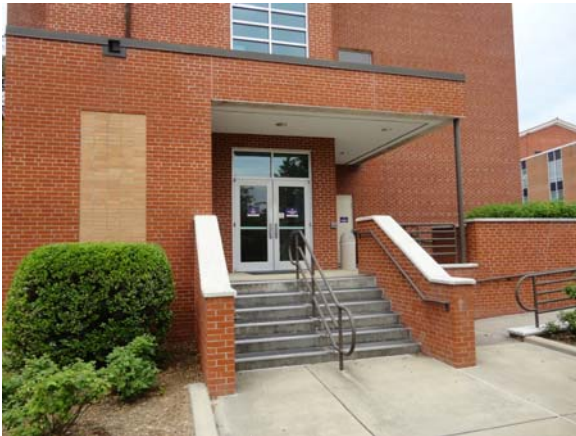
RAWL057a 5/10/2021
Newer glass entry/egress doors
East entry
