EAST CAROLINA UNIVERSITY

Facility Condition Assessment

Rivers Building (010)

Inspected May 13, 2021

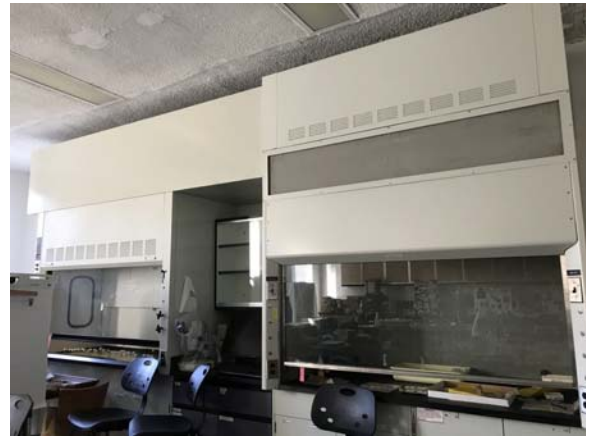
RIVE017e 5/13/2021
Laboratory fume hood
Room 258

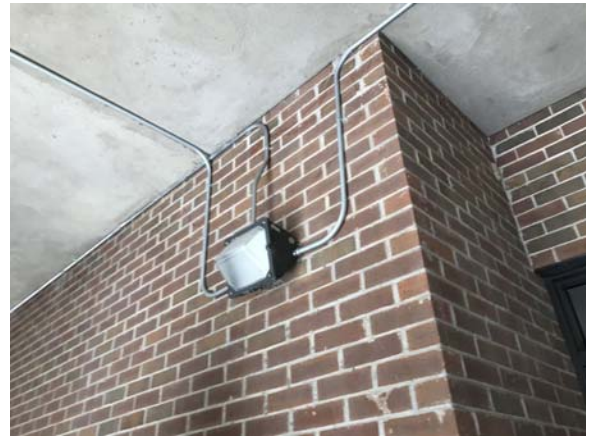
RIVE038e 5/13/2021
HID wallpack
Breezeway

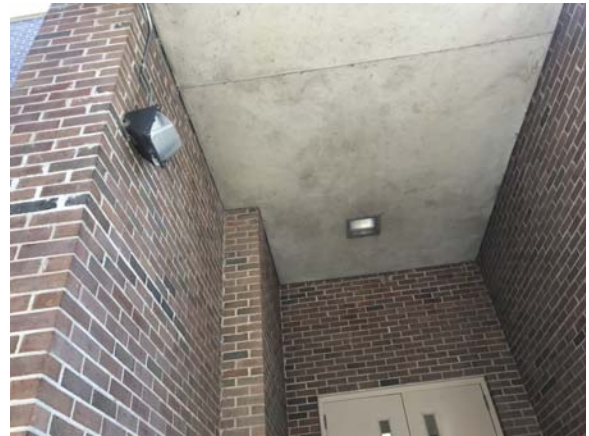
RIVE053e 5/13/2021
HID wallpack and recessed can exterior fixtures
Entry

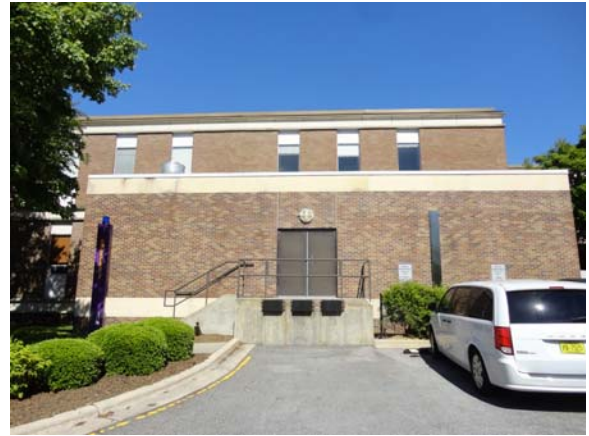
RIVE080a 5/13/2021
Small service area addition and dock area
Central east elevation

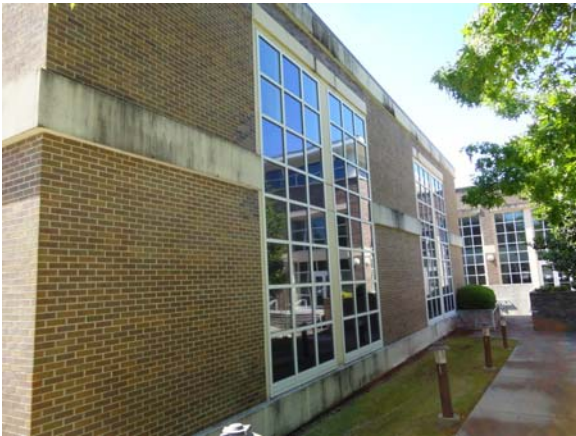
RIVE087a 5/13/2021
Upgraded glass near new addition
Northwest corner elevation
