EAST CAROLINA UNIVERSITY

Facility Condition Assessment

Speight Building (012)

Inspected May 11, 2021

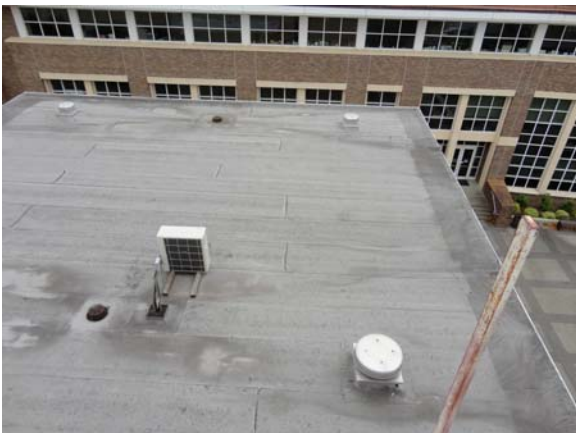
SPEI006a 5/11/2021
Another of the four lower roofs
Lower roof

The multi-level flat roofs are aging and should be upgraded in the near few years. The roof hatch in the #3 stair tower has a newer top hatch but the lower hatch is poor and the ladder lacks any handrail extension features. Replace the lower hatch and install a railing extension unit to the top of the access ladder. Also, relocate the roof transition ladder that is located too close to the edge of the roof to help improve safety for service personnel.

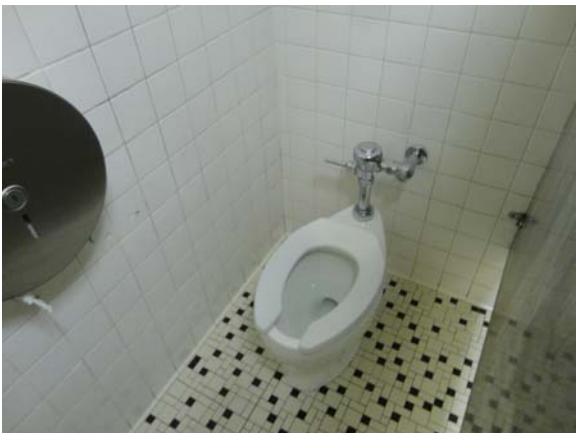
SPEI015a 5/11/2021
Older standard tankless water closet
Third floor, all-gender restroom

Restrooms have older fixtures and none of these facilities are accessible despite the accessible restroom signage. It is recommended that both all-gender restrooms, as well as the men's and women's restrooms, be upgraded with new accessible fixtures, accessories, and finishes. All of the restrooms should be fitted with accessible power door assist units to further improve access. Also, upgrade all of the aging single-level water fountains with new fully accessible dual-level fountains set in wheelchair accessible corridor alcoves.

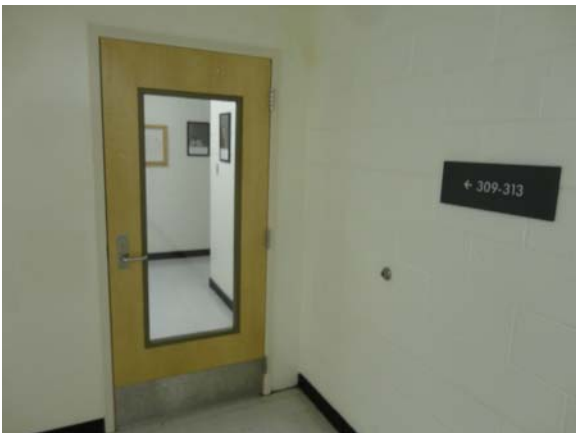
SPEI018a 5/11/2021
Newer door with lever hardware
Third floor corridor

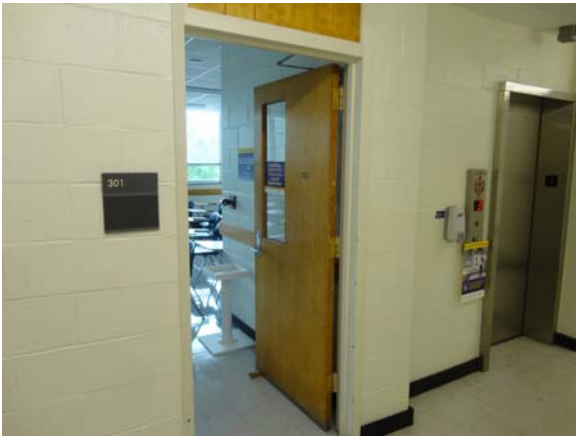
SPEI020a 5/11/2021
Aging original nonrated door
Third floor corridor

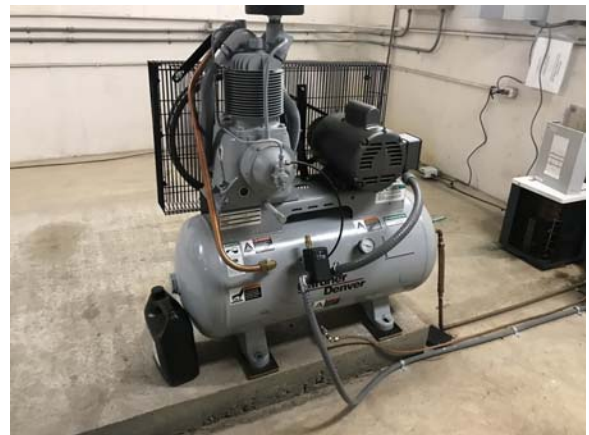
SPEI030e 5/11/2021
Controls air compressor
Room 165
