EAST CAROLINA UNIVERSITY

Facility Condition Assessment
Umstead Residence Hall (075)
Asset UMST

Inspected May 12, 2021

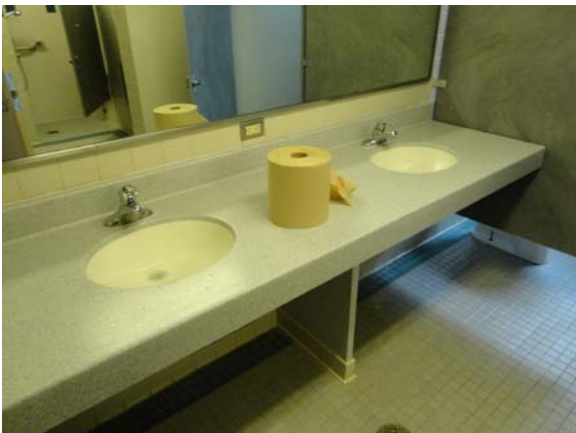
UMST015a 5/12/2021
Updated counter lavatories
Third floor, men's central hall bath

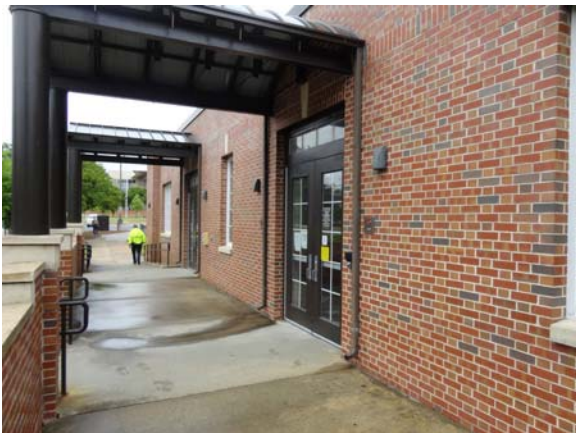
UMST052a 5/12/2021
Sign of blocked drain scupper
Lower south roof

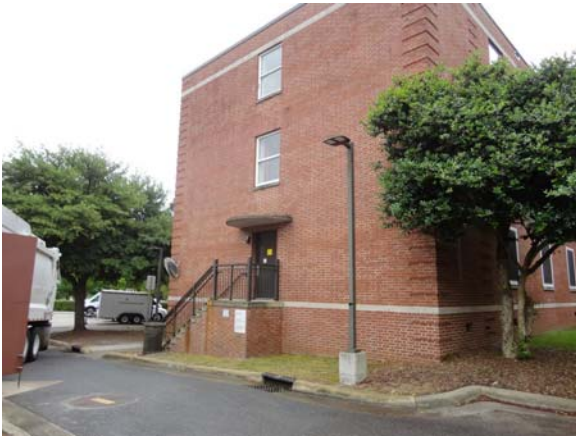
UMST062a 5/12/2021
Only one handrail on service stair
East basement service entry
