EAST CAROLINA UNIVERSITY

Facility Condition Assessment

Whichard Building (031)

Inspected May 10, 2021

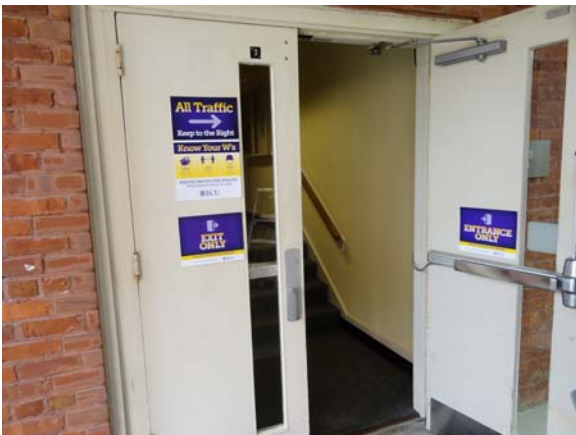
WHIC018a 5/10/2021
Newer exterior doors
Second floor, original building north exit

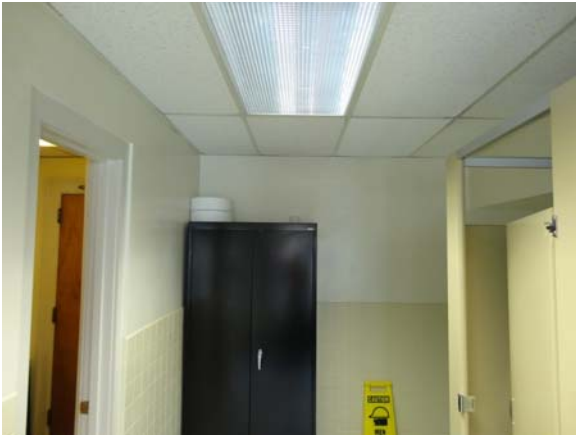
WHIC022a 5/10/2021
Tile wainscot and acoustical ceiling
Second floor, men's restroom

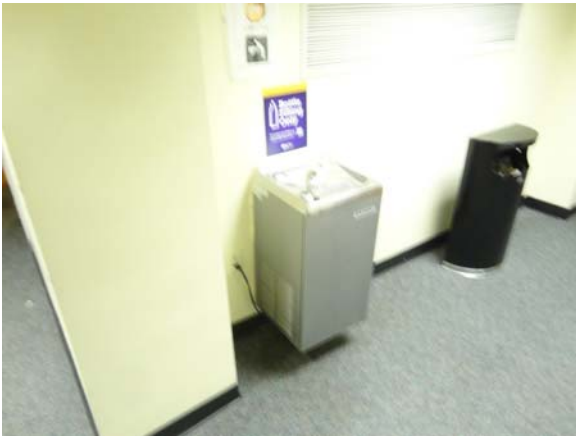
WHIC026a 5/10/2021
Aging, single-level water fountain
Second floor, original building corridor
