EAST CAROLINA UNIVERSITY

Facility Condition Assessment

Belk Building

Inspected January 11, 2023

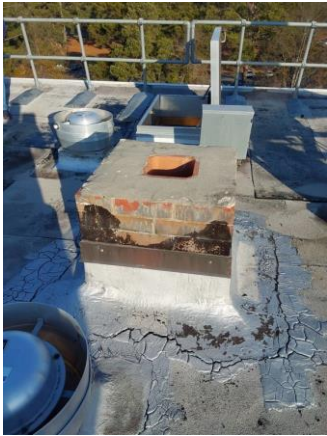
013002a 1/11/2023
Original brick stack
Roof

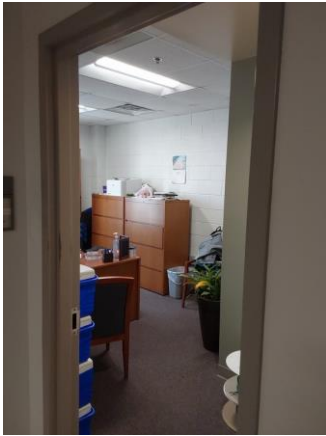
013016a 1/11/2023
Typical office finishes
Room 3409

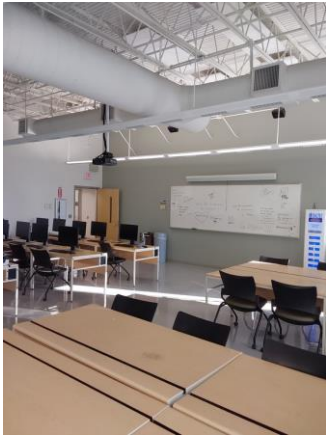
013017a 1/11/2023
Computer lab with finishes shown
Room 3102

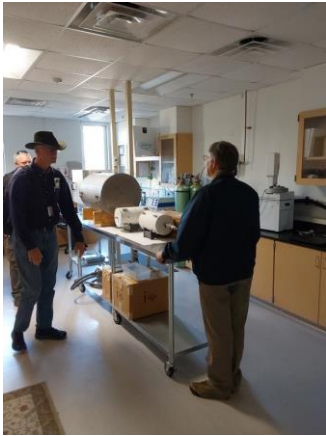
013023a 1/11/2023
Low intensity lab with solid surface counters
Room 3301

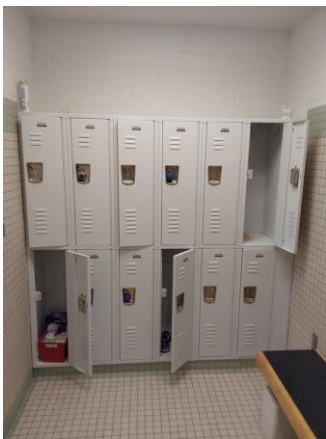
013030a 1/11/2023
Women's lockers
Room 2702

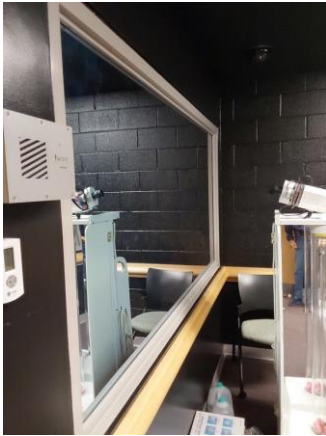
013032a 1/11/2023
Observation glass
Room 2104

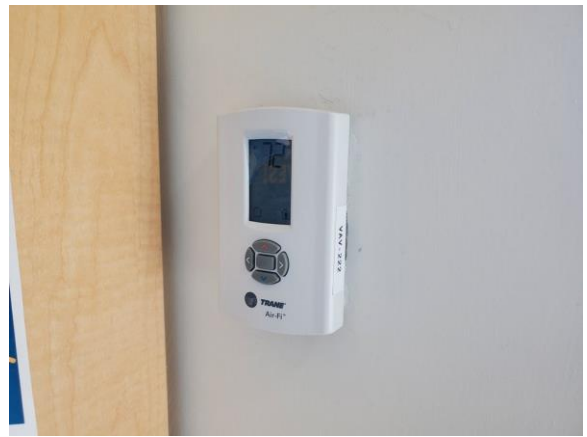
013033e 1/11/2023
Updated thermostat
Second floor corridor

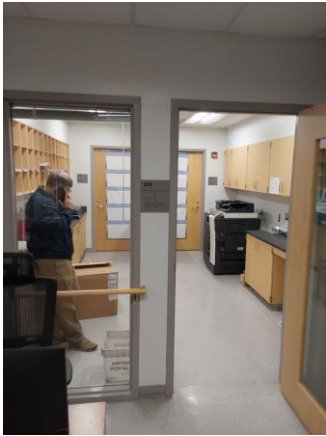
013034a 1/11/2023
Copy room casework
Room 2219

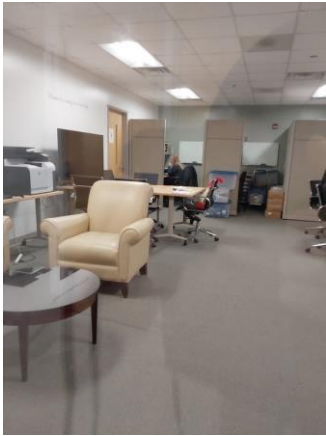
013037a 1/11/2023
Large office with finishes
Room 2601

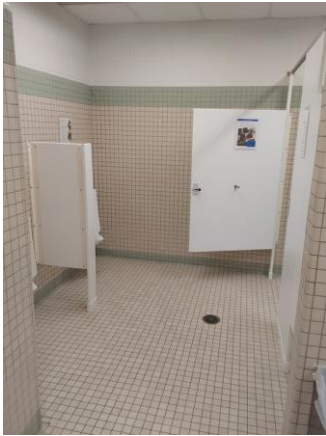
013038a 1/11/2023
Ceramic wall and floor tile and partitions
Room 2702

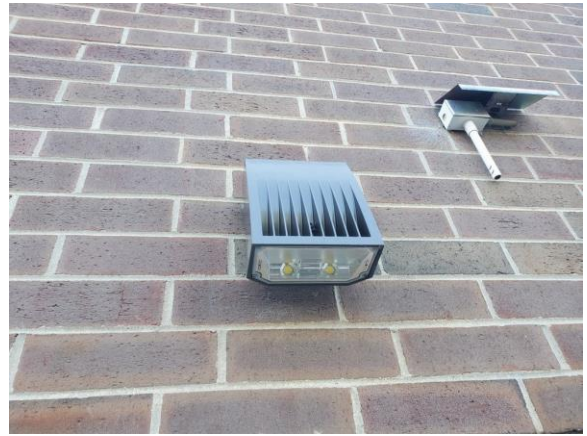
013068e 1/11/2023
Updated LED exterior lighting
Exterior
