# EAST CAROLINA UNIVERSITY

Facility Condition Assessment

Flanagan Building

Inspected January 9, 2023

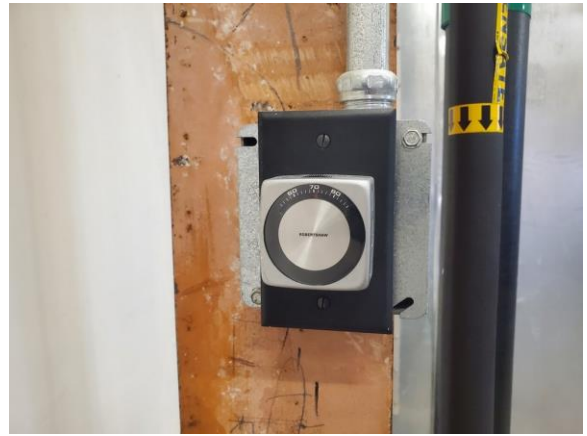
002017e 1/9/2023  
Aged thermostat  
Room 450

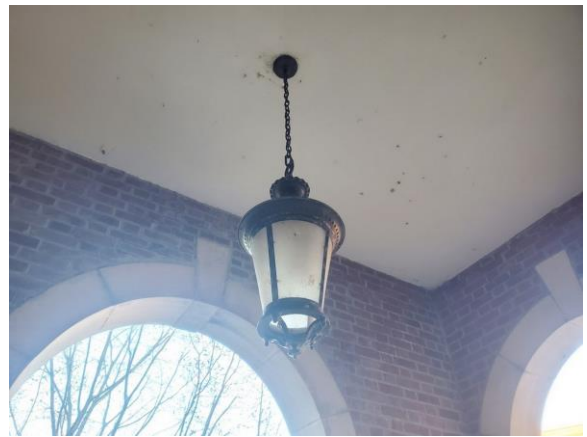
002054e 1/9/2023  
Elegant, pendent style exterior light  
Stair 2006

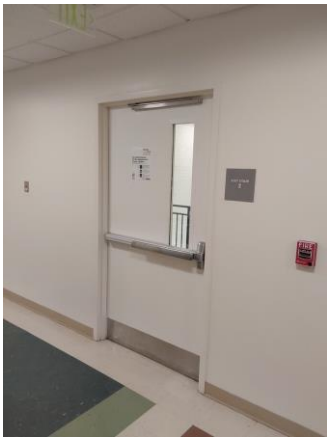
002057a 1/9/2023  
Typical panic hardware  
Stair 2

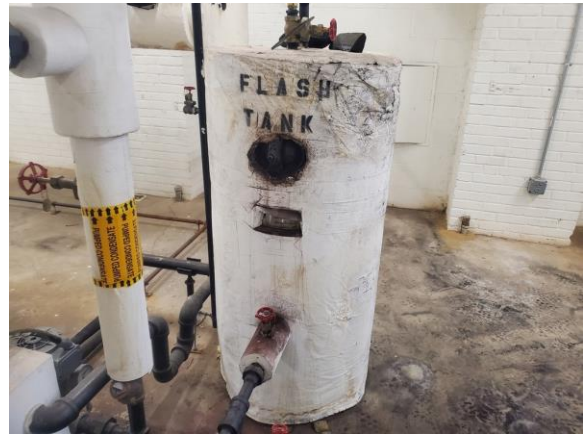
002062e 1/9/2023  
Flash tank  
Room 153

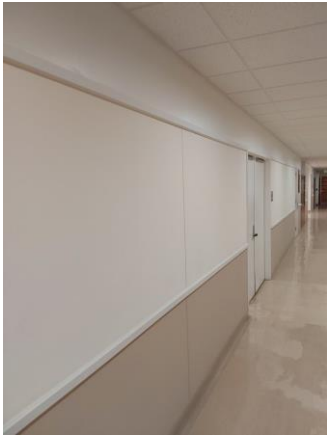
002083a 1/9/2023  
Corridors with welded seam vinyl flooring  
Room 140

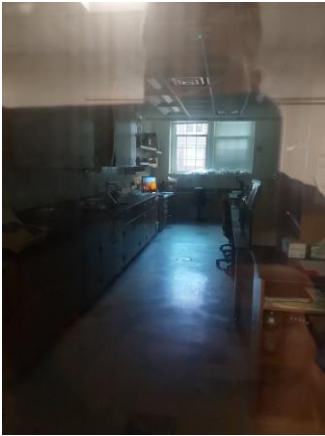
002087a 1/9/2023  
Door access control boxes first floor  
Room 170

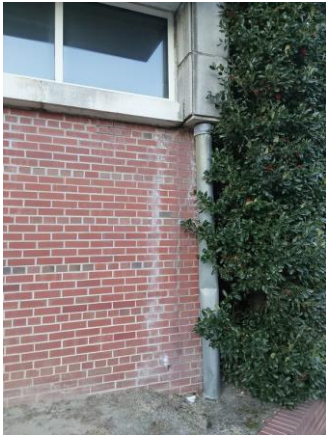
002112a

Water deposits on brick  
South elevation

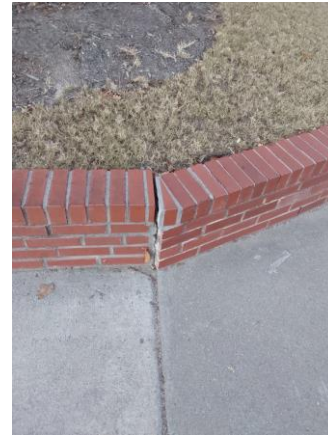
002113a

Damaged brick knee wall  
South elevation
