# EAST CAROLINA UNIVERSITY

Facility Condition Assessment

Fletcher Music Center

Inspected January 10, 2023

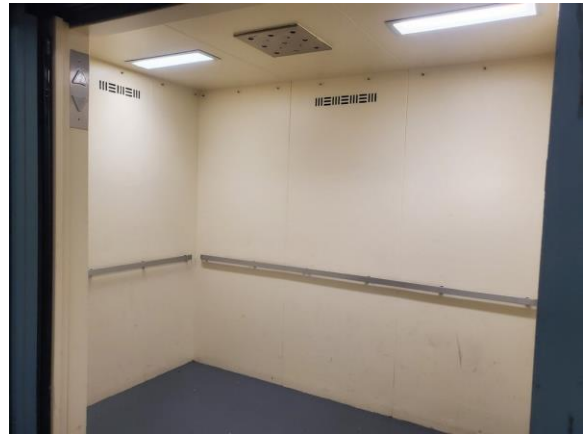
009005e 1/10/2023  
Interior of passenger elevator  
Elevator

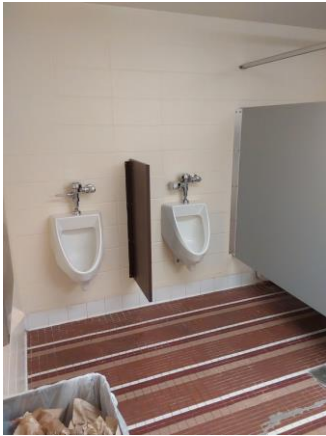
009008a 1/10/2023  
Urinals  
Room OA381

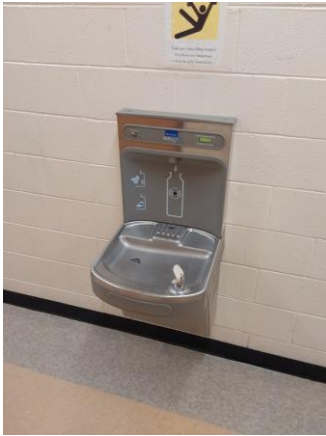
009041a 1/10/2023  
Single water fountain with bottle filler  
Room OA118

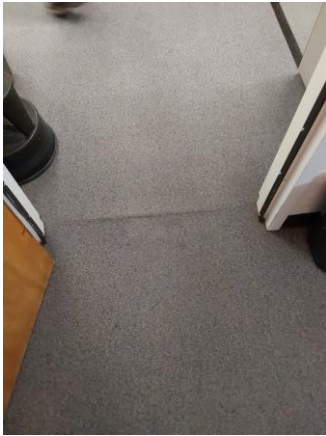
009046a 1/10/2023  
Threshold bump  
Room OA110 E

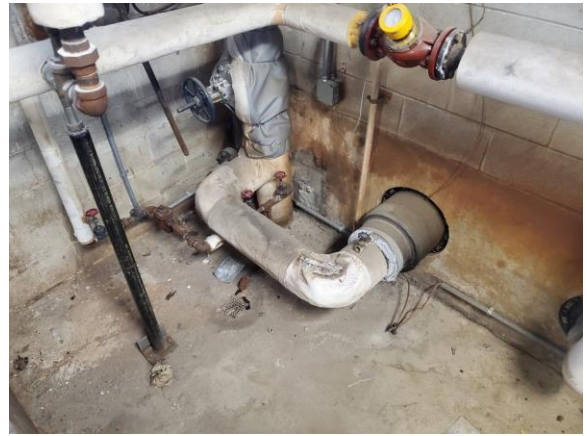
009047e 1/10/2023  
Main steam from utility system  
Mechanical 124

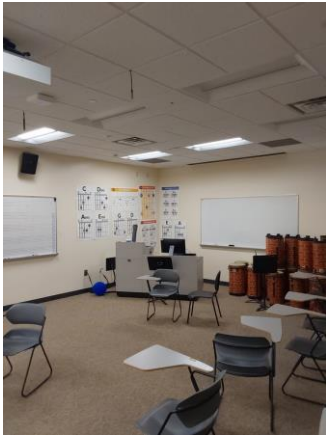
009052a 1/10/2023  
Music education room finishes  
Room OB126

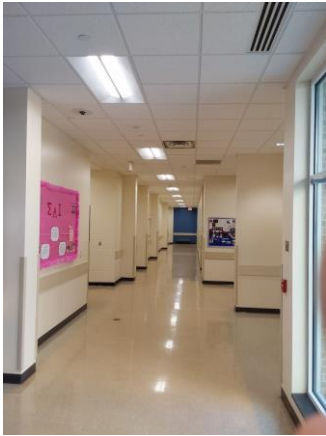
009053a 1/10/2023  
Typical finishes for newer portion of corridors  
Room OB117

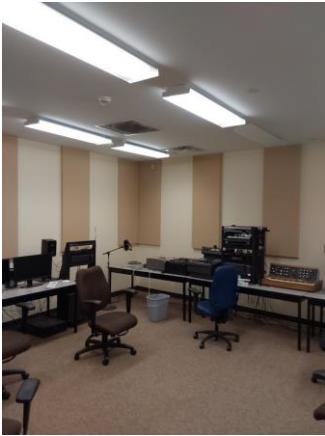
009059a 1/10/2023  
Electronic music room with acoustic panels  
Room OB113

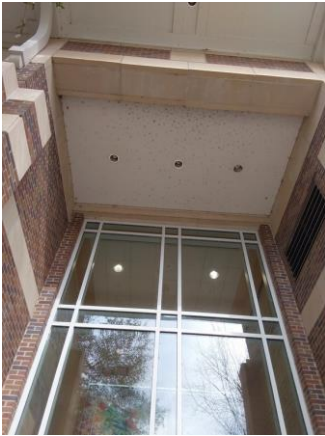
009115a 1/10/2023  
Main entrance  
South elevation
