EAST CAROLINA UNIVERSITY

Facility Condition Assessment

Joyner East

Inspected January 12, 2023

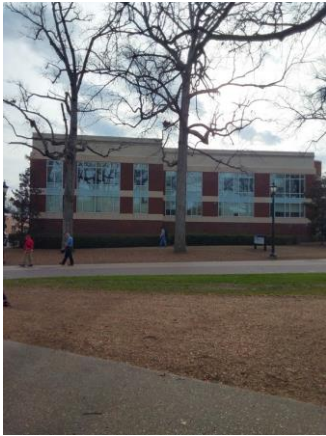
001A005a 1/12/2023
Custom glazing
North elevation

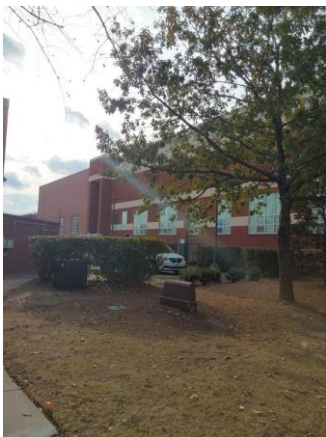
001A006a 1/12/2023
Glazing and drive
East elevation

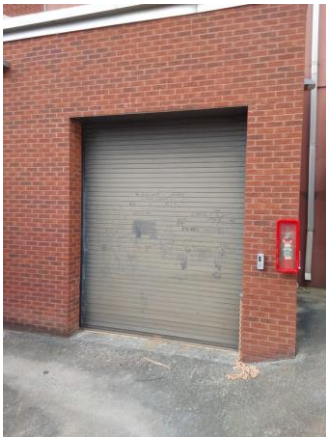
Both the glass and aluminum and hollow-metal doors are in good condition with no recommendations at this time. However, the overhead coiling door at the loading dock will require maintenance for the pads within ten years. The stationary storefront windows and curtainwall are all in good condition, as are the muntin style windows overlooking the basement roof.

001A011a 1/12/2023
Overhead coiling door
South elevation

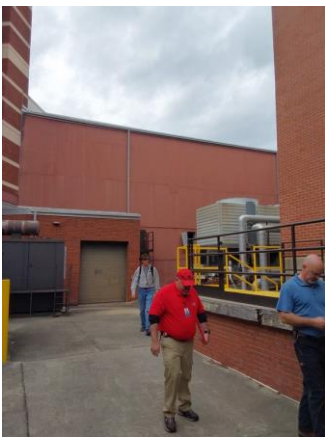
001A018a 1/12/2023
Back of water wall
West wall

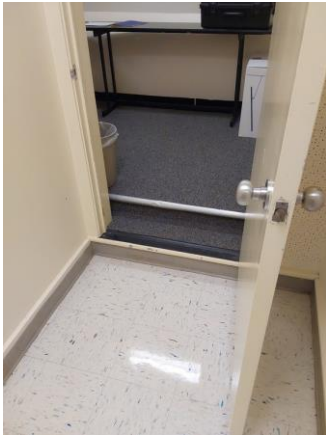
001A044a 1/12/2023
Step up threshold
Room 205B

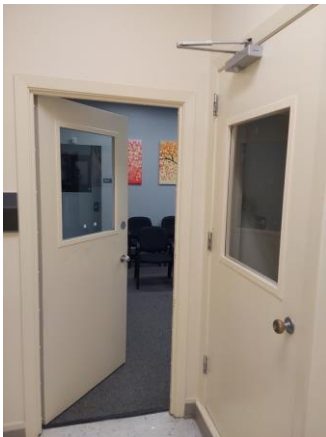
001A045a 1/12/2023
Doors with knob hardware and vision glass
Room 205C

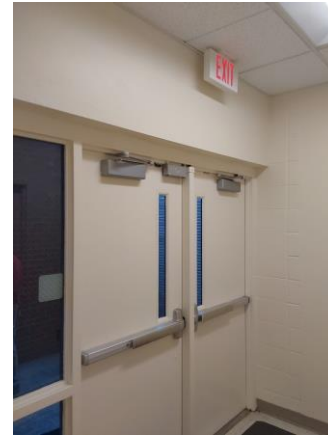
001A075a 1/12/2023
South exit doors with panic hardware
South corridor
