EAST CAROLINA UNIVERSITY

Facility Condition Assessment

McGinnis Auditorium

Inspected January 10, 2023

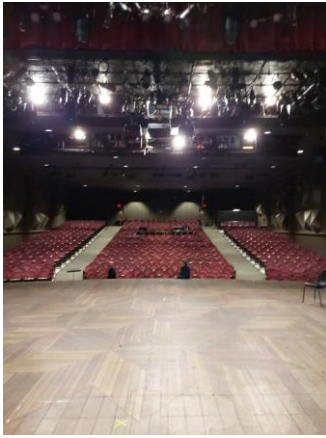
033011a 1/10/2023
Auditorium with 510 seats
Room 209

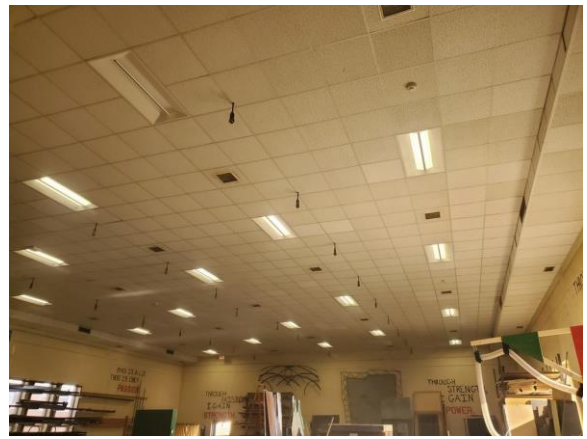
033012e 1/10/2023
2x4 recessed lighting
Scene shop 2-E-2

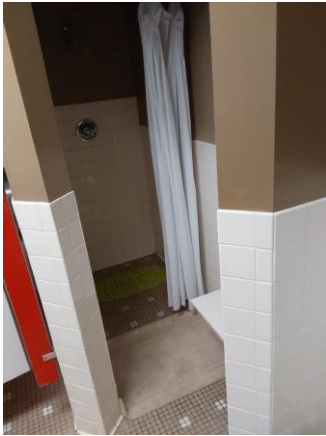
033053a 1/10/2023
Noncompliant shower
Room 128

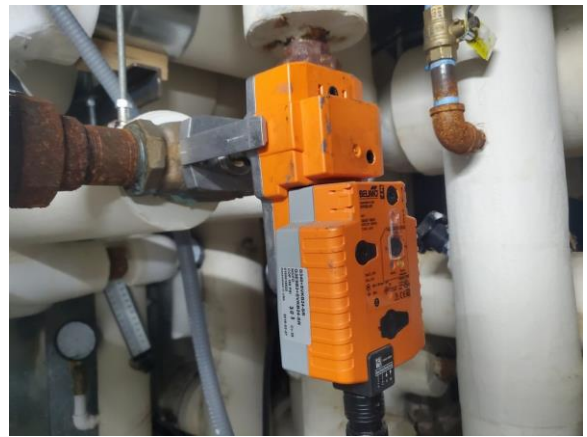
033057e 1/10/2023
Updated control components for major instrumentation
Mechanical 126

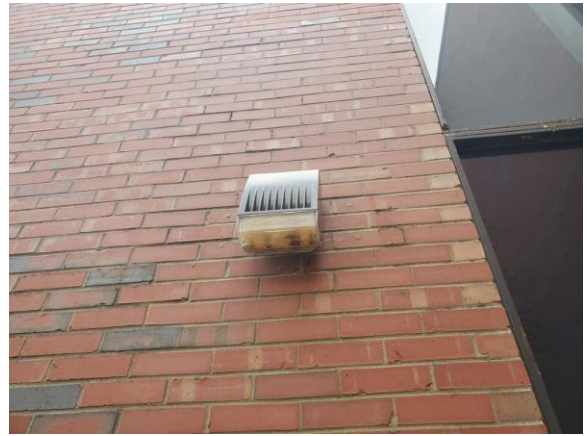
033064e
Surface-mounted LED light fixture
Exterior
1/10/2023

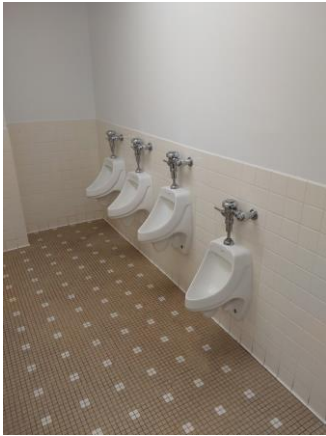
033065a
Urinals
Room 105
1/10/2023

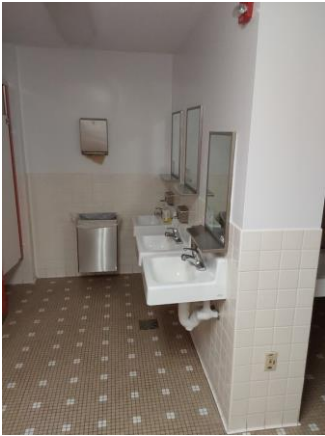
033068a 1/10/2023
Wall-hung lavatories and ceramic tile
Room 108

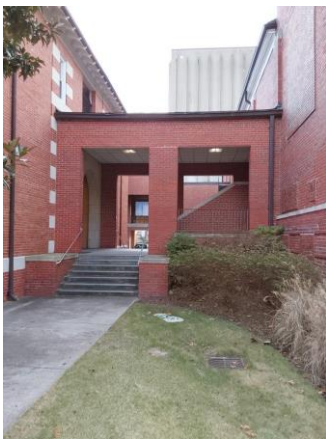
033085a 1/10/2023
Building connector
North elevation

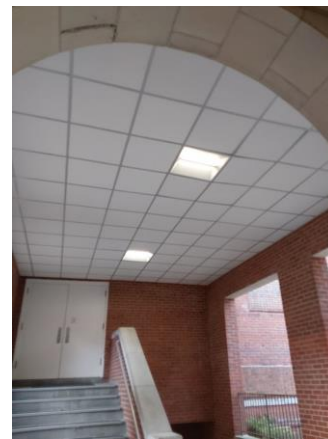
033086a 1/10/2023
Building connector ceiling
West arcade
