EAST CAROLINA UNIVERSITY

Facility Condition Assessment

Old Cafeteria Complex

Inspected January 26, 2023

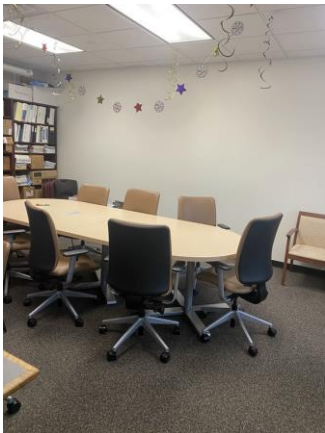
047008a 1/26/2023
Acoustical tile ceiling, painted walls, carpeting
Conference room

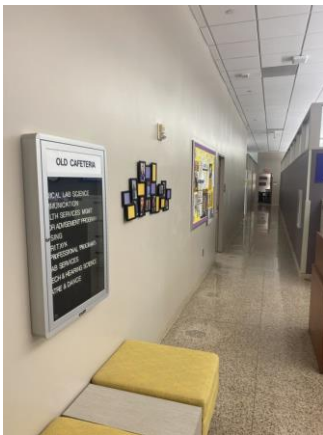
047024a 1/26/2023
Acoustical tile ceiling, painted walls, terrazzo
Work area

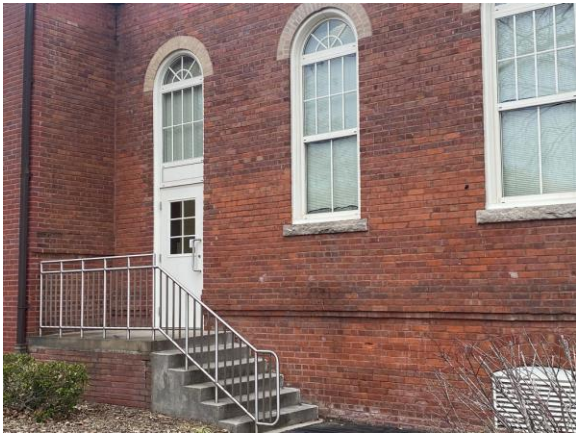
047034a 1/26/2023
Brick facade, glazing, metal and glass door
Exterior

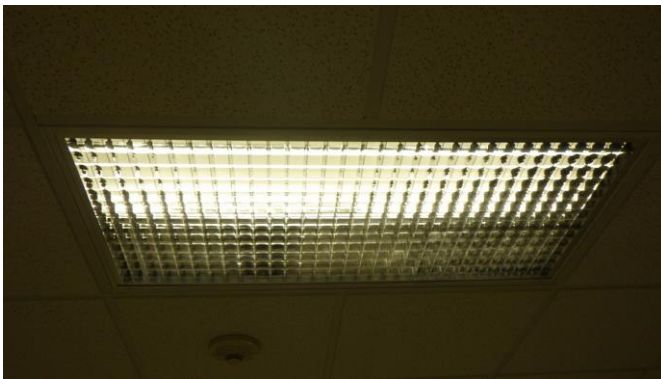
047073e 1/26/2023
Open parabolic lay-in fluorescent interior light fixture
Corridor G100A

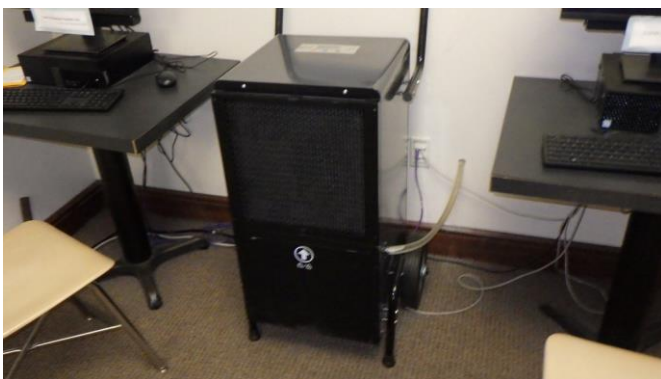
047075e 1/26/2023
Portable dehumidifier
Office suite G120
